Final report RO-2017-102: Signalling irregularity,  
Wellington Railway Station, 3 April 2017

Rail inquiry RO-2017-102  
Signalling irregularity  
Wellington Railway Station  
3 April 2017

Approved for publication: May 2018

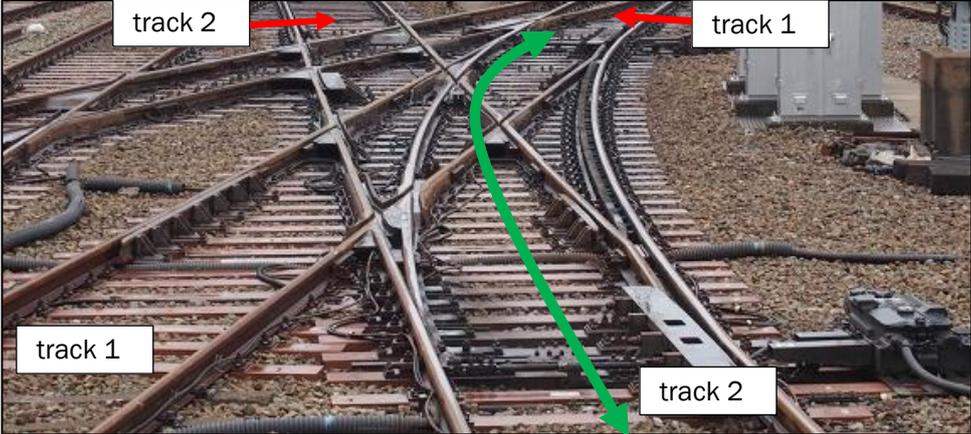
Figure 11  
Single slip switch. Track change

Rail traffic may change between track 2 and track 1 as switching equipment provides the capability to change tracks.

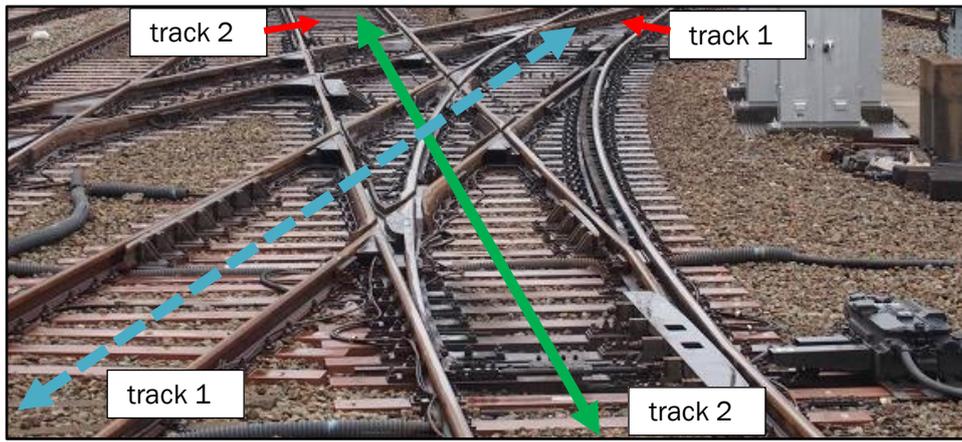
**Figure 12**  
**Single slip switch. No track changes**

Rail traffic may travel over track 1 or track 2. No track change is required
