# AIRGRAFT ACCIDENT REPORT

**No. 90-012T**

**BELL 206B ZK-HZX**

**Transport Accident Investigation Commission  
Wellington - New Zealand**

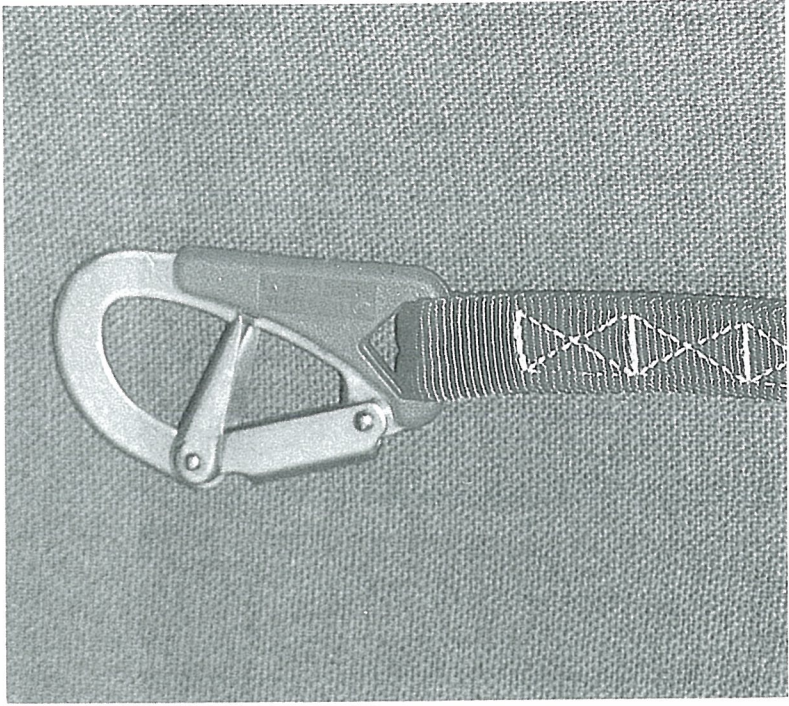
[FIGURE 31]

e. Karabiner falls free.

1.4 Each of the hooks had a guard, or keeper, across the open section of the hook.

1.25 An attempt to replicate the conditions which lead to the accident was not conclusive but each item of the equipment was intact and the process by which karabiners have been released from hooks with similar keepers was well known in several fields which used such equipment. As a result hooks have been designed with additional safeguards which prevent the keeper from moving under the influence of the karabiner once it is in place (See Fig. 3). As the man had checked the karabiner was in place on the hook prior to lift off it could not have come off by whatever means had a lockable keeper been available and used correctly.

1.32 The probable cause of this accident was the carriage of two men on a single hook, the lack of a keeper which was proof against a known hazard, the last man on the hook inadvertently applying a twist to his karabiner which secured his webbing harness as he placed the karabiner on the hook and the
