NO. 93-020

**MID-AIR COLLISION
AEROSPATIALE AS 355 F1 HELICOPTER
PIPER PA 28-181
ZK-HIT/ZK-ENX
AUCKLAND CITY
26 NOVEMBER 1993**

This report explains the mid-air collision of a AS 355 helicopter with a PA 28 aeroplane, both on Police patrol flights over Auckland City on 26 November 1993. Safety issues discussed include the limitations of the "see and avoid" concept of collision avoidance, the use of radio contact between aircraft and the variety of radio frequencies in use.

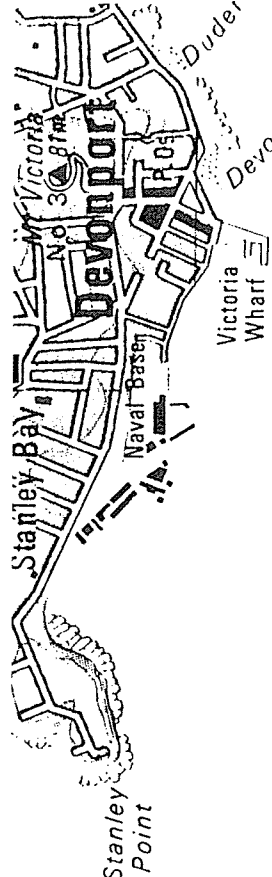
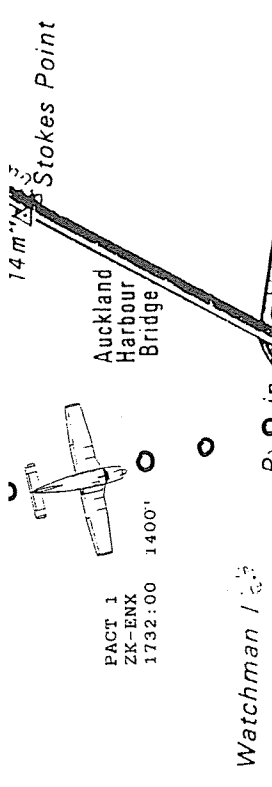
Figure 1

1.16.4. Some smoothing and interpolation was used to produce the track plots derived from the primary and secondary radar plots, which are shown overlaid on a map of Auckland (Figure 1). A few secondary radar returns for each aircraft were missing, either as a result of terrain masking, or the aircraft turning and thus shielding its transponder aerial from the radar. The altitude information shown was that derived from each aircraft's encoder by ATC. The first radar return of Police 1 was at 600 feet, heading south-west, so the flight path to that point is an estimate only.

2.9. The track plot, figures 1 and 3, showed that at 1734:00, 48 seconds before the collision, the aircraft were closing as ZK-ENX had started turning some 10 to 15 seconds earlier. At that time they were about 3000 m apart and would have each presented a visual target of some 2.4 minutes of arc in size.
