Report 95-004

**Beech 65-A80-8800 Queen Air
(Excalibur Conversion)**

ZK-TIK

29 March 1995

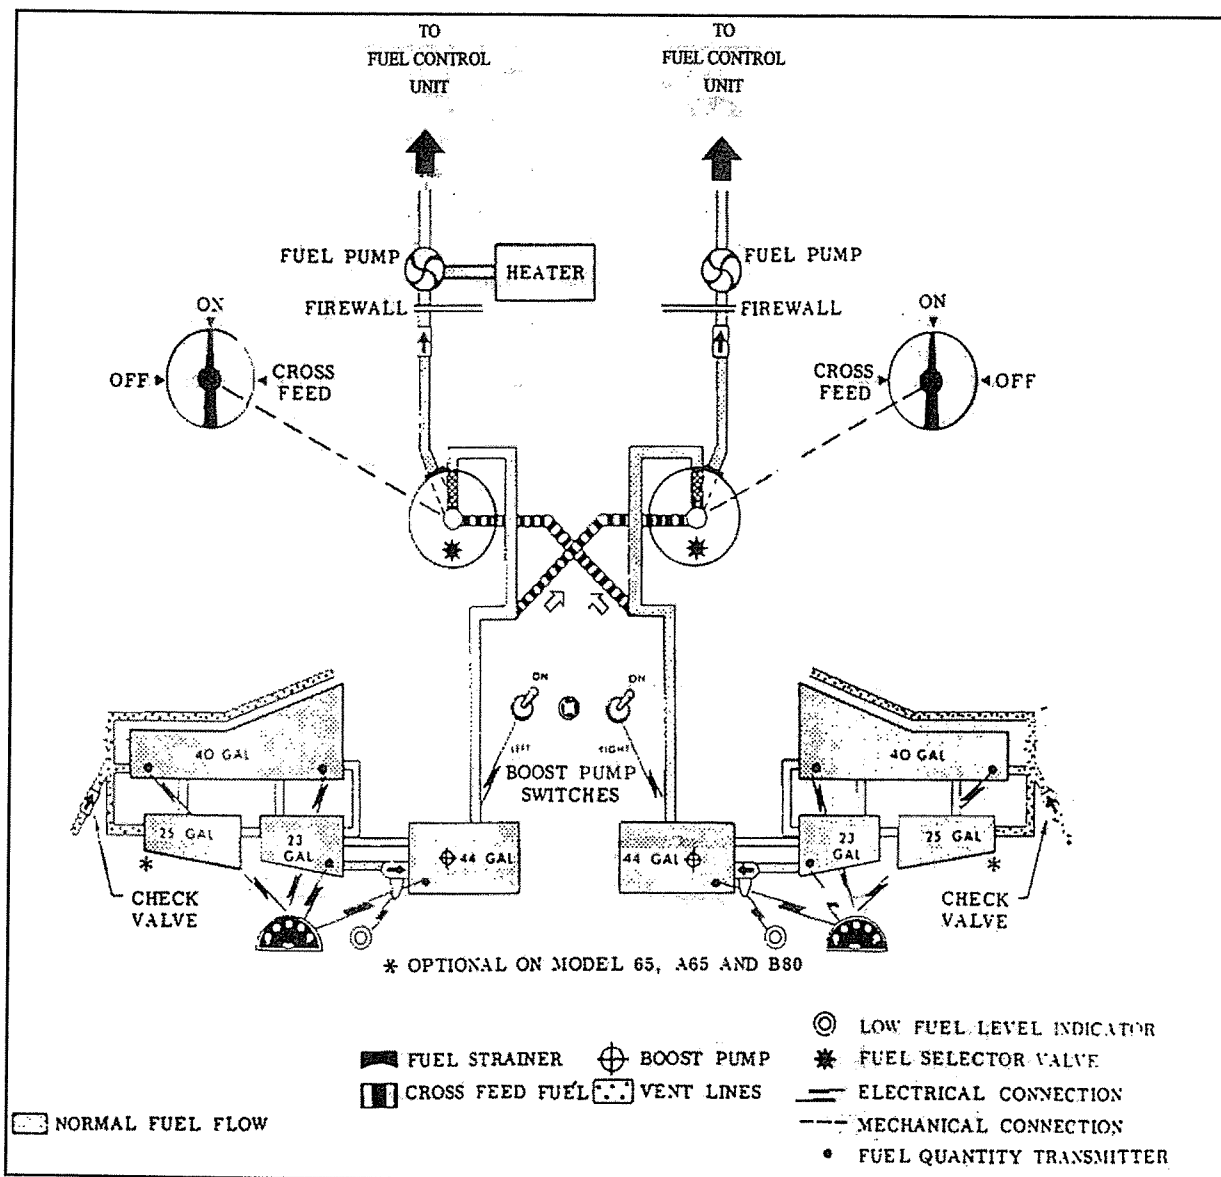
Figure 3
ZK-TAK (B80) fuel system
(For comparison)

- 1.6.16 The Queen Air B80 fuel system and selector panel, as applicable to the operator's other aircraft, ZK-TAK, are shown in Figures 3 and 4 respectively. The number, location and capacity of the individual fuel cells are identical to the A80 system, but differences exist in the configuration and management of the system. The principal differences from the A80 system are:

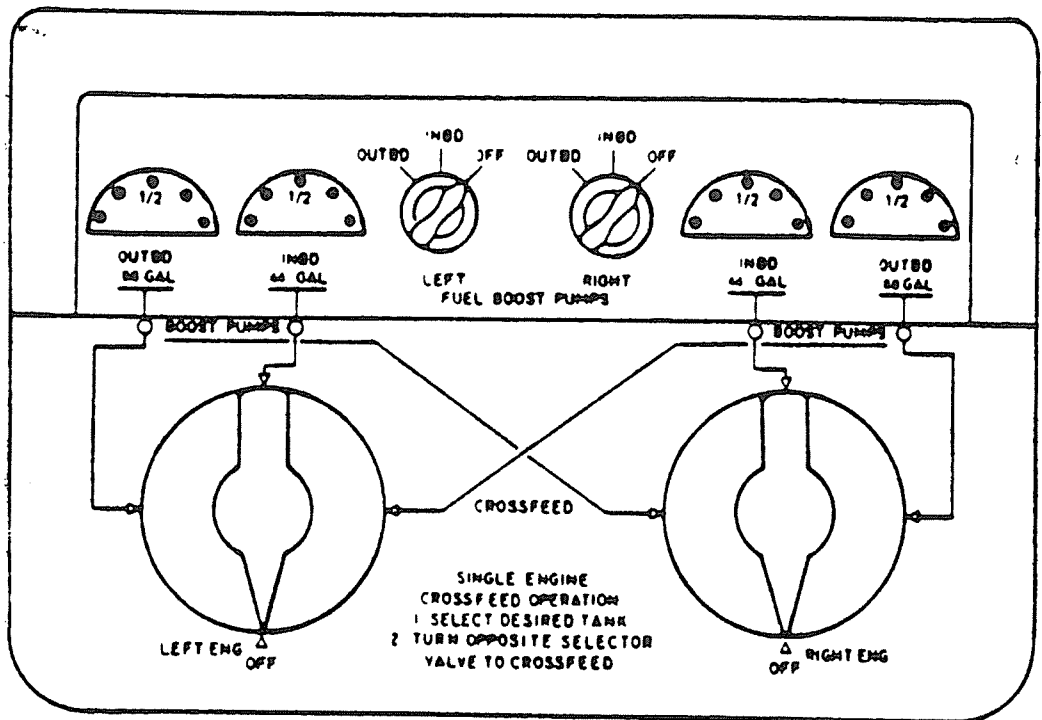
ZK-TIK (A80)

1.6.14 The fuel panel, incorporating the selector handles, boost pump switches and contents gauges, is located on the cockpit left sidewall, immediately beneath the pilot's side window, and is accessible only to the pilot occupying the left seat (but visible to the pilot in the right seat). A
