No. 95-203

Wave-Piercing Catamaran *Condor 10*

Queen Charlotte Sound

16 April 1995

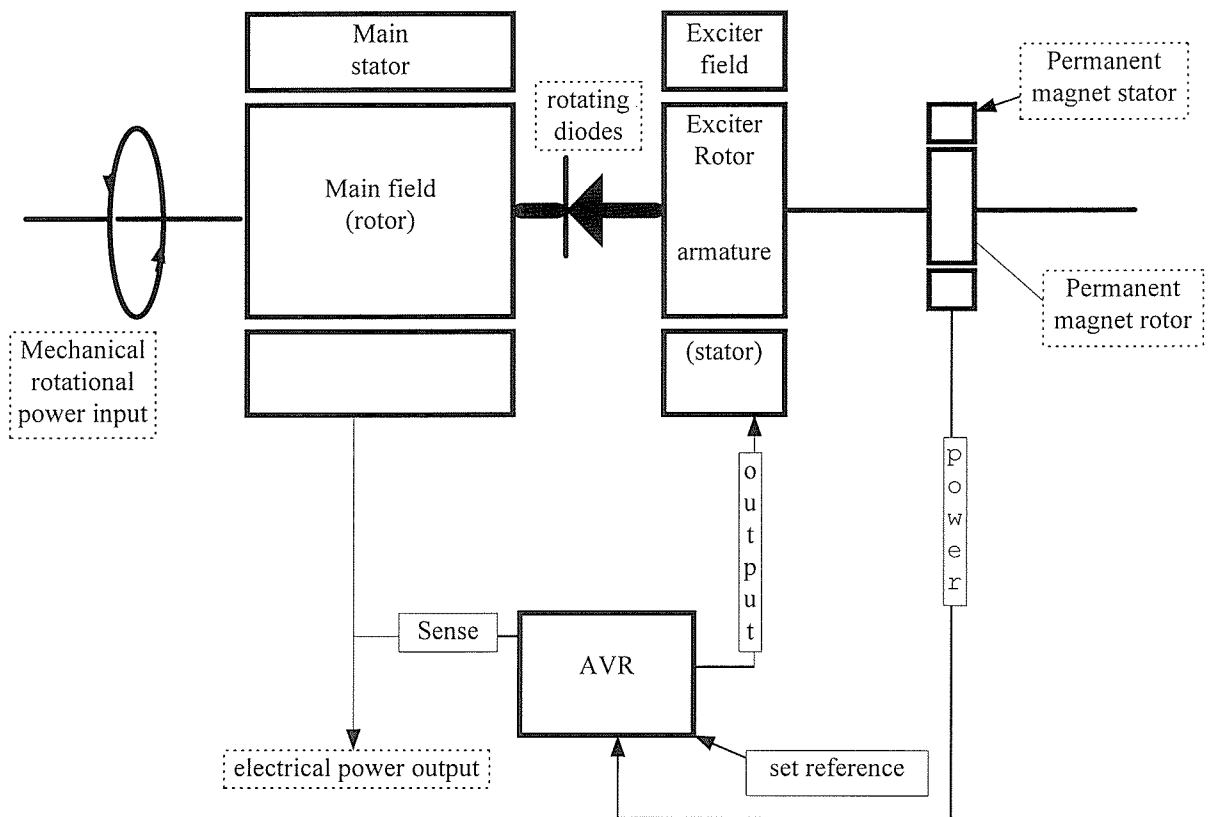
Figure 3

1.5.2 The alternators use a permanent magnet generator (PMG) to generate excitation power for the automatic voltage regulator (AVR). The AVR regulates the alternator rotor current via the exciter field, to maintain the alternator output at the nominal value. (see figure 3)

**Block schematic diagram showing principle of operation
(Stamford UCM274 alternator)**

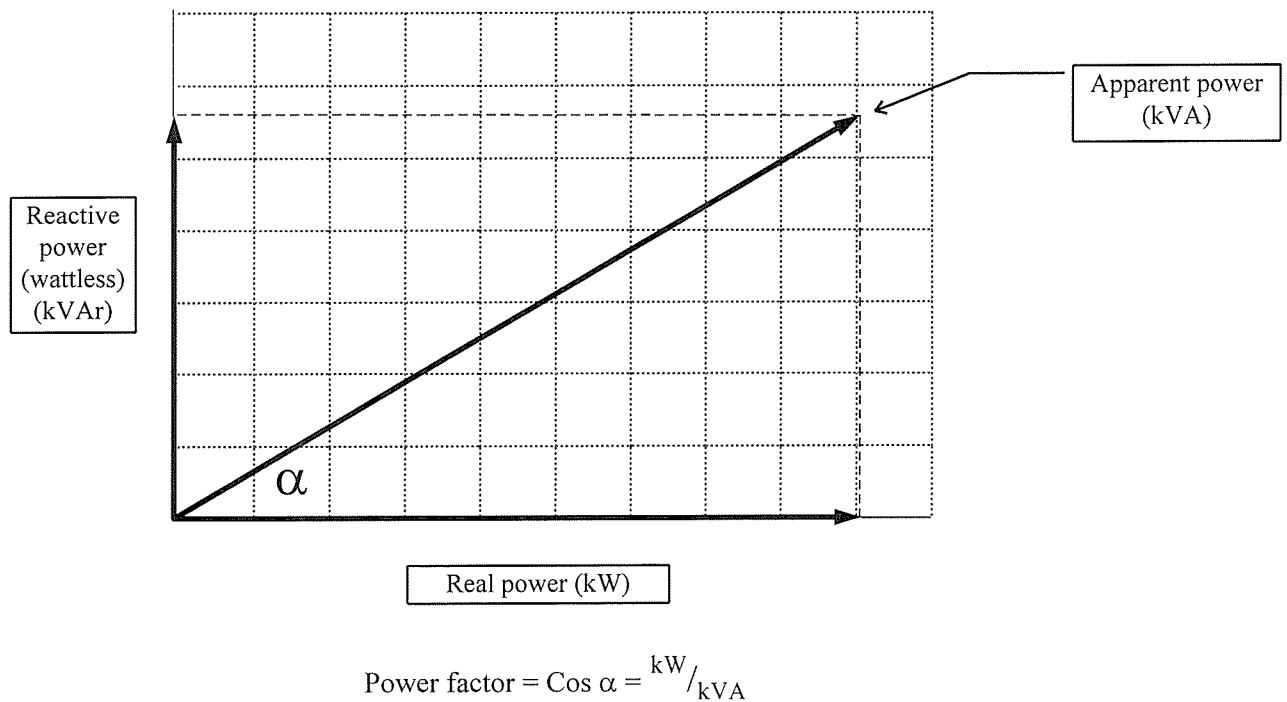
Figure 4

- 1.5.8 The generation control system on *Condor 10* detects only the true power transferred to the loads. With inductive loads such as the electric motors on *Condor 10*, there is a substantial component of reactive power (sometimes referred to as "wattless" power), as well as real power required for the load. The generators still have to supply the reactive power but it is returned to the system during the second half of each supply voltage cycle. In other words reactive power circulates between the load and the generators rather than being permanently transferred to the load as work. (See figure 4)

Power Vector Diagram
