Report 96-209

Longline Fishing Vessel *Warlock*

20 August 1996

Marine Accident Report 96-209

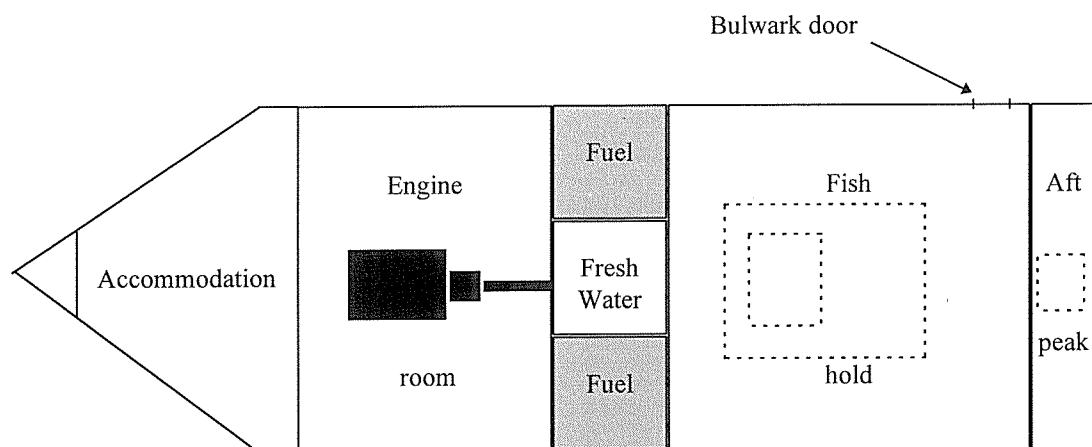
Figure 2
Under deck plan of *Warlock*
(Diagram not to scale)

- 1.2.5 The *Warlock's* engine room was located amidships with the accommodation forward of the engine room (See Figure 2.). The wheelhouse, located on top of the engine room, had a rear-facing, sliding door which opened onto the aft deck. Access to the accommodation and engine room was from inside the wheelhouse.
- 1.2.6 The fish hold was located aft of the fuel and fresh water tanks. It was fitted with removable pond boards, to prevent the catch from shifting, and an aluminium hatch cover. A smaller working hatch was located within the main hatch cover. There was no means of securing the main hatch cover, other than a lug for fitting a padlock. Its own weight was relied on to form a seal.
