Report 96-212

Restricted-Limit Fishing Charter Boat *Lambo*

foundering

26 November 1996

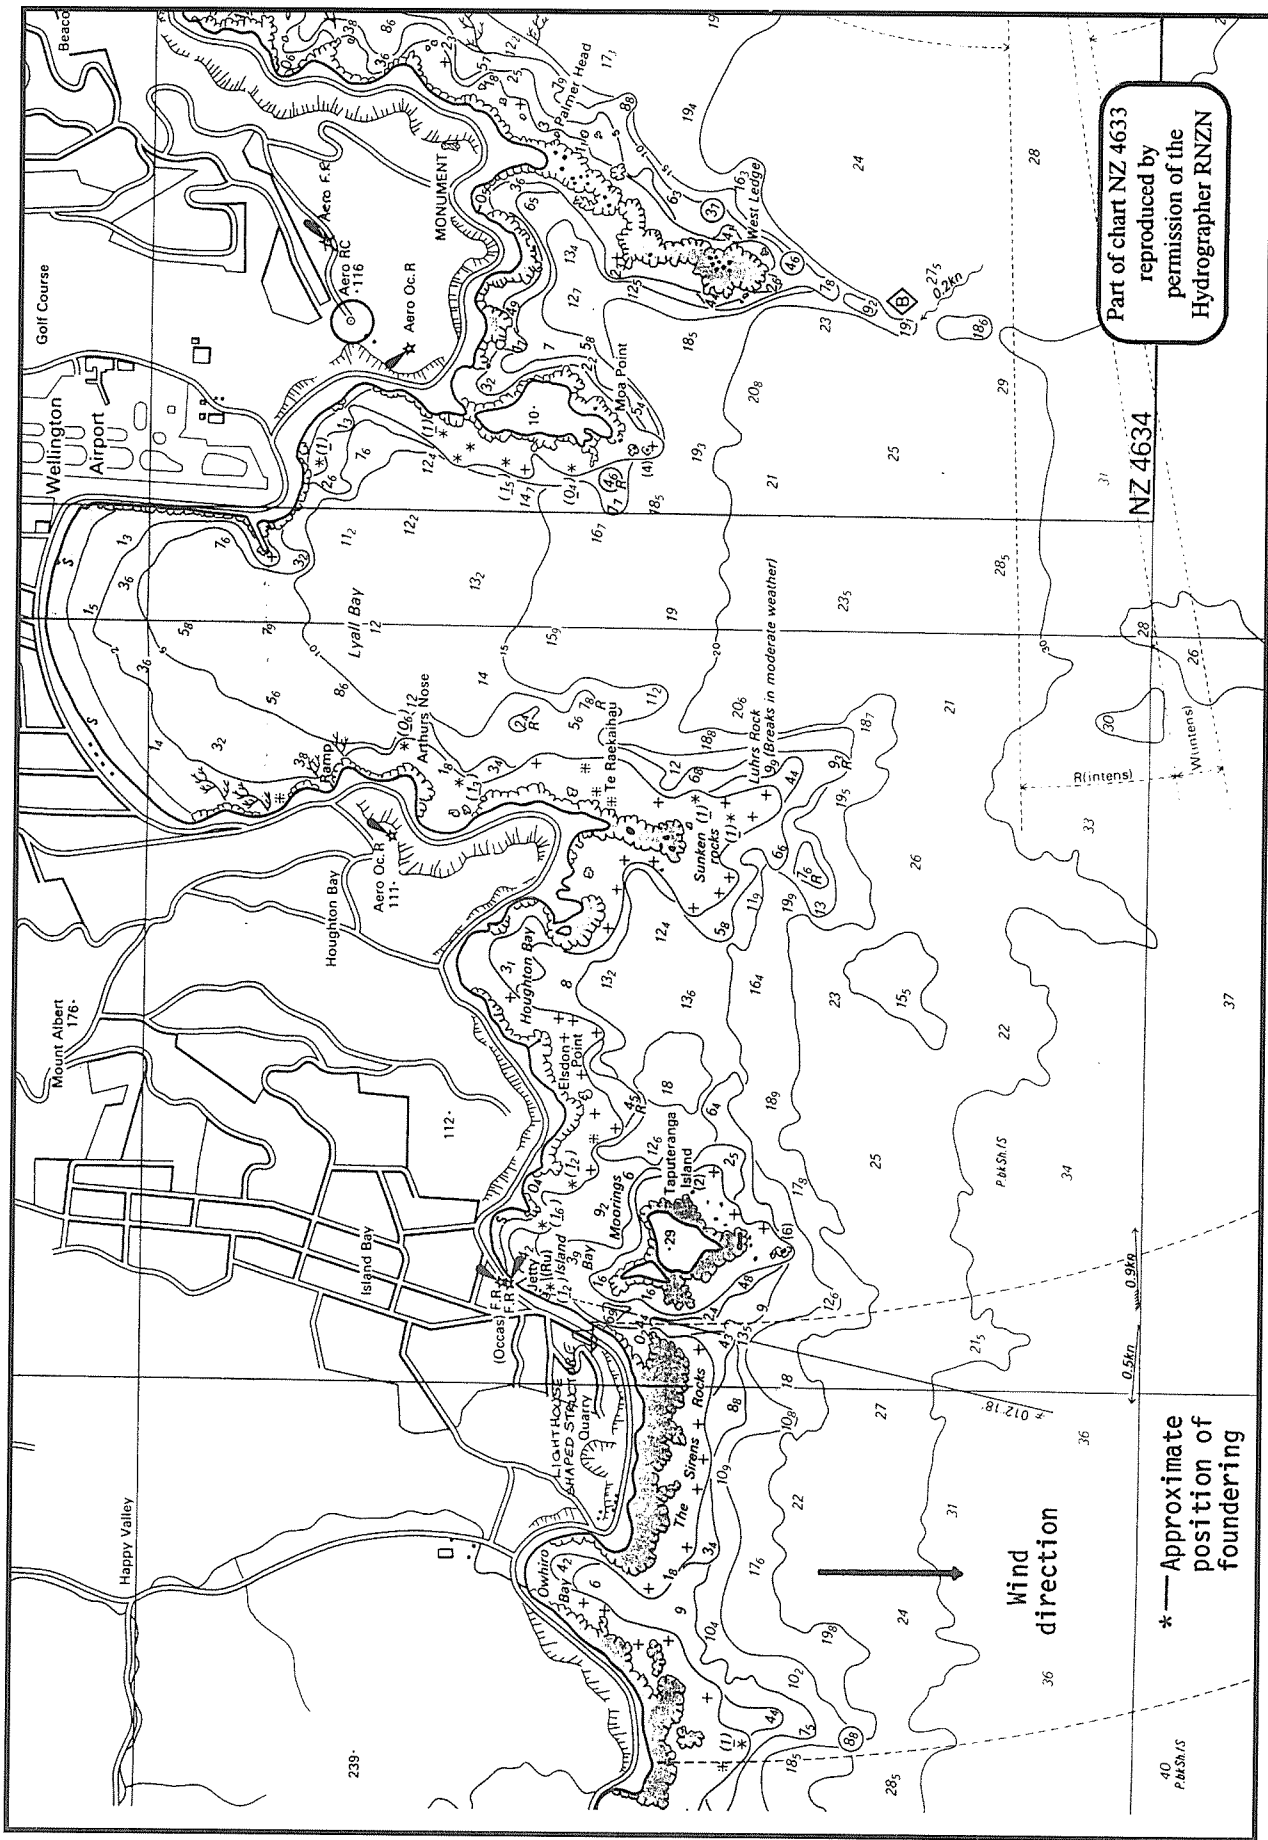
Figure 1
Part of south coast, Wellington

- 1.1.10 The skipper anchored the *Lambo* off Moa Point at about 0800 hours. He would normally have fished in the slight chop and ground swell that was running there, but with five people on board, and one of them in a wheelchair, he decided to move in closer in the lee of the coast off Houghton Bay. (Refer to Figure 1 for locations)
