Report 98-101

Train 721

heat buckle derailment

near Scargill

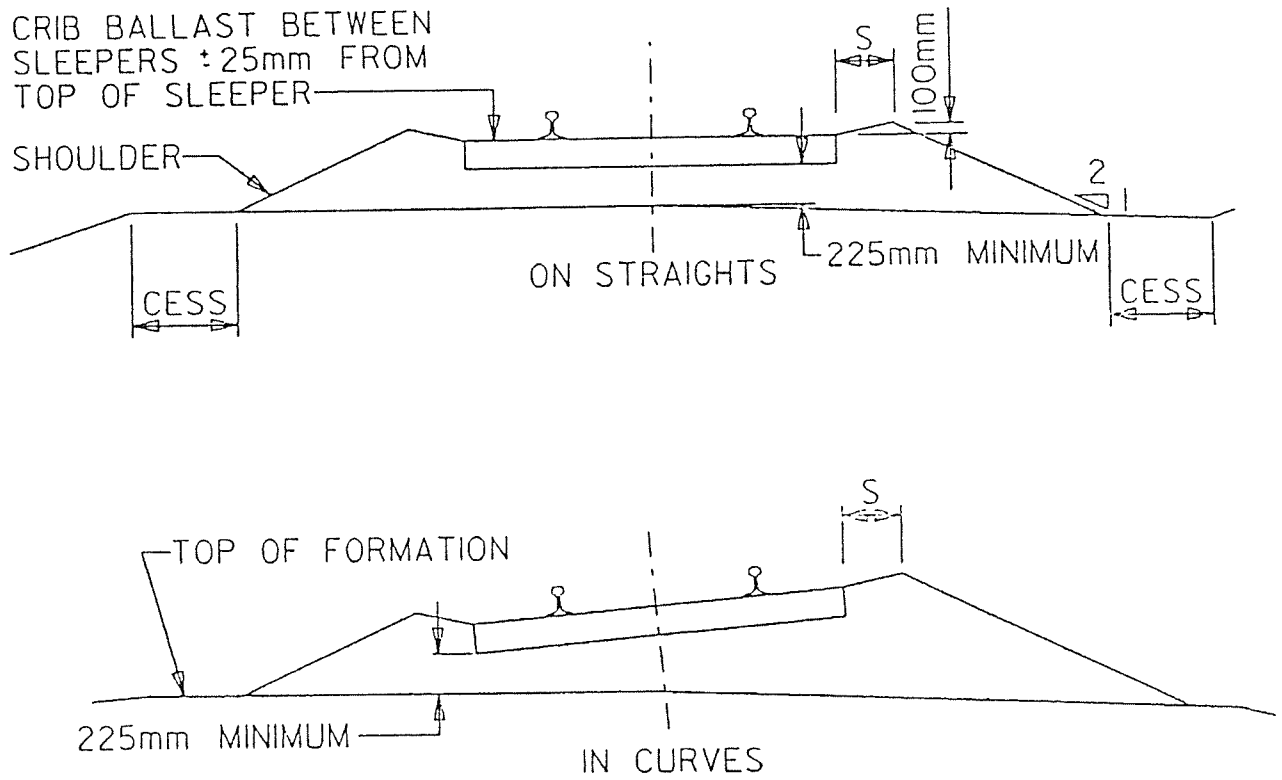
¹ This entry relates to the curve on which the derailment occurred. It indicates the track was sitting too high on the embankment (pinnacle track) due to successive tamping raising track level and leaving insufficient embankment width to provide the required ballast profile. As a result of this the curve had intermittent areas of weak shoulders.

MINIMUM SHOULDER WIDTH 'S'

ON STRAIGHTS AND CURVES 400m RADIUS AND OVER, BOLTED AND WELDED TRACK.	350mm
ON CURVES UNDER 400m RADIUS	
BOLTED TRACK	350mm
WELDED TRACK	450mm
