Report 98-201

general cargo vessel *T.A. Explorer*

grounding

19 January 1998

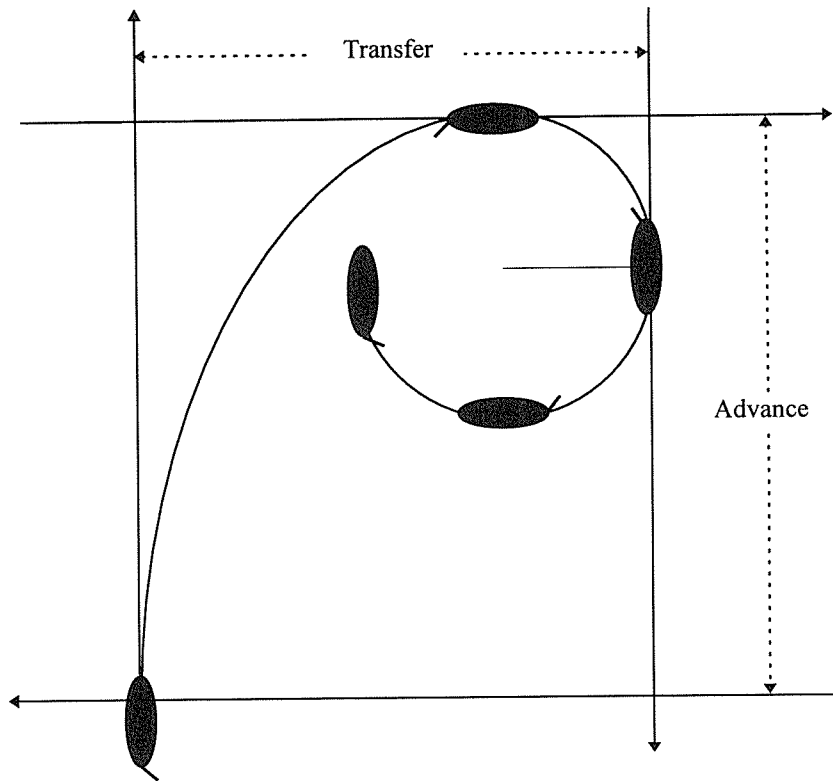
Figure 3
Example of a turning circle diagram
 (Diagram not to scale)

- 1.7.2 Vessels entering or departing Nelson have to negotiate a tight 94° turn in the channel which has an approximate radius of 2.6 cables. On an outward passage, when a turn is commenced near the southern end of Main Wharf, the available advance (see Figure 3) for a vessel to make the turn and end up close on the main leads, is about 3.65 cables.

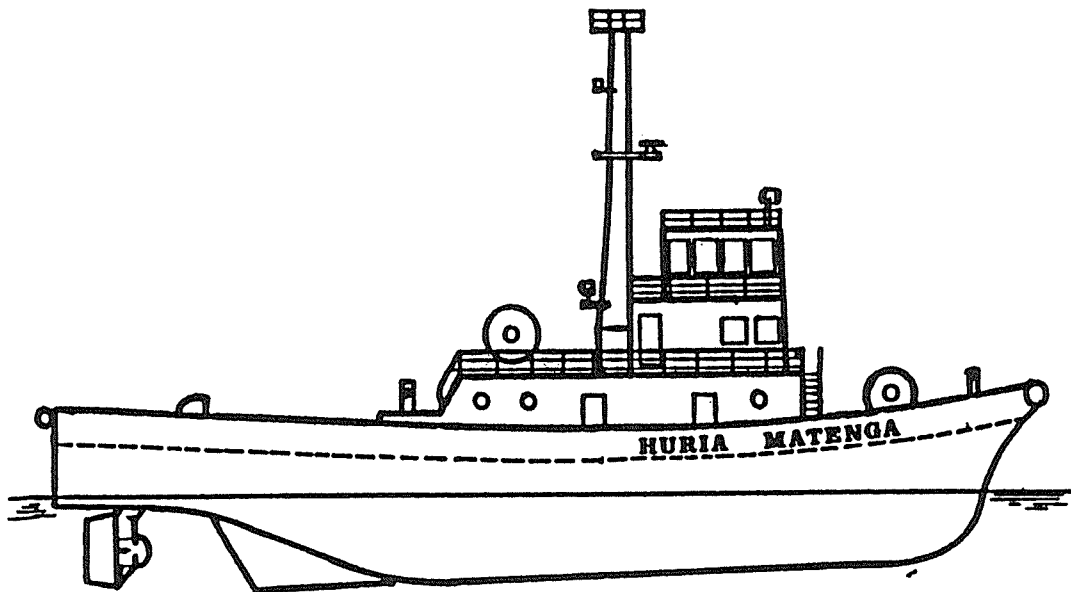
Figure 4
Tug *Huria Matenga*

- 1.4.1 The *Huria Matenga* was a 30.5 m azimuth stern drive (ASD) harbour tug (sometimes referred to as a reverse tractor tug). Propulsion was by two 1120 kW Niigata diesel engines, each driving an omnidirectional, fixed-pitch propeller shrouded by a Kort nozzle. The design name for these drive units is “Z-pellers”. The two Z-pellers were located near the stern of the tug.

1.4.6 The *Huria Matenga* was fitted with a retractable Pitot Speed Log; however, it was never used due to the shallow conditions in which the tug operated, and due to the unreliability of the log in the often turbulent waters associated with ship manoeuvring, which meant that the tug skipper could only estimate the speed of the tow.

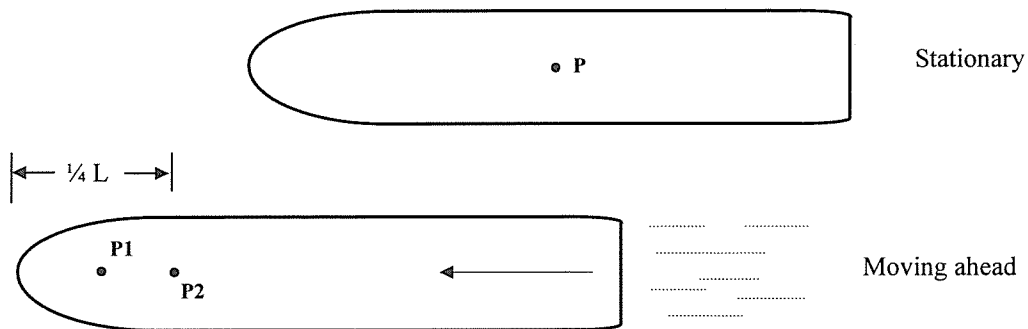
**Figure 5
Pivot point**

1.9.3 Referring to Figure 5 below, when a ship begins making headway, forward movement is initially resisted due to inertia. The pivot point (P) moves forward to a position about one eighth of the length of the vessel from the bow (P1). As speed increases, the forward momentum of the ship is balanced by the longitudinal water resistance to that momentum, and the pivot point moves back and settles at a point about a quarter of the length of the ship from the bow (P2).

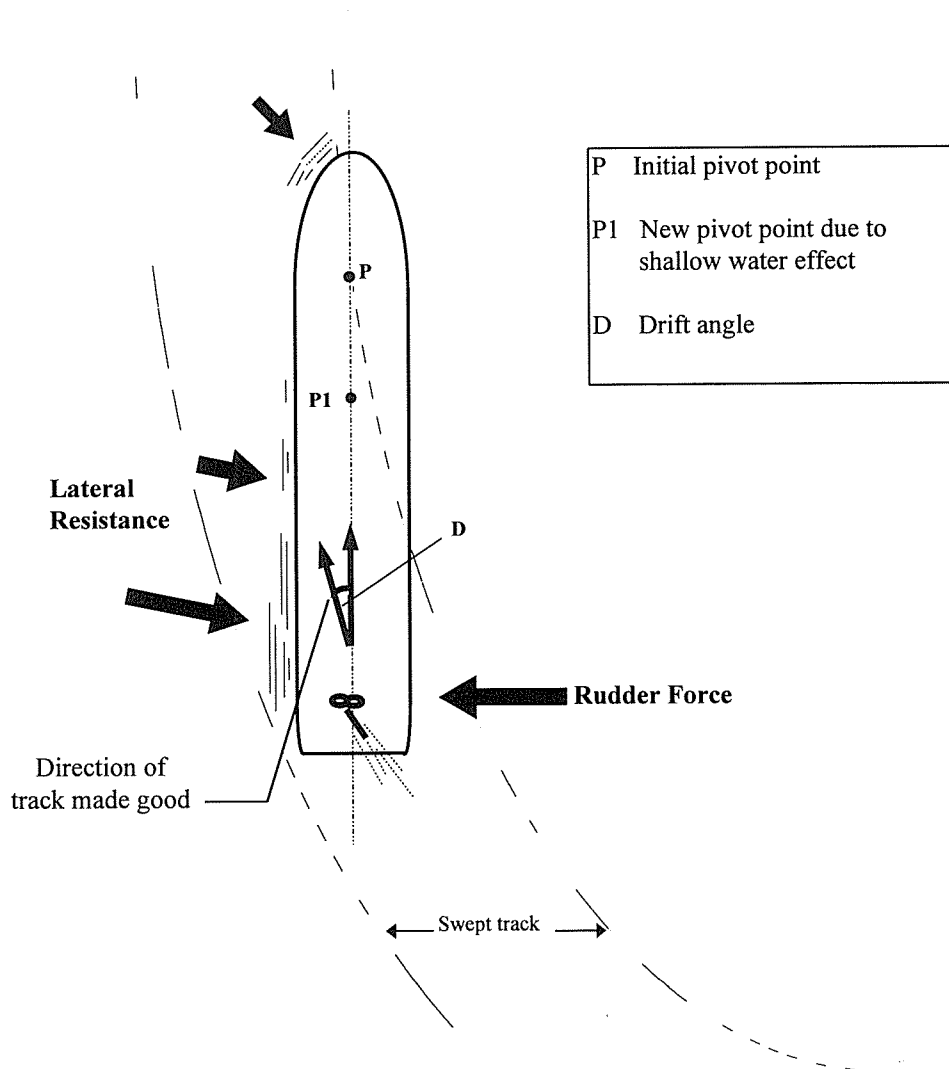
Figure 6
Lateral forces in the turn

1.9.5 When rudder is applied to a ship, a turning moment is created about the pivot point, and the vessel begins to turn. The greater the distance between the rudder and the pivot point, and the higher the rudder force, the greater the turning moment will be. As the vessel enters the turn, it experiences a certain amount of sideslip in the water, which results in a build up of water resistance along the side of the ship. This resistance (lateral resistance) opposes the rudder force. When the rudder force and lateral resistance find a balance, the vessel will settle at a relatively constant drift angle (D) and a relatively constant rate-of-turn (see Figure 6).

1.9.6 The drift angle in a turn creates a considerable braking force on the ship, which, for the *T.A. Explorer* in deep water, causes up to 50% reduction in the speed of the ship. However, in shallow water (water depth less than twice the draught of the ship), the lateral resistance on the hull increases because the water flow under the vessel is restricted, requiring the rudder force to overcome higher lateral resistance forces. Additionally, the longitudinal resistance mentioned in paragraph 1.9.3 increases, pushing the pivot point back to $P1$ (in Figure 6), thereby reducing the lever arm between it and the rudder. The combination of these two effects: reduces the drift angle, reduces the loss of speed in the turn, and results in a deterioration in turning performance.

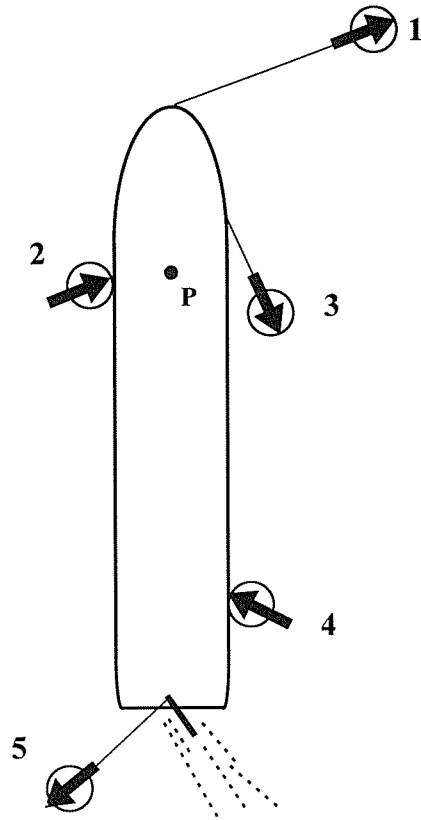
- 1.10.1 Referring to Figure 7 below, the effectiveness of a tug in each position is as follows:

Position 4 Because of the long lever about the pivot point, the tug is in an effective position to assist the starboard turn by pushing. The underwater resistance of the tug assists the starboard turn.

Position 5 The tug is in a very effective position. The longest possible lever about the pivot point is obtained, and the tug provides retarding forces while providing good steering assistance. The tug can easily give steering assistance on both sides, or be an effective brake by “digging in” astern.

- 1.10.2 The summary of the effectiveness at each tug position is based on the assumption that a tug skipper is able to position his tug and apply the required force in the direction indicated by the arrows in Figure 7. The effectiveness of the tug will be largely dependent on the speed of the ship through the water. The higher the speed; the more tug power will be required to keep up with the ship; the less power will remain to assist the ship.
