Report 98-212

Restricted-limit passenger catamaran *Scat Cat*

foundering

Lake Rotorua

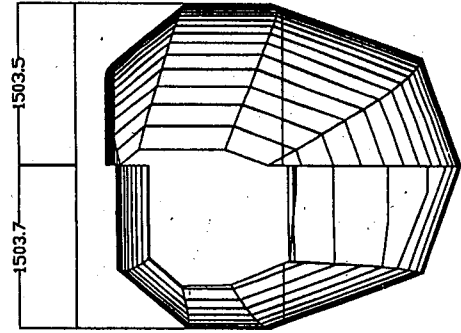
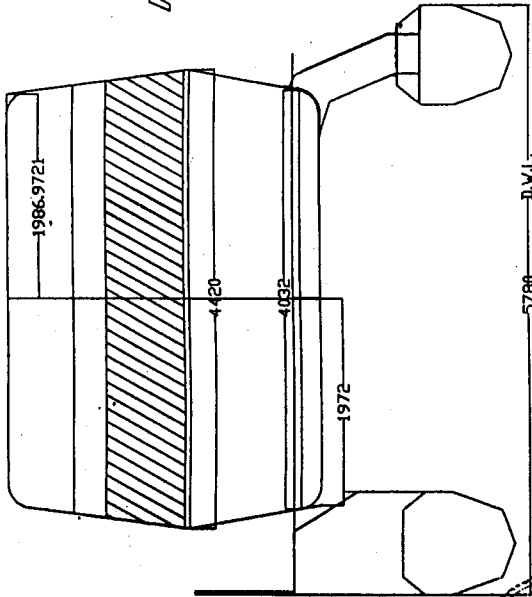
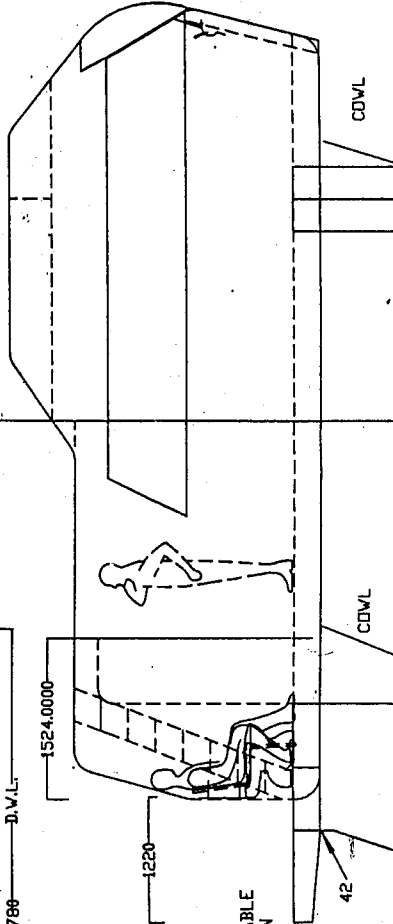
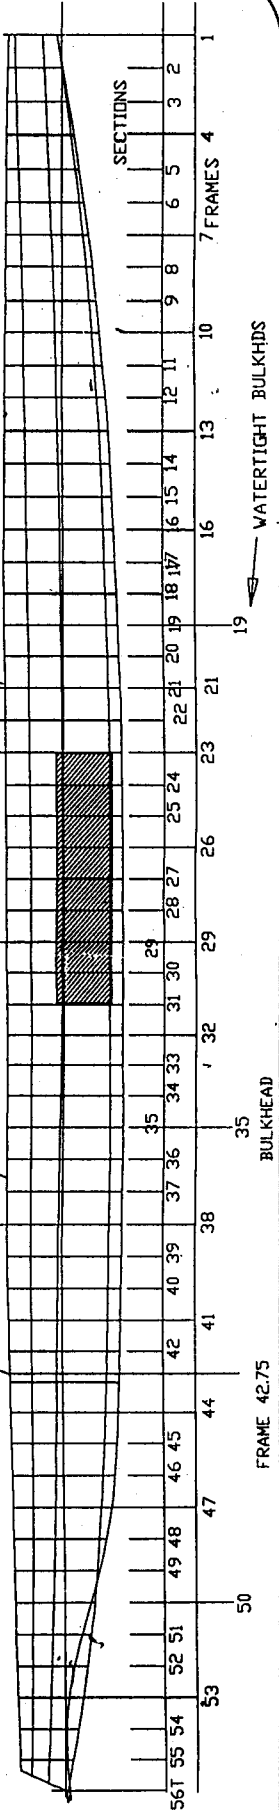
Figure 2
 Line plan of Scat Cat showing general construction

- 1.4.5 Each of the two pontoons was divided into four sections separated by watertight bulkheads. The aft sections were 1.8 m long void spaces. The second sections were 4.3 m long and housed the engines. The third sections were 4.9 m long and housed storage tanks; fuel and water on the port side and fuel and sewage on the starboard side. The forward sections were 5.5 m long void spaces. (See Figure 2)
