Report 99-201

bulk woodchip vessel *Prince of Tokyo*

grounding

Port Otago harbour entrance

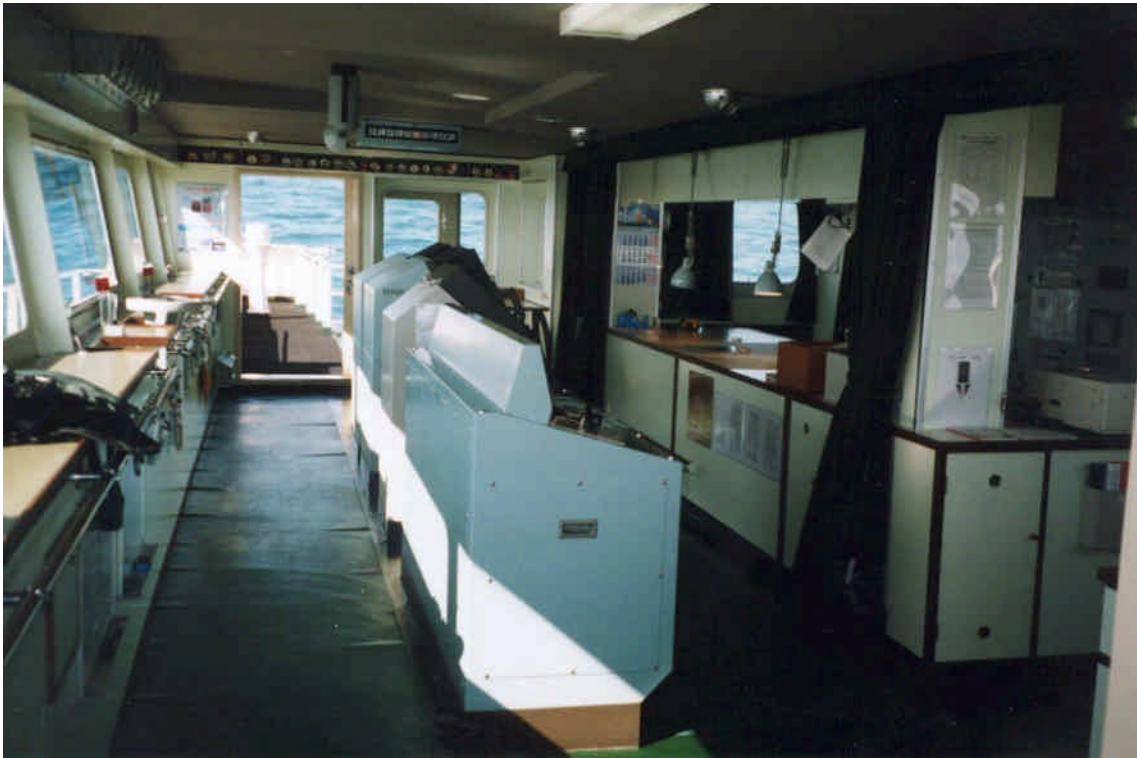
Figure 5
View inside wheelhouse looking to starboard bridge wing

1.3.7 The bridge of the *Prince of Tokyo* was spacious (see Figure 5). The wheelhouse was about 12 m wide, the distance from each door to the extremity of the bridge wing was about 10 m. From the wheelhouse windows there was an uninterrupted view of the top of the gangways on each side of the maindeck.
