Report 99-206

passenger charter yacht *City of Dunedin*

grounding and fire

8 May 1999

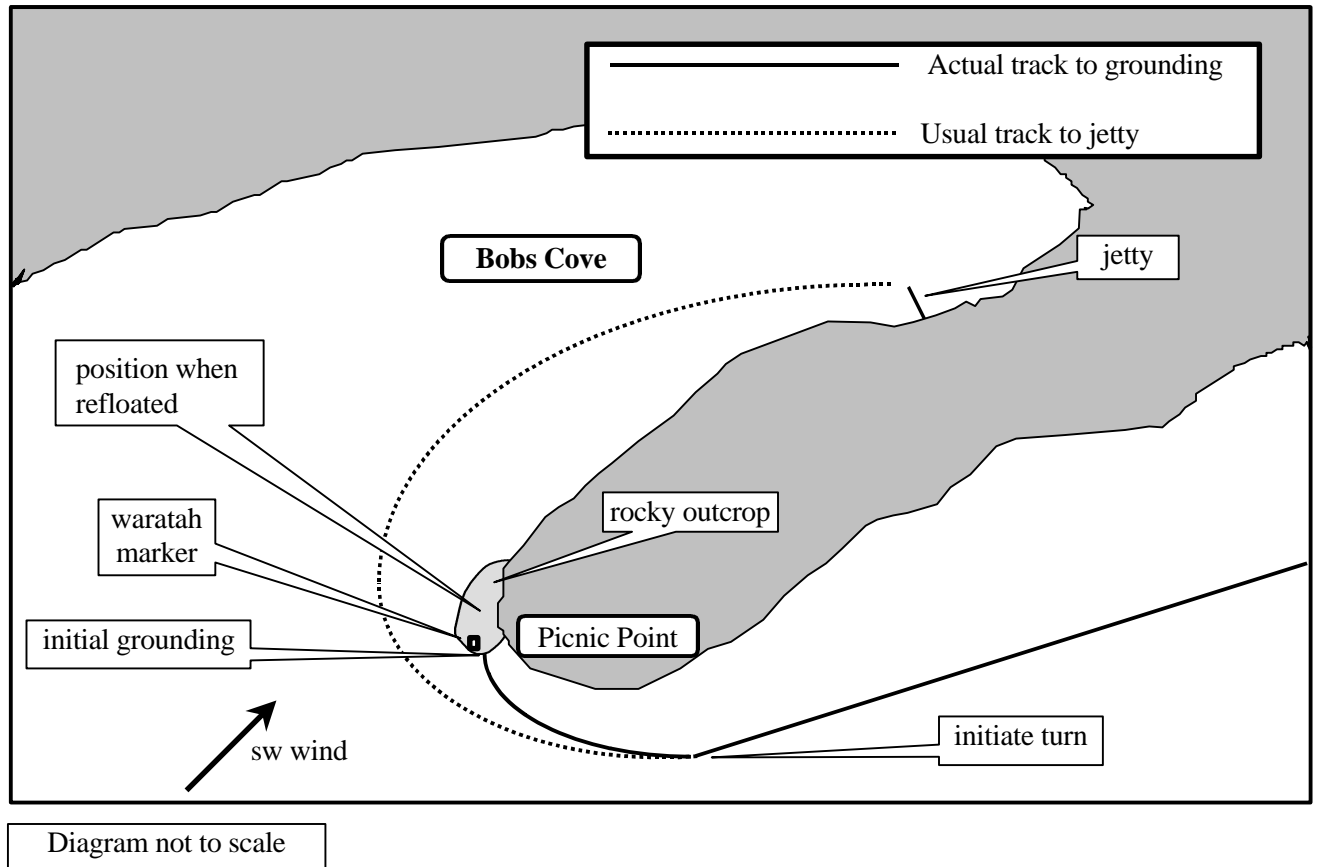
Figure 2
Diagram showing approximate track to Bobs Cove and the grounding position

- 1.1.13 About 10 minutes later, as the vessel was approaching Bobs Cove, the skipper noticed that there was an increasing amount of exhaust fumes, to the extent that he later described it as smoke. He helped the passenger that was on the tiller to initiate the turn to starboard around the headland (see Figure 2) and then went below, took the cover off the engine housing and checked that the engine was not overheating. He found nothing untoward despite the greater than usual amount of exhaust fumes.

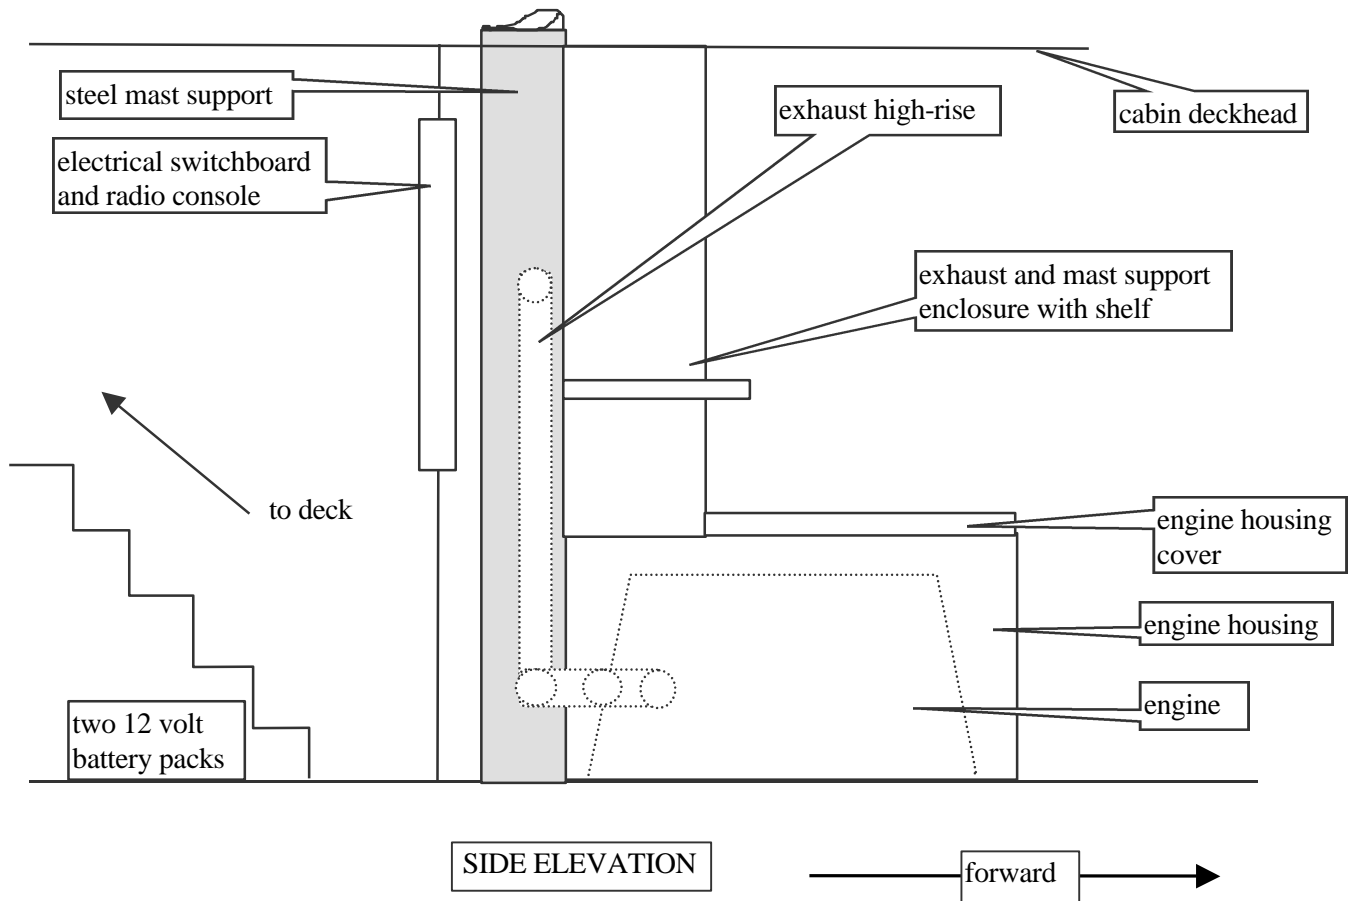
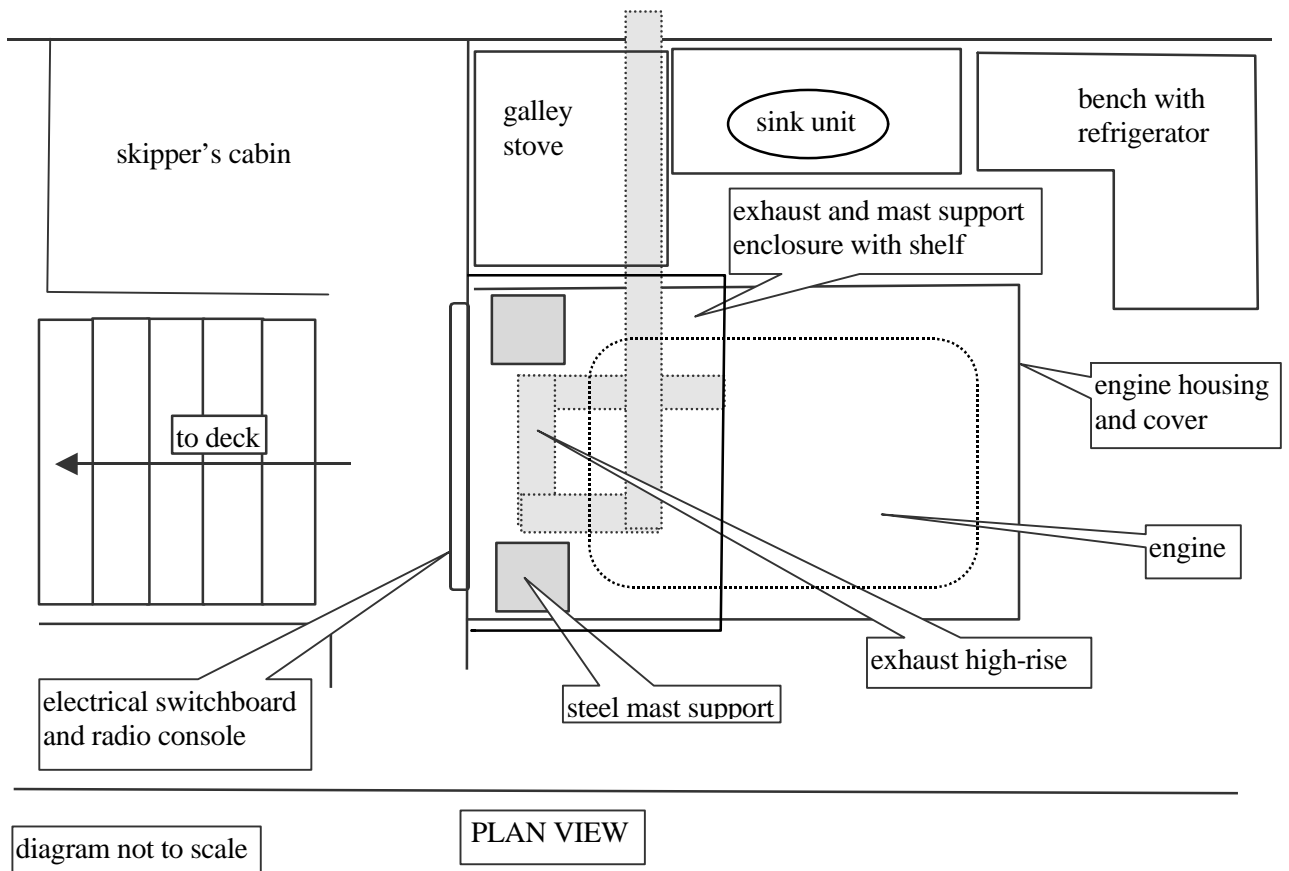
Figure 4
Plans showing layout of cabin in way of engine

- 1.1.17 At the aft end of the engine was a vertical wooden structure, which enclosed both the engine exhaust high-rise and the mainmast support. The structure went from the top of the engine housing cover to the deckhead, and incorporated a small shelf. Behind the mast support, the structure formed a bulkhead at the aft end of the cabin and also housed the electrical switchboard and radio console, which were accessed from the bottom of the companionway (see Figure 4).
