Report 99-210
commercial jet boat *Helijet 2*
collision with rockface
Kawarau River, Queenstown
20 August 1999

Abstract

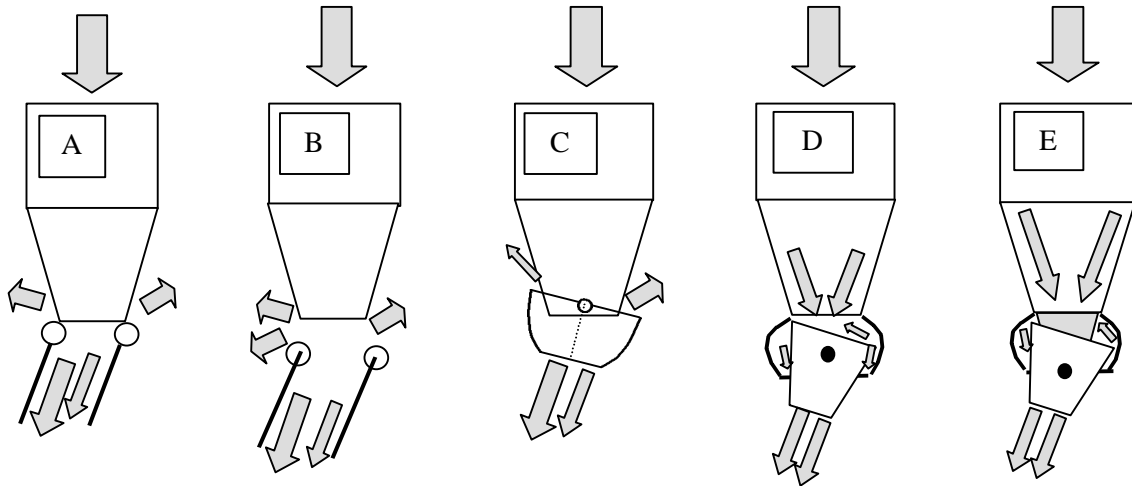
Figure 6
Development stages of Hamilton Jet jet boat steering

1.8.8 In about 1958, steering was achieved using a twin deflector “gate” system but operating loads on the steering components were high. It was only moderately efficient and there was a reduction of forward thrust when the water flow was deflected (see A in Figure 6).

1.8.9 The original steering design was used until about 1973, when the deflector pivot points were moved aft. The forces on the steering components were reduced but still considered to be heavy. The water flow passed both sides of the deflector when steering and although the reduction of forward thrust was not significant, the system was not responsive to small movements of the deflector (see B in Figure 6).

1.8.10 In about 1982, the steering design moved away from the gate system and the single conical deflector was introduced. The pivot point of the deflector was positioned to give partially balanced reaction forces, but without a forward seal a backflow and spray were generated when steering and the forward thrust was reduced (see C in Figure 6).

- 1.8.11 In about 1990, the single ball joint steering nozzle/deflector was introduced. There was a pressure drop within the spherical bowl area and forward thrust was reduced at all times, but there was good steering efficiency and low forces on the steering components. With this design came the possibility of the nozzle jamming within the spherical bowl, caused either by damage to the components or by debris limiting or stopping its movement (see D in Figure 6).

- 1.8.12 In about 1998, the design was further improved by the introduction of an insert extension of the tailpipe into the spherical bowl. The insert directed the water flow to exit aft of the bowl cavity, reducing turbulence and improving efficiency. There was a minimal gap between the insert and the inside surface of the nozzle, reducing energy loss (see E in Figure 6).
