Final Report AO-2015-007: Airbus Helicopters AS350BA, ZK-HKU,
collision with terrain, Fox Glacier, 21 November 2015

Aviation inquiry AO-2015-007
Airbus Helicopters AS350BA, ZK-HKU
Collision with terrain
Fox Glacier
21 November 2015

Approved for publication: February 2019

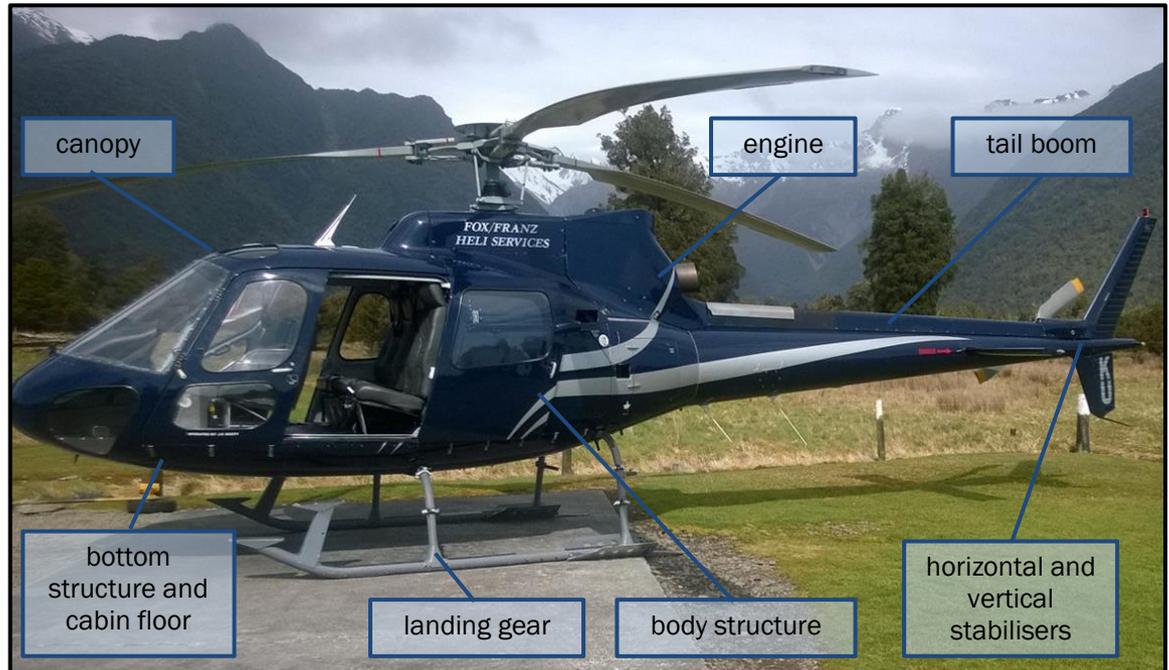
Figure 5
AS350 helicopter parts
(Photograph courtesy of the operator)

3.3.1. The AS350 is a single turbine engine-powered light utility helicopter manufactured in France by Eurocopter (now Airbus Helicopters). The main structural components are shown in Figure 5.

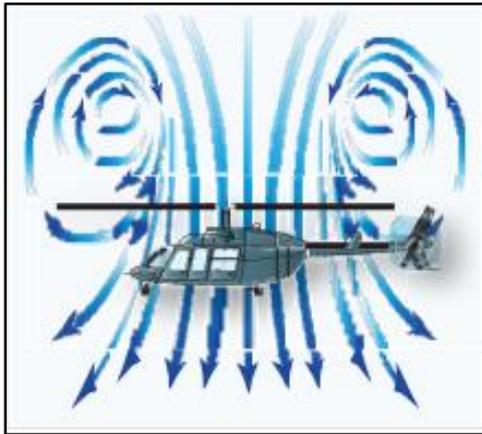
Figure 11
Typical rotor downwash flow
(Courtesy of Federal Aviation Administration)

When a helicopter is generating rotor thrust or lift, there will be some recirculation of air around the end of the blades or rotor disc.⁷³ The recirculation is most pronounced at high power and low airspeed, as in a hover, and reduces as the helicopter moves forward. Vortex ring state occurs when the tip vortex becomes more energised and a secondary inner vortex is established towards the centre of the rotor disc because the rate of descent exceeds the induced downward flow (see Figures 11 and 12).

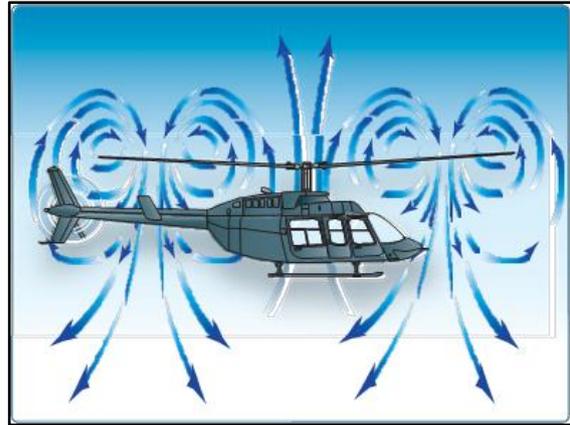
Figure 12
Vortex ring state
(Courtesy of Federal Aviation Administration)

The onset of vortex ring state can be sudden, resulting in the helicopter descending at a very high rate. Any increase in rotor thrust in an attempt to reduce the high rate of descent energises the vortices further and increases the rate of descent. Rates of descent of more than 3,000 feet (914 m) per minute are not unusual. A National Transportation Safety Board report into an AS350-B2 accident cited rates of descent between 4,000 feet (1220 m) and 6,000 feet (1829 m) per minute (National Transportation Safety Board, 2001). This is significantly faster than the 1,500 to 2,000 feet (457 to 610 m) per minute rate experienced in an autorotation following a total power loss.
