Final Report AO-2016-008: Robinson R66 helicopter, Partial power loss- forced landing,  
Hokonui Hills, Southland, 14 November 2016

Aviation inquiry AO-2016-008  
Robinson R66 helicopter  
Partial power loss– forced landing  
Hokonui Hills, Southland  
14 November 2016

Approved for publication: October 2018

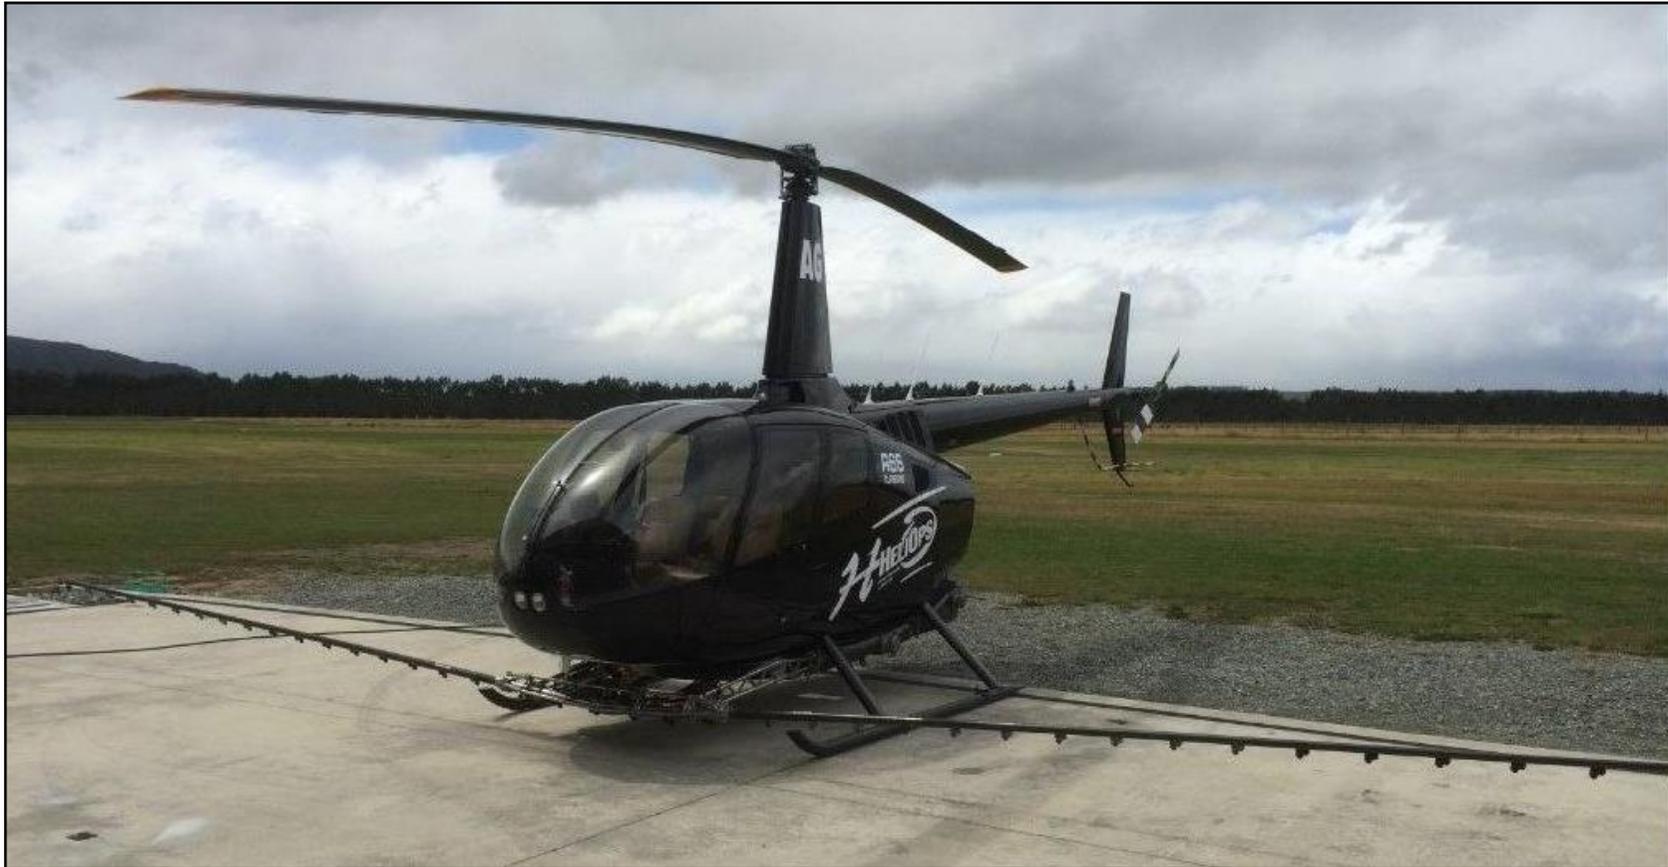
Robinson Helicopter Company R66, ZK-HAG  
Photo courtesy of the maintenance provider

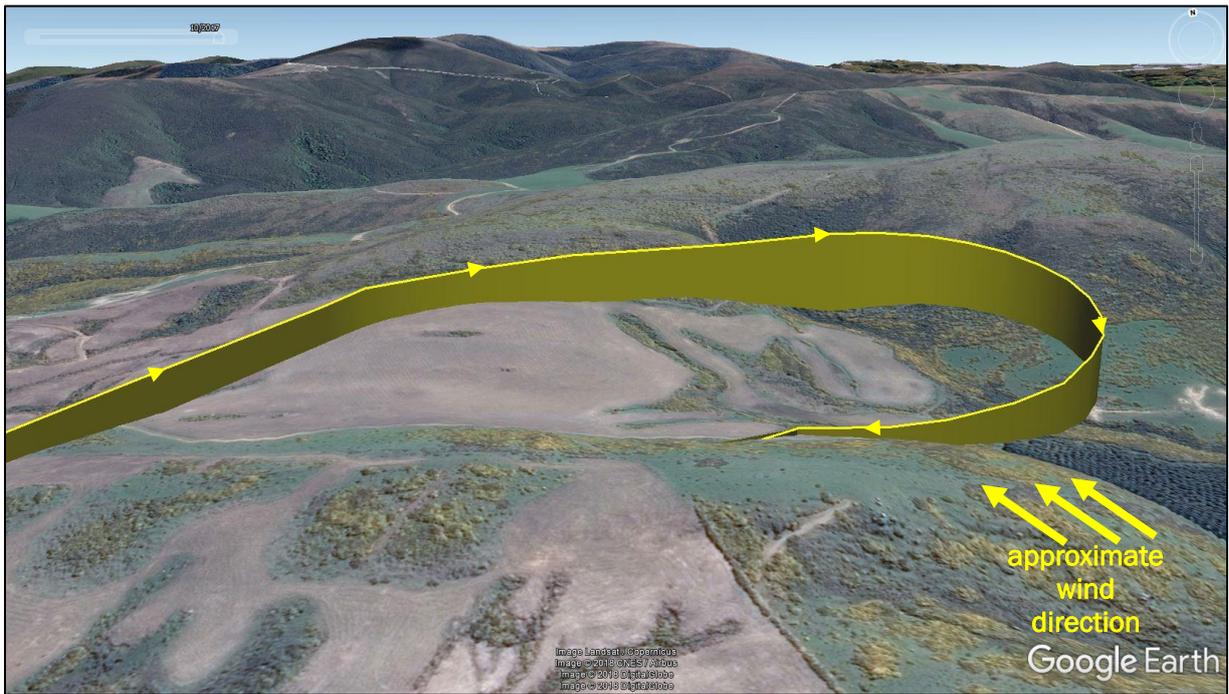
Figure 1  
Accident flightpath

- 3.1.5. The helicopter returned to the targeted spray area for what was expected to be a two-minute flight. From a straight and level flight at approximately 80 knots<sup>5</sup>, the pilot initiated a descending right-hand turn to line up with the spray run (Figure 1). While in descent, the low rotor RPM (revolutions per minute) warning light and horn activated. The pilot responded by lowering the collective lever<sup>6</sup>, and the rotor RPM recovered to within the operating range. The pilot then decided to continue the descent and lined up for the spray run.

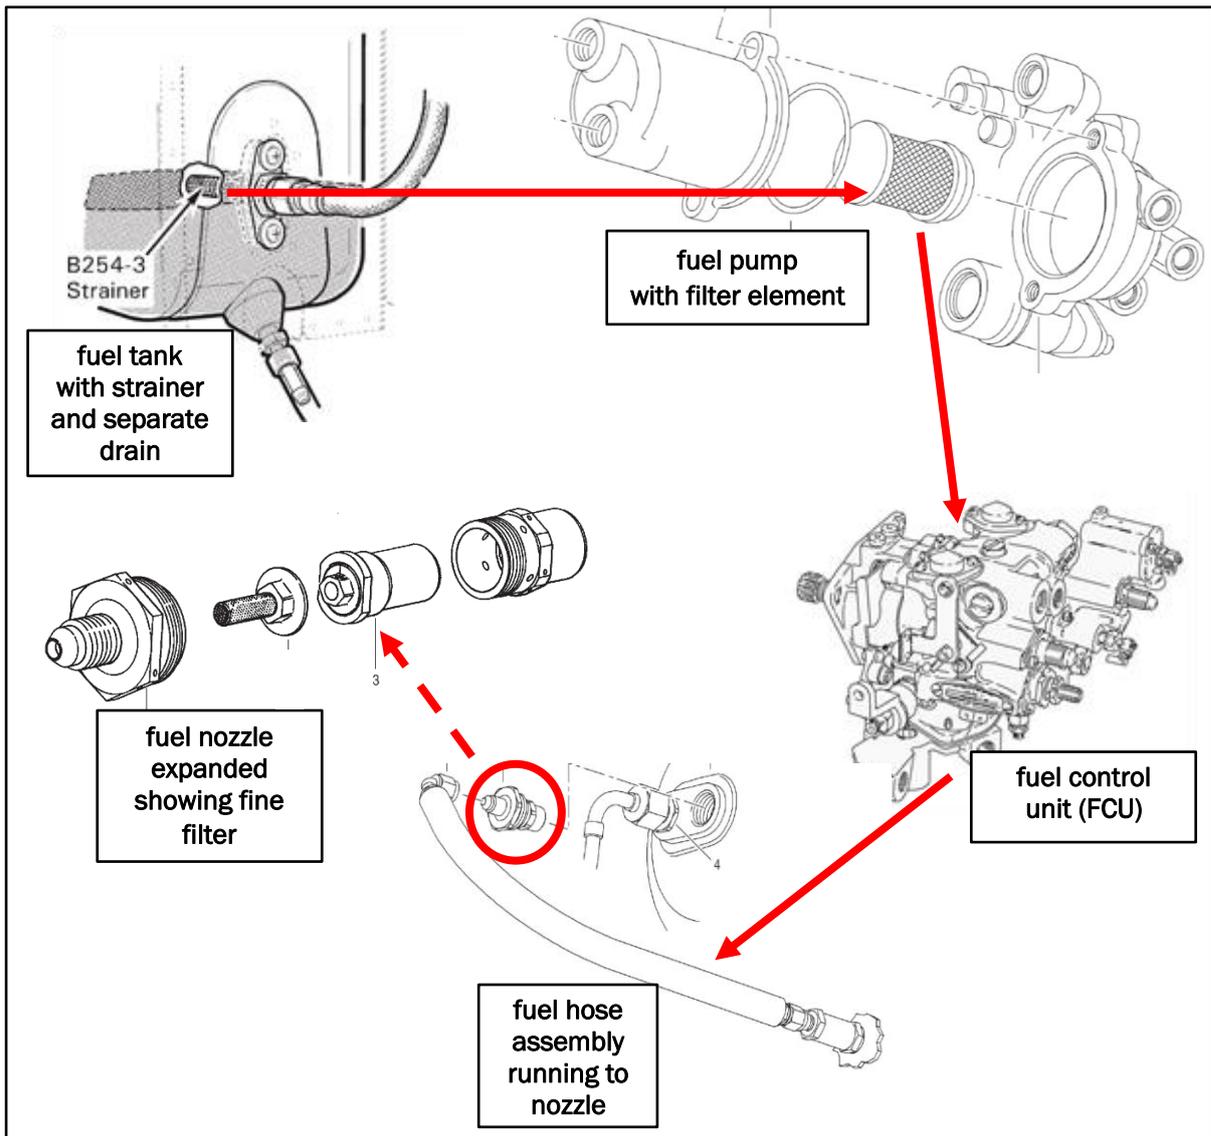
Figure 3  
R66 fuel filtering system arrangement

- 3.9.3. The R66 fuel system was gravity fed from the fuel tank to the engine following the path shown in Figure 3.

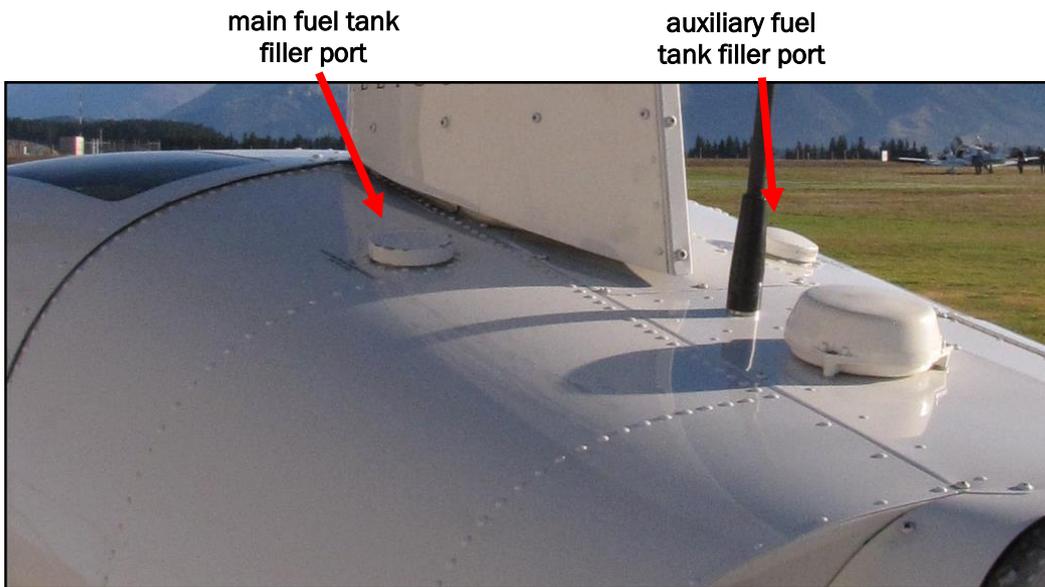
Figure 9  
Comparison Robinson Helicopters R22 refuelling ports

- 4.3.10. The R66 fuel filler port differed from that used on R22 and R44 helicopters. The filler port was larger and sat flush within a flat area under a hinged cowling (Figure 8). The R22 and R44 fuel ports, by comparison (Figure 9), were mounted on the top surface and had raised edges around them.
