Final Report AO-2017-001: Eurocopter AS350 BA, ZK-HKW, Collision with terrain,
Port Hills, Christchurch, 14 February 2017

Aviation inquiry AO-2017-001:
Eurocopter AS350 BA, ZK-HKW
Collision with terrain
Port Hills, Christchurch,
14 February 2017

Approved for publication: May 2018

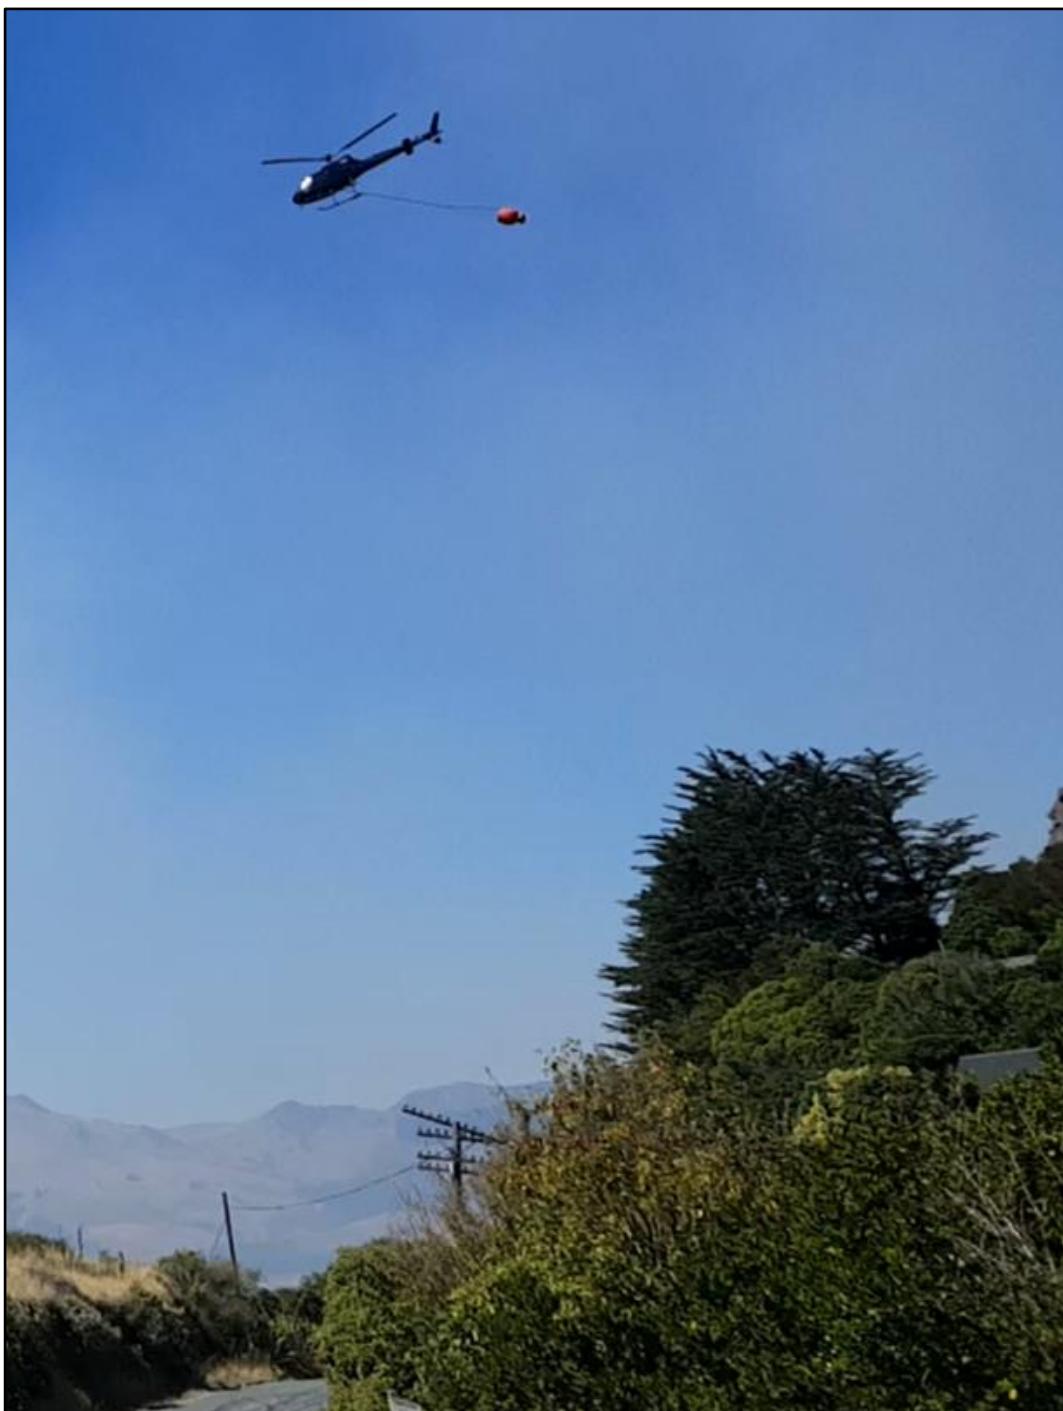
Figure 5
Video image taken earlier the same day, showing the helicopter with the empty bucket trailing

- 3.7.3 A mobile phone video recording taken by a witness who was situated on Summit Road close to the Sign of the Kiwi showed the helicopter flying in the same circuit around Sugarloaf on the morning of the day of the accident.
- 3.7.4 The recording showed the helicopter flying with a full bucket toward the drop point, dropping the water on the fire, then continuing over Dyers Pass Road towards the dipping pond. The video recording showed how the empty monsoon bucket trailed behind the helicopter in normal flight under the conditions at that time (see Figure 5).

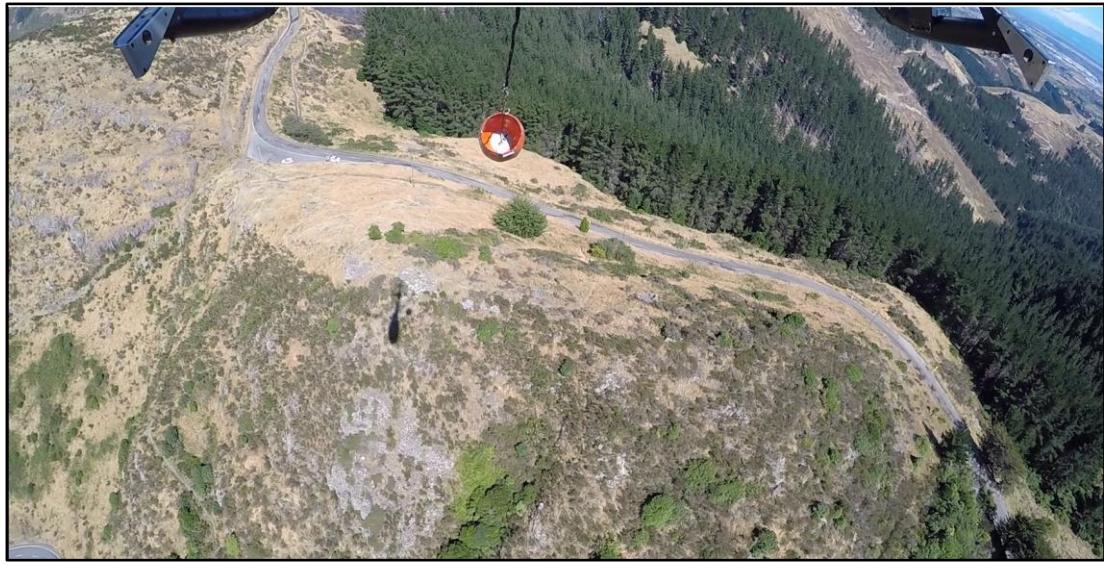
Figure 6
On-board video image corresponding to the time of the image shown in Figure 5

- 3.7.5 A digital video camera was mounted under the forward fuselage, on the helicopter centreline, aimed down and rearwards toward the monsoon bucket. It was attached to the bracket that supported the helicopter's rear-facing mirror. The camera also recorded sound.
- 3.7.6 The on-board video camera recorded all the flights on the day of the accident and the previous day. The camera had a clear view of the monsoon bucket in flight and when filling at the dipping pond, the front parts of the landing gear and the ground underneath the helicopter. The video recording enabled the normal in-flight behaviour of the bucket to be compared with its behaviour on the accident flight (see Figure 6).

- 3.7.7 The track flown, the height above ground, the groundspeed and the relative movement of the helicopter were estimated from the video²².
- 3.7.8 Changes in the position of the video frame with reference to the landing gear indicated the relative movement of the camera as it flexed on its mount (compare Figure 5 and Figure 6).
- 3.7.9 The on-board video data was sent to the BEA for further analysis of the images and sounds.

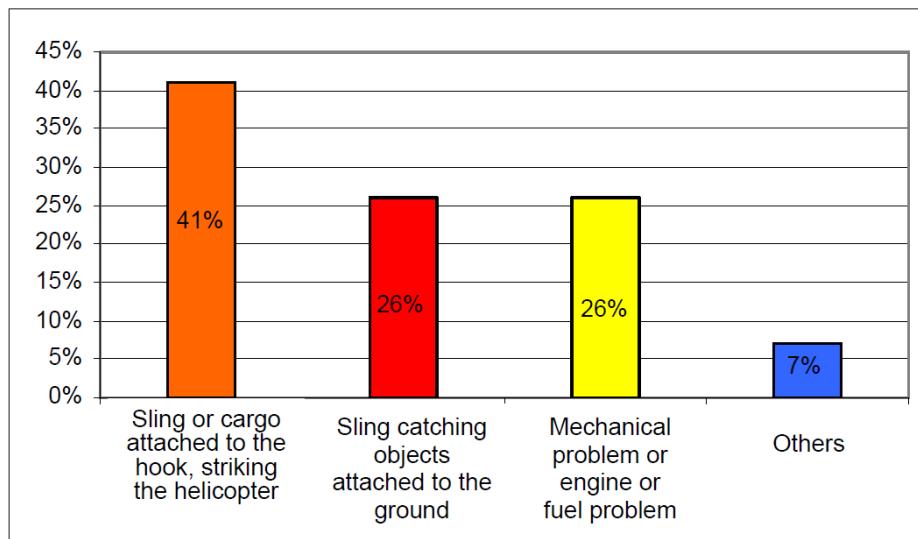
In most of the cases (41%), the sling contacts the tail rotor, which may cause the TGB and parts of the fin to be damaged. The two main reasons are either an abrupt dive maneuver or bursting of the bag which behaves like a parachute when empty. In both cases, the cable and its cargo are subject to airstream loads which prevail over the weight of the cable and cargo. Consequently, the sling or load follows the airstream into the tail rotor area.
