Transport Accident
Investigation
Commission

Aviation inquiry AO-2018-009
MD Helicopters 500D, ZK-HOJ
In-flight breakup
Near Wānaka Aerodrome
18 October 2018

June 2024

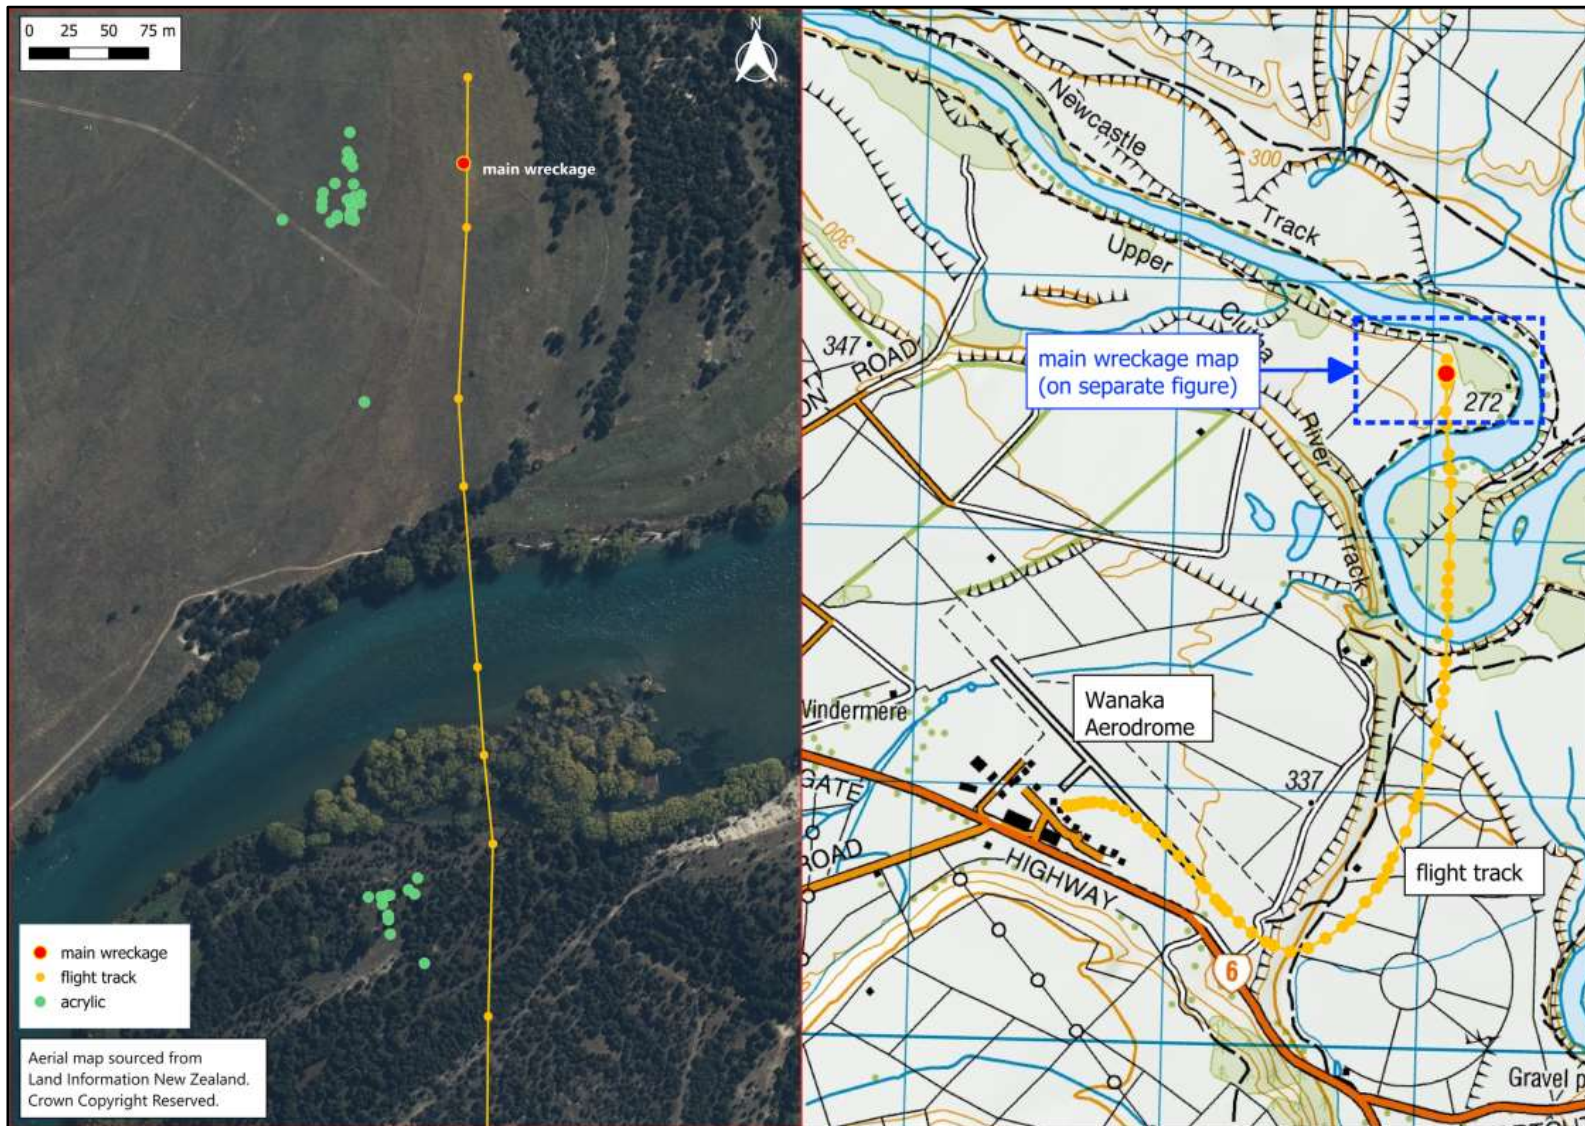
Figure 4: Overview of wreckage distribution

- 2.36. Items of wreckage were spread over a wide area. For example, the remnants of acrylic¹⁶ from shattered windshields were found downwind of the impact area (the yellow sector on Figure 5). Other remnants were found much later on the south side of the river (see Figure 4). It is likely that some items fell into the Clutha River. A reconstruction of the helicopter windshields revealed that only about 60 per cent of the acrylic windshields was recovered (see Appendix 5).

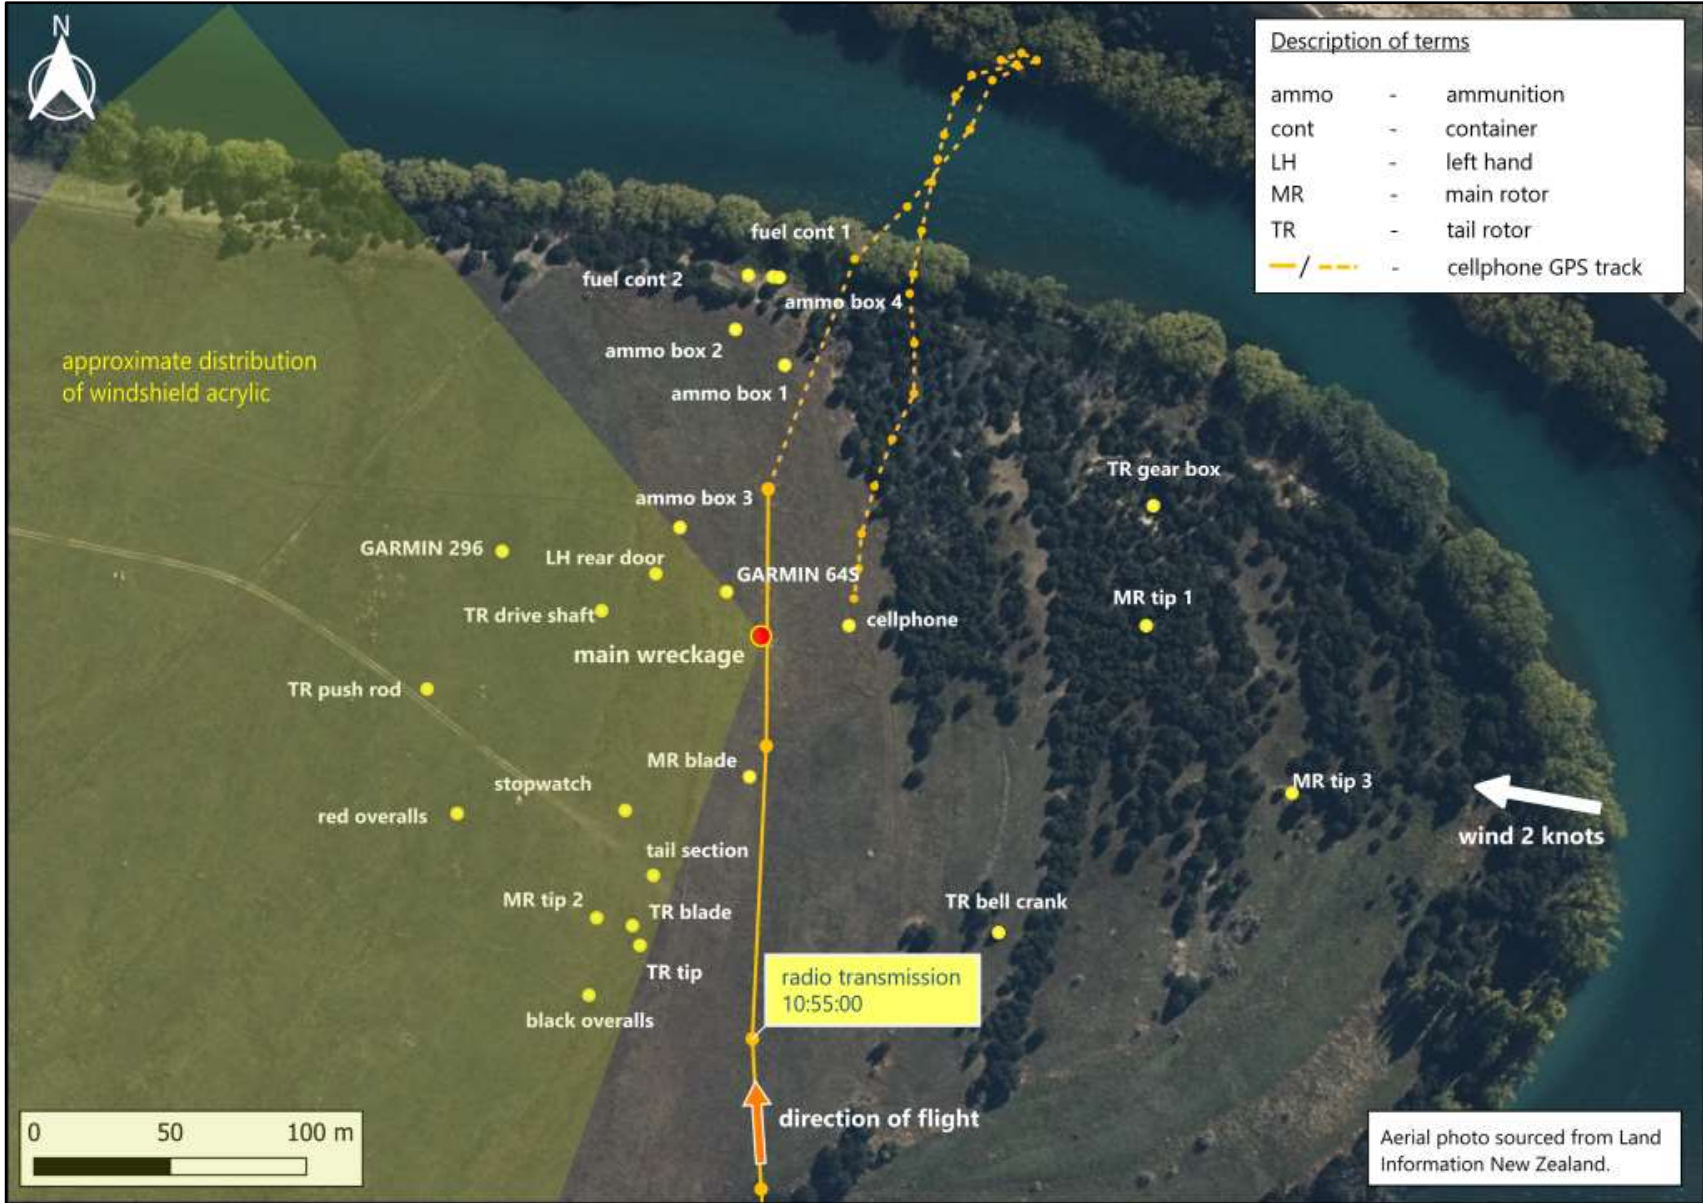
Figure 5: Wreckage map showing location of significant items

- 3.117. The Commission considered it **very unlikely** that unsecured items in the cabin were suddenly shifted in a way that could have enabled them to open the left rear door in flight and initiate the accident sequence. It was a calm morning with little or no turbulence. The helicopter was flying in a straight line before it was seen to be spinning, and the tracking data did not indicate the presence of a force that could move items to the left side of the rear cabin. Heavy items³⁹ were flung out against the left-rear door, but that was after the black overalls had exited and well into the breakup sequence when the helicopter was spinning to the right (see Figure 5 for the location of items where they fell).

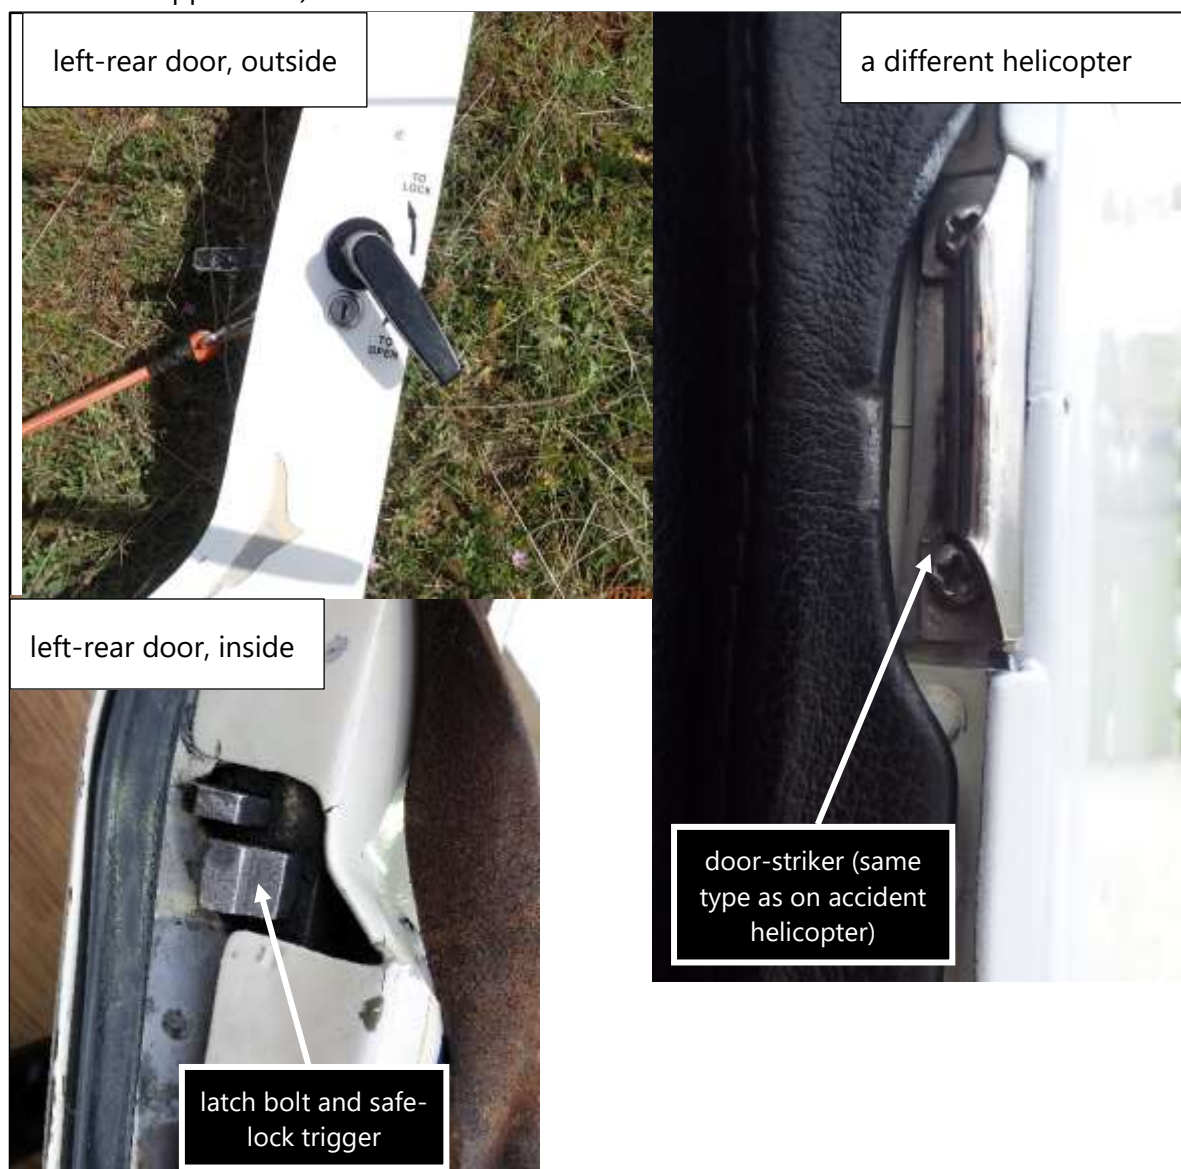
Figure 10: Rear door from the helicopter (left) and photograph of a door-striker on another helicopter (right)

3.32. To place the door into the safe-lock configuration for flight, the outside handle is lifted to above horizontal to move the latching mechanism into the safe-lock position. The safe-lock position further extends the latch bolt behind the door-striker to draw the door closer to the door frame, and it locks the latch bolt in this extended state. Upon the release from this position, the outside door handle drops down to rest in a horizontal position in line with the airflow (see Figure 10, and for more detail see Appendix 1).

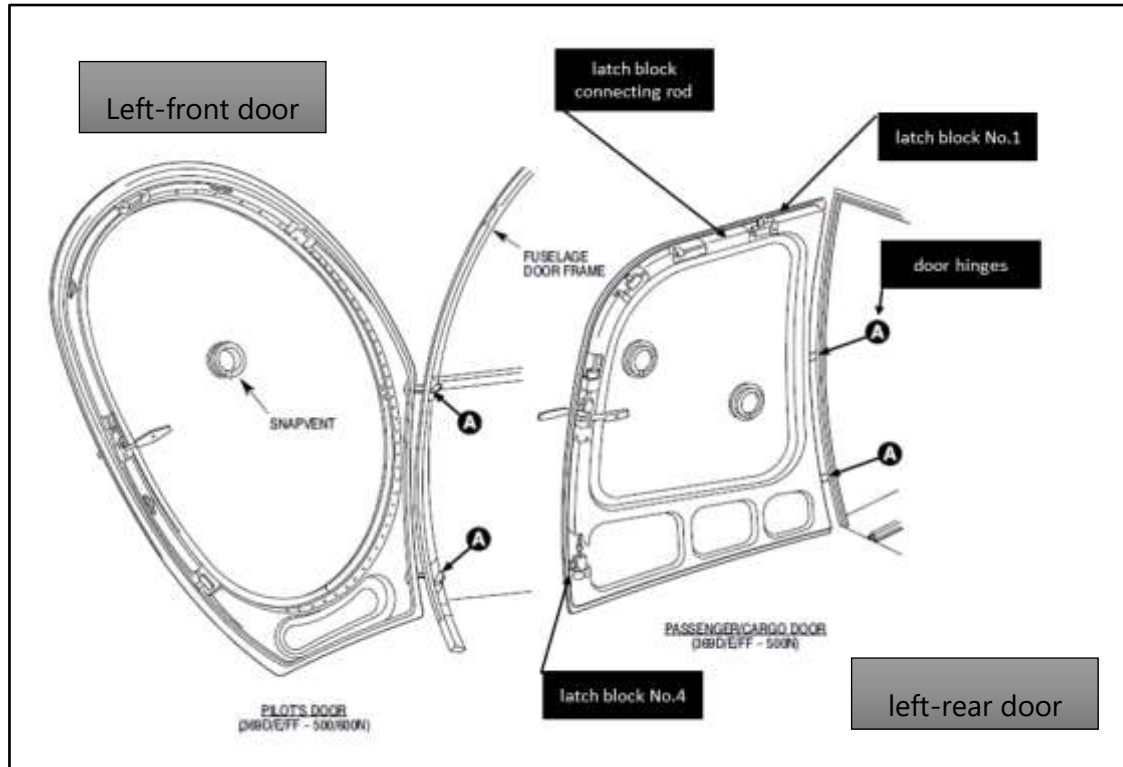
Figure 11: Left-front and left-rear helicopter doors

3.33. The curvature and sizes of the doors require a distributed arrangement of the door-latch mechanism. The doors are hinged on the front edge, with the door handle on the rear edge. The door is fitted with four separate latch blocks spaced around its top and rear edges, numbered one to four.²⁵ The latch blocks are linked to the door handle by connecting rods between the latch block sliders, and operate together when the door handle is turned. All four doors have similar latch mechanisms (see Figure 11).

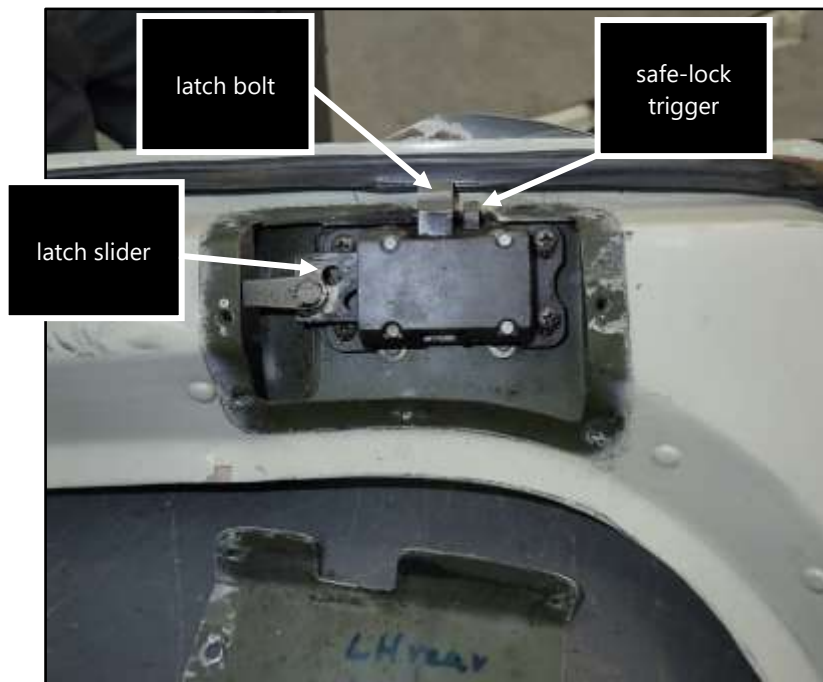
Figure 12: Latch block No.1 from left-hand rear door (cover removed)

- 3.35. The latch blocks are supplied as single items that cannot be disassembled. Each latch block houses: a spring-loaded latch bolt; a safe-lock trigger; and a latch slider (see Figure 12). The latch slider has a shaped cam slot connected to a cam roller on the latch bolt (further detail on the slider and cam roller is shown in Appendix 1). As the latch slider is moved longitudinally, the cam slot drives the latch bolt to extend or retract laterally.

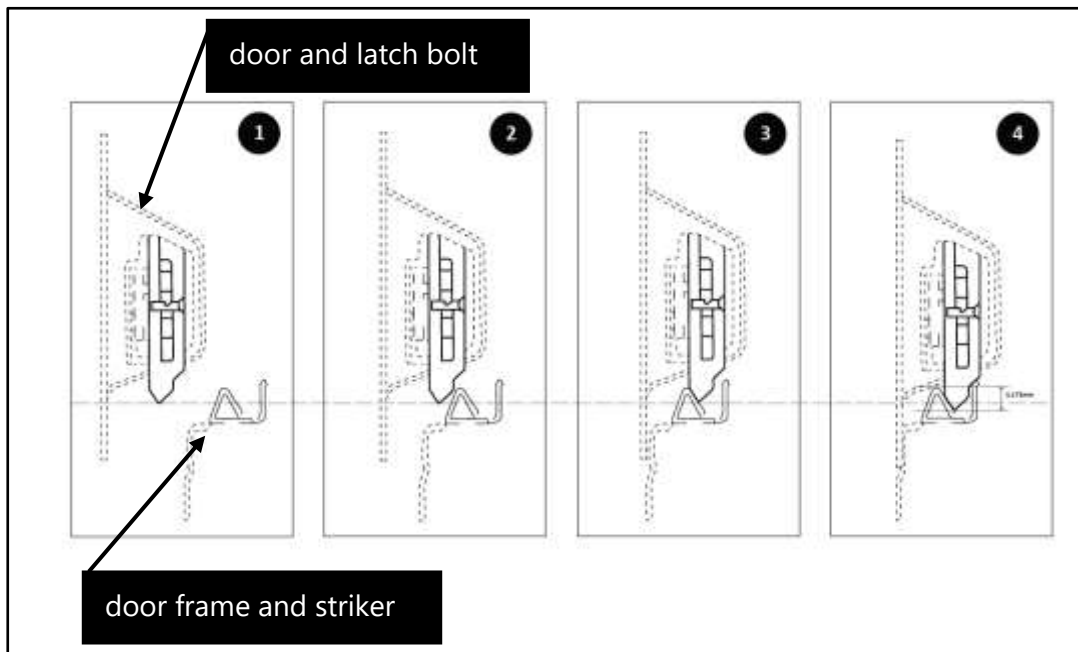
Figure 13: Door-latching operation (wedge-shaped latch bolt)

- 3.38. Figure 13 shows the four stages of a latch bolt engaging with its door-striker. In stage (1) the door is in the open position. In stage (2) the spring-loaded latch bolt contacts the door-striker and rides up against the spring pressure. In stage (3) the latch bolt has ridden up over and extended behind its door-striker. This is the 'closed' position. In stage (4) the door handle has been turned to the 'safe-lock' position and the latch bolt has extended further behind its door-striker. The door has been pulled hard against the door seal by this safe-lock movement. The overlap distance is how far the latch bolt extends down behind the top of the door-striker.

- 3.114. One potential scenario was that unsecured items within the cabin had shifted in flight and moved the left-rear door handle, causing the door to open. However the items' movement would have had to be caused by a sudden change in motion of the helicopter or a crew movement in the rear cabin to create the initial movement of an unsecured item. The inside door handle faced forward and the tip would have needed to move upwards about 60 mm (a 60-degree rotation) from safe-lock to the 'closed' position and a further 40 mm upwards (a 30-degree rotation) to retract the latch bolt and open the door (refer stages 1 to 4 in Figure 13).

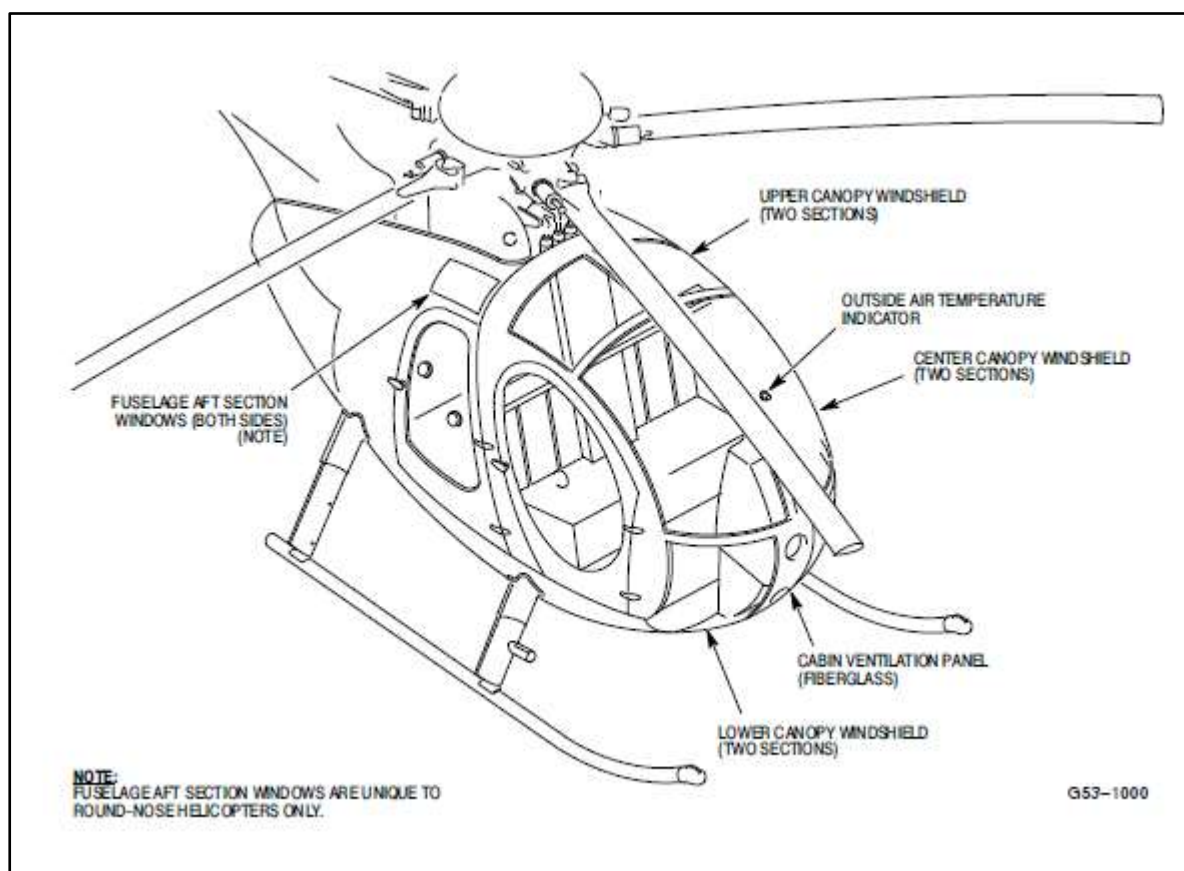
Figure 16: MD 500D windshields
(MDH manual CSP-HMI-2)

- 3.84. The MD 500D has four pairs of windshields. These are made with stretched acrylic panels approximately 2.5 mm thick. From the front the panels are named: Lower (around the tail rotor control pedals); Centre (the main forward view for the pilot and a passenger); Upper (above the front two seats); and Aft (above the rear seats) (see Figure 16).

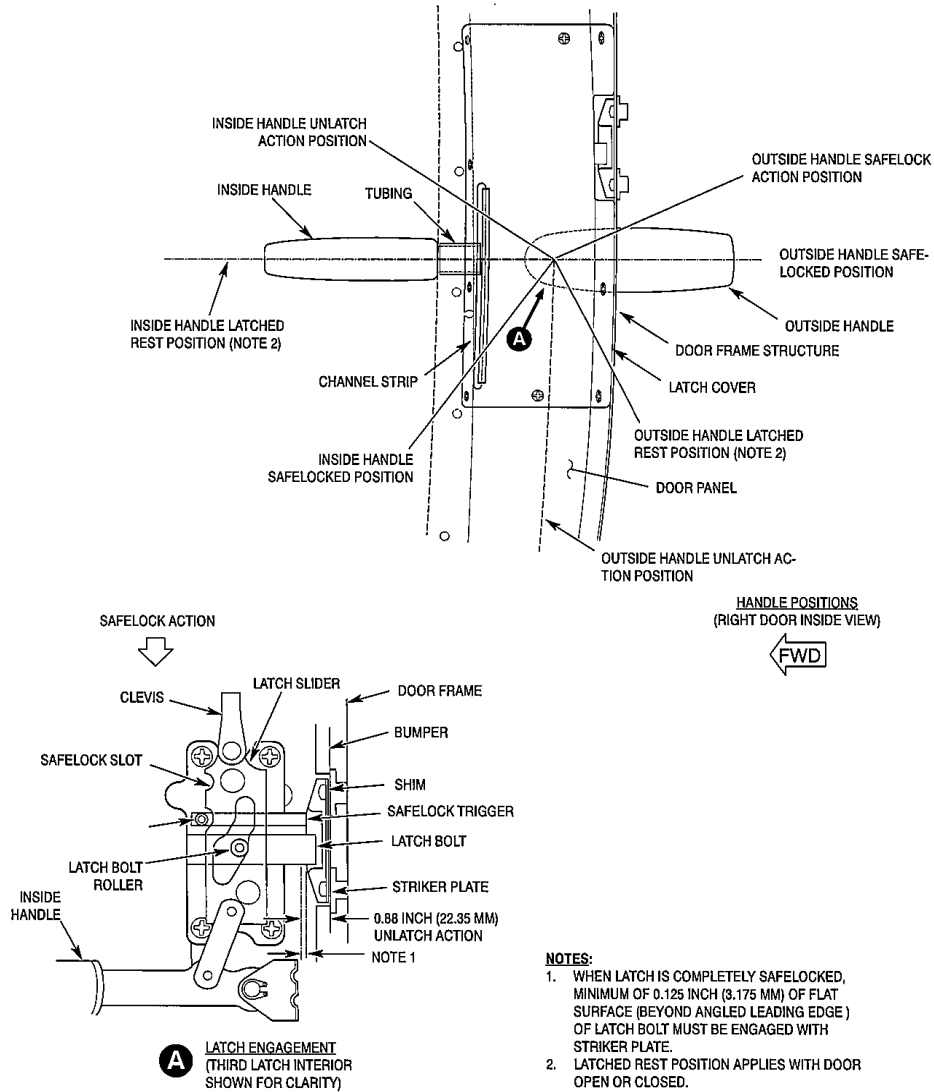
Figure 203. Door Handle Positions and Latch Engagement (Sheet 1 of 3)

- 3.64. Item 16 in Chapter 52 of the maintenance manual referred to Figure 203, where Note 1 of that figure described the minimum overlap distance for the safe-lock function as 3.175 mm (see Appendix 1). This distance is about the same as that of the latch bolt extension when the mechanism is moved into safe-lock. The overlap distance can be observed from inside the cabin.

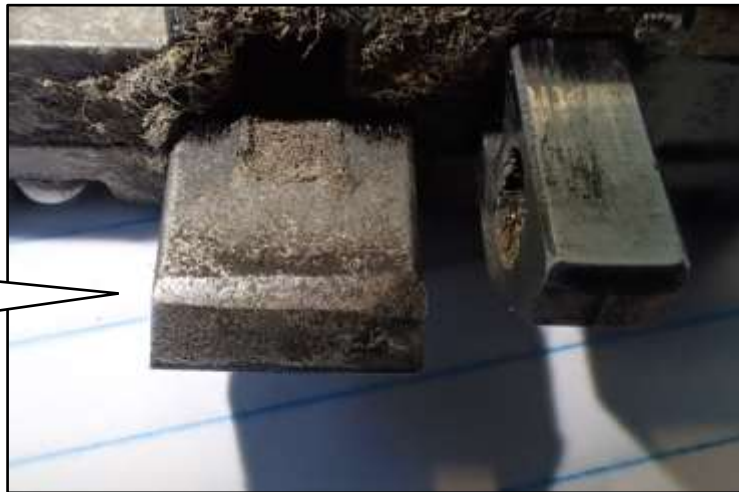
clevis and
pin wear at
top of latch
block No.3
(door
handle)

No.4 latch block wear on safe-lock face of latch bolt

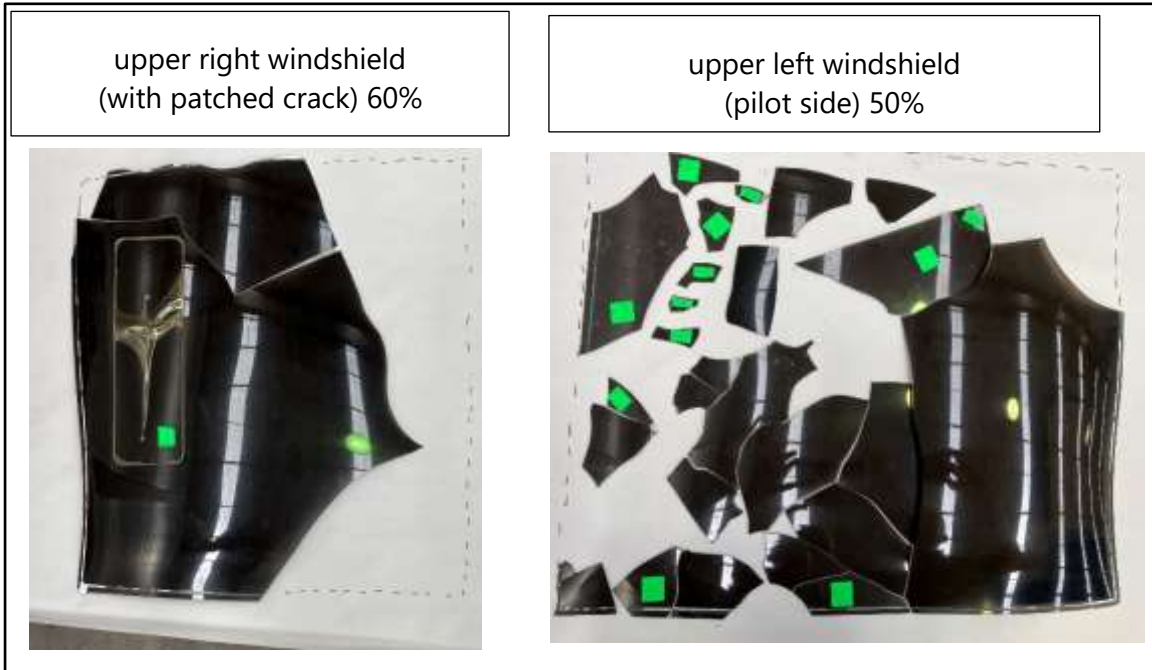
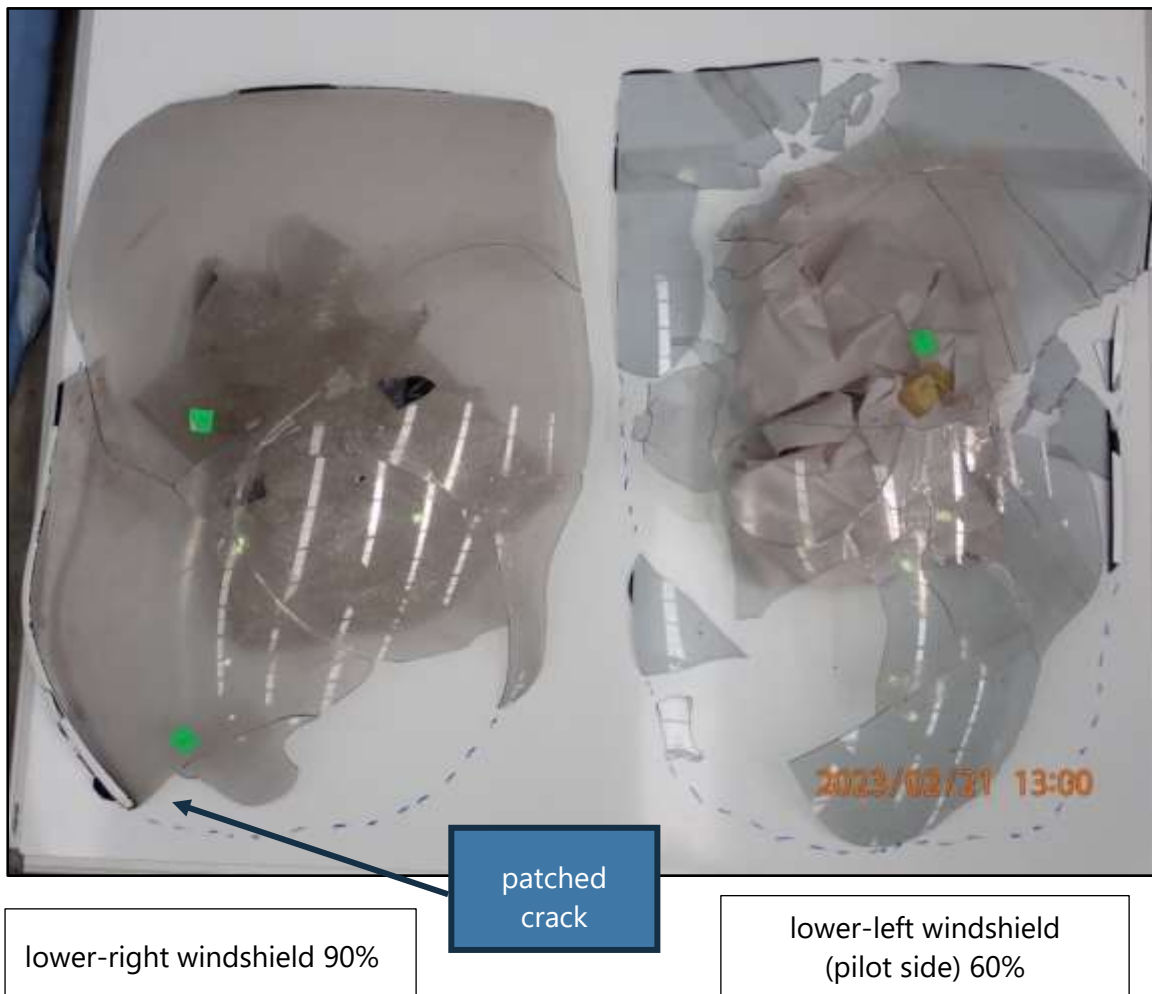
- 3.82. Several large pieces of acrylic window and many smaller fragments were recovered from the accident site. After attempting to reconstruct the windshields, an estimated 40 per cent of the pieces were still missing. The two lower and two upper windshields were the most complete reconstructions. Pieces from the two centre windshields and the door windows were either too small or too few to match or attempt to reconstruct (see Appendix 5 for the reconstruction).
- 3.83. The examination revealed two windshield crack repairs and an area of crazing. The repairs had been carried out by the helicopter owner. The repairs and crazing had existed before the operator leased the helicopter. The helicopter owner was

centre windshields (both left and right sides
and approximately 40% recovered)
