Transport Accident
Investigation
Commission

Final report

Aviation inquiry AO-2022-005
Boeing 737-484SF ZK-TLL
Incorrect fuel configuration
Sydney to Auckland
7 June 2022

November 2024

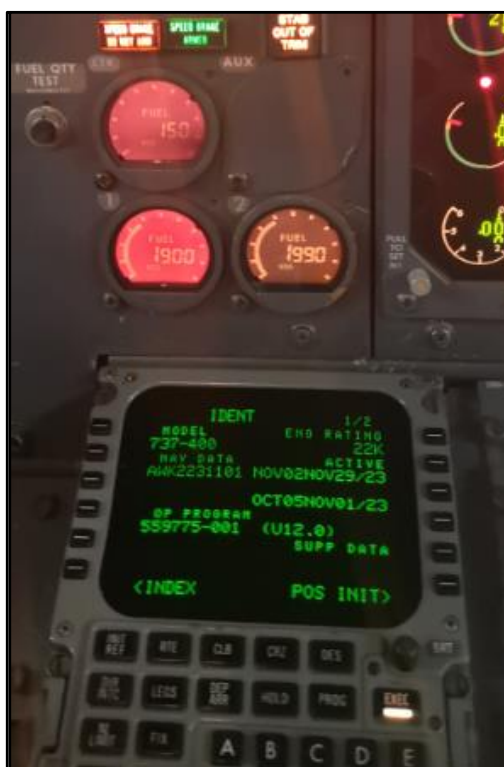
Figure 5: B737-400 center console

- 3.27. Commission investigators obtained a copy of the flight plan used by the flight crew. Several fuel checks were annotated. The captain recalled that they had carried out en-route fuel checks against the flight management computer and not the fuel gauges, as was their normal practice (Figure 5 shows the flight management computer located on the centre console, with fuel gauges directly above). The Operations Manual stated the actions required to carry out a fuel check but did not mention fuel distribution.
