Transport Accident  
Investigation  
Commission

# **Final report**

***Aviation inquiry AO-2023-003***  
***Runway excursion (veer-off)***  
***Boeing 777-319ER, ZK-OKN***  
***Auckland International Airport***  
***27 January 2023***

**May 2025**

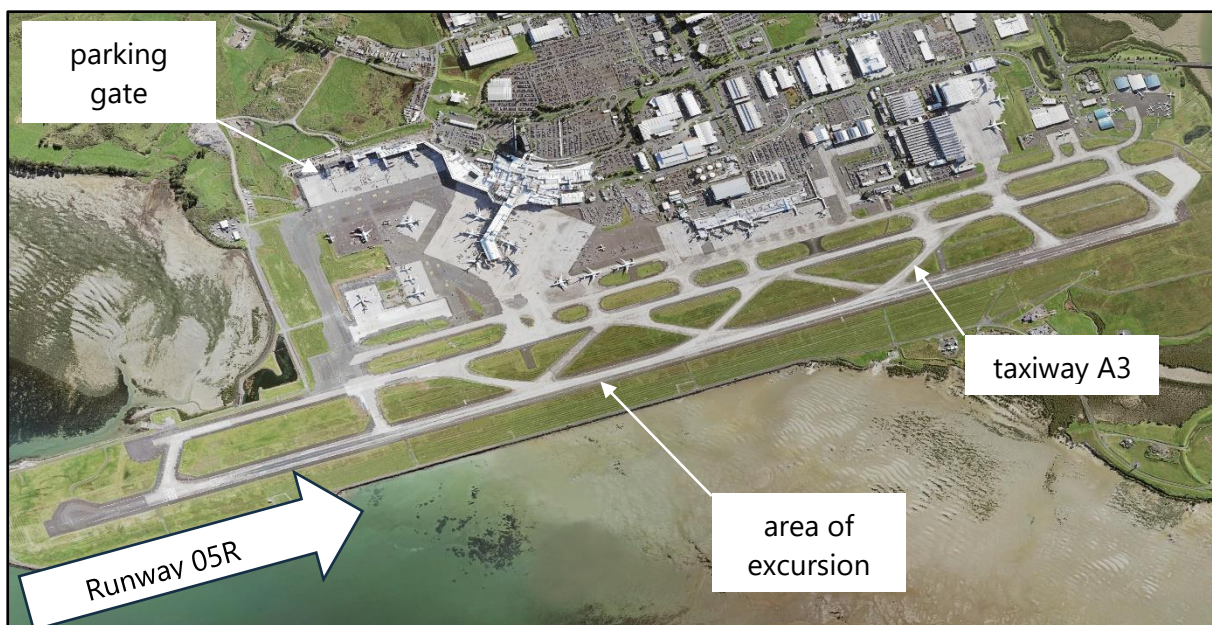
**Figure 3: Auckland Aerodrome**

- 3.14. Also of relevance is the fact that the aeroplane exited the runway at taxiway A3, the usual exit point in good weather conditions (*refer* Figure 3). This suggests that the rain did not reduce the aeroplane's braking ability significantly or affect the directional control of exiting the runway.
