Transport Accident
Investigation
Commission

Final report

Aviation inquiry AO-2023-010
Kawasaki BK117 B-2, ZK-HHJ
Collision with terrain
Mount Pirongia
19 September 2023

April 2025

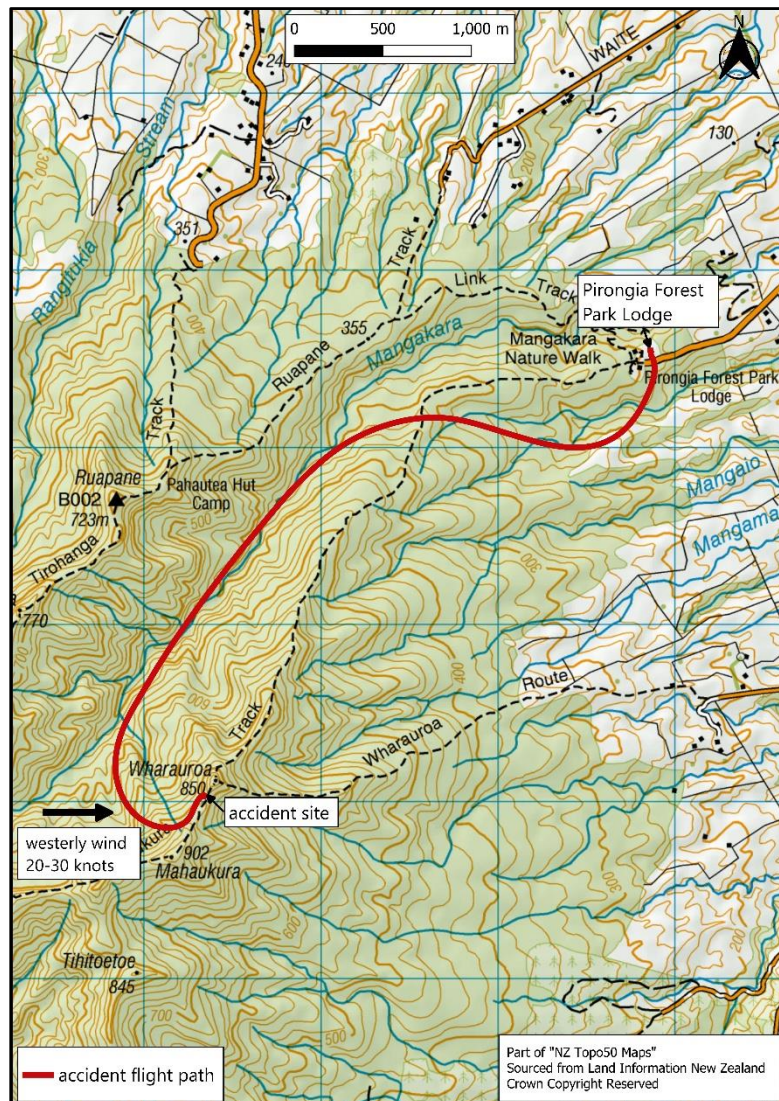
Figure 4: Accident flight

- 2.6. At 1702 the helicopter departed Pirongia Forest Park Lodge and flew up the valley on the western side of Wharauroa Lookout. After passing abeam Wharauroa Lookout the helicopter entered a 180-degree climbing turn to the left and continued ascending to an altitude of 3000 feet (ft). The pilot continued the left turn before starting a descent onto final approach towards the patient on the windward side of a ridge (see Figure 4).

- 2.8. Initially, the pilot tried to arrest the helicopter's descent rate. When the pilot observed the treetops in their peripheral vision, they realised that an impact was imminent and shifted focus from recovering the high rate of descent to controlling the impact to minimise injury.

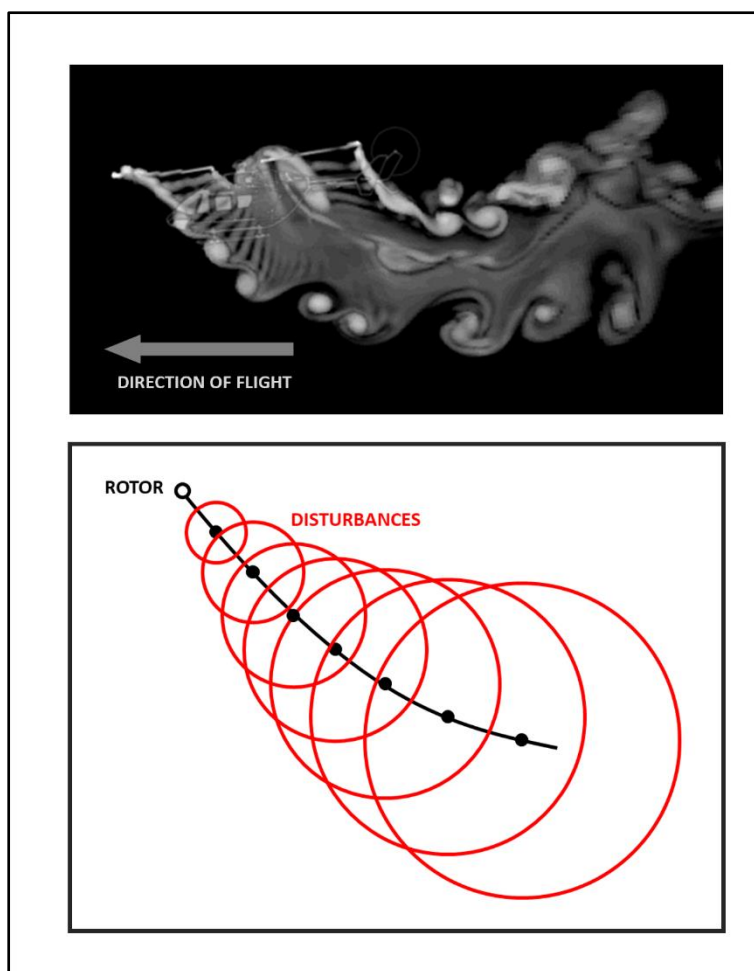
Figure 8: Representation of the main rotor wake in forward flight

- 2.54. In normal flight, a helicopter's main rotor creates a long, cylindrical wake that streams down into the flow below and behind the main rotor (see Figure 8). The wake from a helicopter's main rotor is inherently unstable. This instability causes the orderly structure of the wake eventually to break down into a highly turbulent, chaotic flow. In normal flight this breakdown occurs below and behind the helicopter and has very little influence on the aerodynamics of the main rotor itself.

- 2.55. A physical representation of the main rotor wake with the helicopter in forward flight is demonstrated in Figure 8. The image shows how the wake near the main rotor initially has an ordered cylindrical shape and how, further away from the helicopter, the wake becomes increasingly more disordered as its inherent instability starts to take hold. The figure at the bottom shows an idealisation of this process.

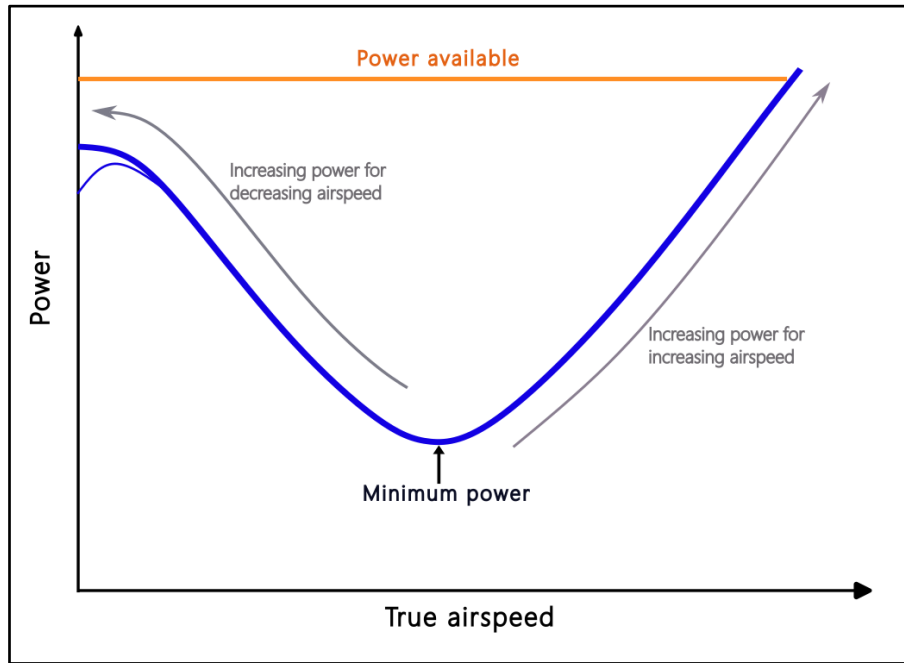
Figure 10: Power versus airspeed for level flight

- 2.62. The power required to sustain level flight increases as the forward speed of the helicopter is reduced below the minimum power setting for level flight (see Figure 10). If the engine(s) cannot provide the necessary power, then the helicopter will begin to descend or settle. This is not VRS but rather a condition where the engine(s) have reached their maximum available power limit. The power required exceeds the power available.

- 2.63. In certain circumstances, if the airspeed is slow enough, the descent rate can build up to the point at which VRS is eventually encountered in its aerodynamic form (see paragraphs 2.55 to 2.57).
