Transport Accident  
Investigation  
Commission

# **Final Report**

***Maritime inquiry MO-2022-206***  
***Charter fishing vessel, i-Catcher***  
***Capsize***  
***Goose Bay, New Zealand***  
***10 September 2022***

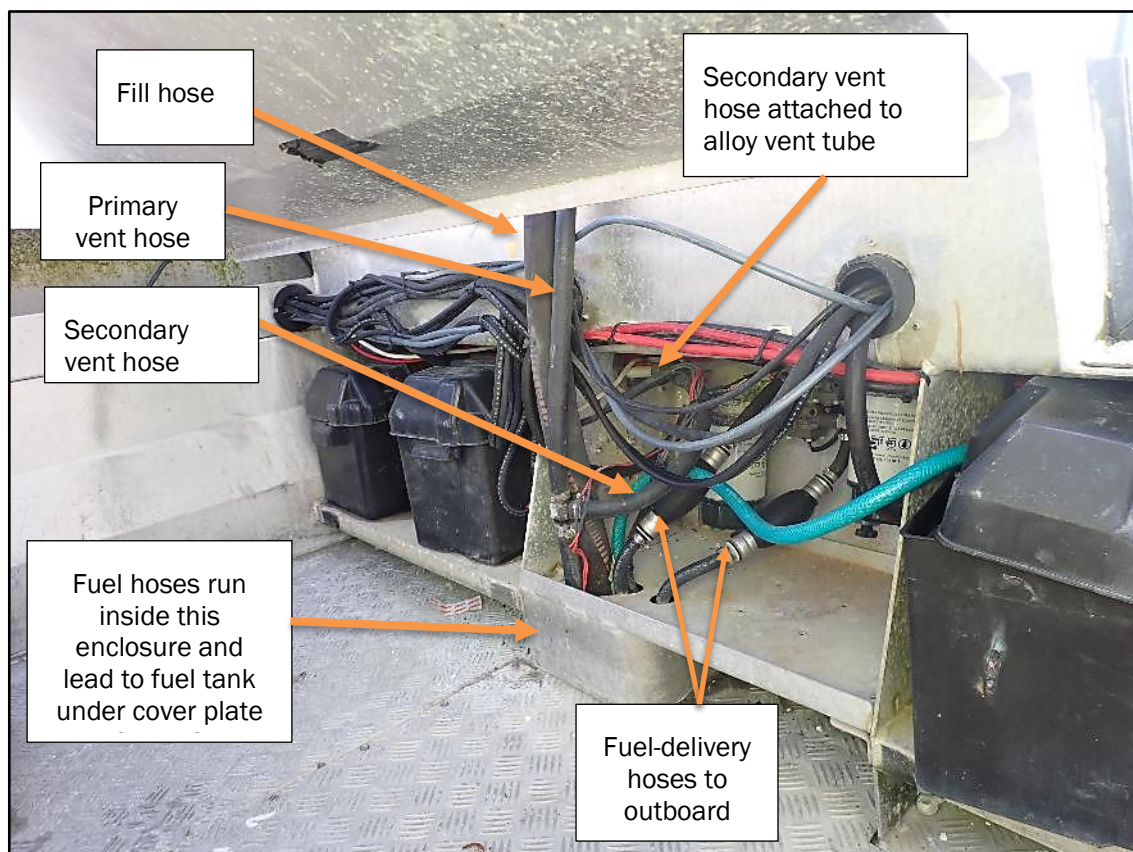
**Figure 10: The i-Catcher's fuel system components (after accident)**

- 2.60. Initial inspection of the fuel system revealed a hole measuring approximately 12 mm x 6 mm in the alloy vent tube used as a secondary fuel vent (see Figure 11). The alloy vent tube was situated above the battery cluster switch located within the interior of the stern of the vessel (see Figure 12).

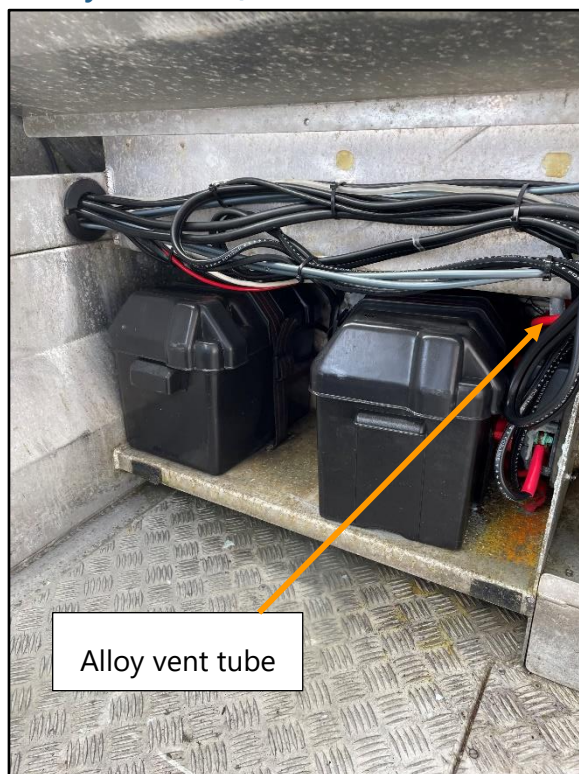
**Figure 12: Location of alloy vent (after accident)**

- 2.61. Identification of the hole in the alloy vent tube required a thorough examination of the venting arrangement. The alloy tube was partially restricted from view by a battery box and surrounding wiring (see Figure 13). The hole was a potential path for fuel to escape when filling the fuel tank or if the vessel overturned. It was also close to the battery leads and contact points, which presented a significant fire or explosion hazard.

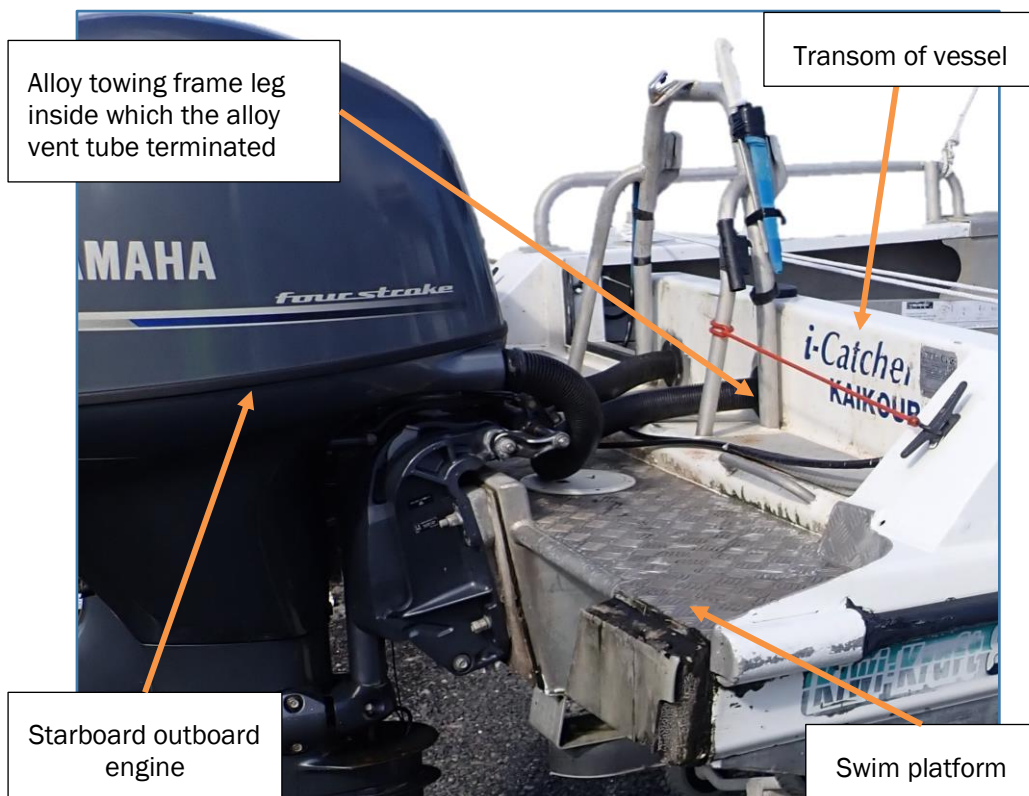
- 2.62. The alloy vent tube terminated inside an alloy towing frame on the transom just forward of the swim platform (see Figure 14 and Figure 15). A pressure test of the alloy frame revealed that it was closed off from the atmosphere, preventing fuel vapours from venting to open air and rendering it ineffective as a fuel-tank vent.

Alloy towing frame leg inside which the alloy vent tube terminated

**Figure 15: Alloy towing frame on stern**

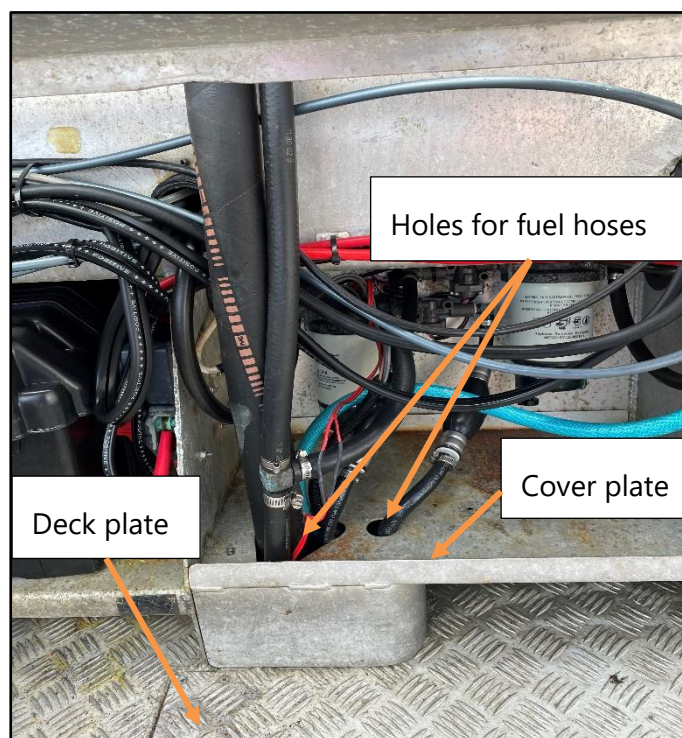
- 2.63. The vessel's fuel-delivery hoses ran from the fuel tank through two holes in a cover plate (see Figure 16)

**Figure 16: Disassembly of fuel system for TAIC inspection**

- 2.64. To enable inspection of the fuel tank and its connections, investigators removed the cover plate and the deck plate and partially disassembled the fuel system. Upon disassembly, investigators found the primary vent hose was not secured with a hose clamp, a critical component to ensure a secure connection to the fuel tank (see Figure 17).
- 2.65. A sealant had been applied around the plating where the fuel and vent hoses connected to the fuel tank. It was observed that a portion of the sealant had broken away, leaving a section of the primary vent hose connection exposed. The fuel tank and its fuel hoses were pressure-tested by Commission investigators, which revealed a leak from the base of the primary vent hose.

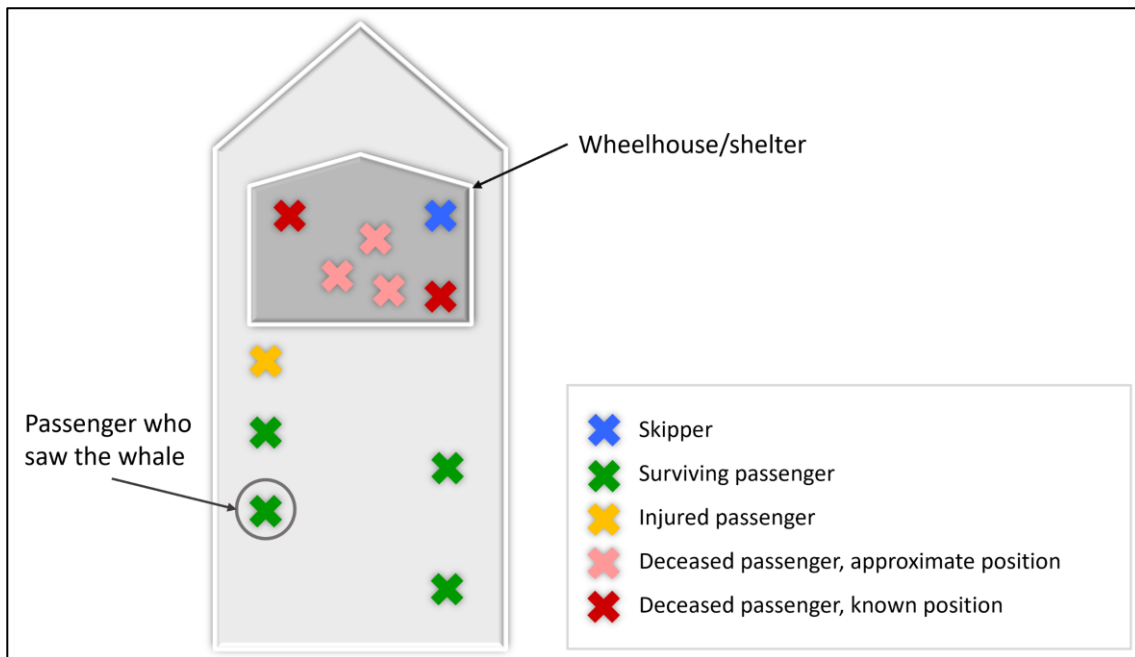
- 3.6. Immediately before the accident, the passengers were evenly distributed throughout the vessel, having minimal impact on vessel stability (see Figure 22). The skipper was seated at the helm on the starboard side of the wheelhouse.
- 3.7. Passengers were generally limited to five people each side because of the size of the vessel. When wildlife was sighted nearby, the skipper would turn the vessel 180° allowing for both port and starboard side passengers to view and photograph the wildlife.
- 3.8. All five surviving passengers were located on the aft deck on the port and starboard sides. Survivors recalled that all the deceased passengers were located under the shelter of the wheelhouse before the capsize.

**Figure 22: Likely position of passengers immediately before capsizing**

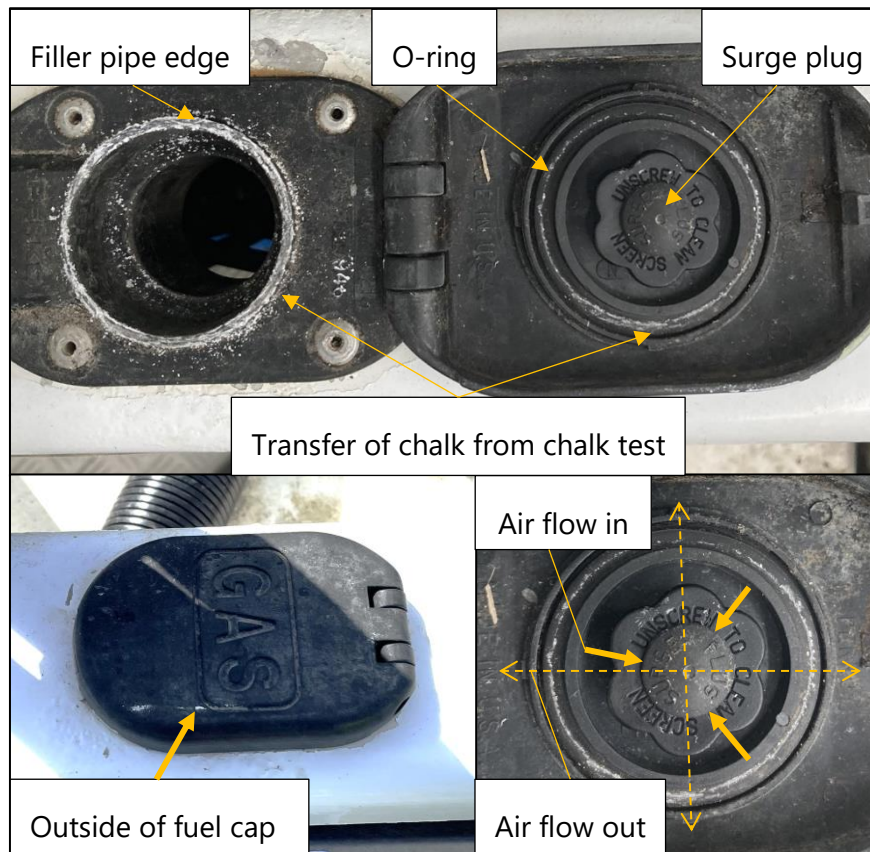
- 3.22. For the cap to seal, it requires that the surge plug is depressed, and the O-ring completes a seal with the edge of the filler pipe (see Figure 27). When inverted, head pressure from the fuel will apply a downward force on the surge plug and fuel cap, which may break the seal.

**Figure 27: Fuel cap components**

- 3.24. Commission investigators tested the seal of the fuel cap's O-ring by conducting a chalk test. The chalk test revealed that when the cap was closed, the O-ring contacted the entire edge of the filler pipe (see Figure 27).
- 3.25. If the fuel cap had leaked, a significant petrol sheen would have been visible outside the hull by the outboard motors and swim platform. Survivors who were sitting on the upturned hull for nearly forty minutes while awaiting rescue, reported seeing very little fuel in the water. Therefore, it is **unlikely** that the fuel cap contributed to the fuel leak.

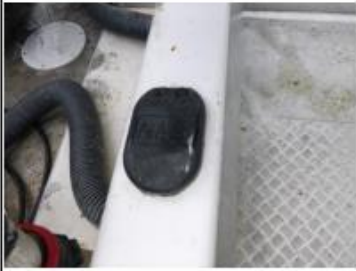
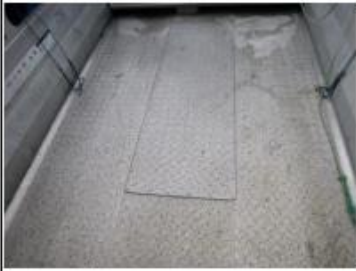
**Figure 29: Example of survey report fuel system description for *i-Catcher***

- 3.45. All *i-Catcher's* survey reports provided minimal description of the vessel's fuel system and did not include details of any inspection of the fuel system below the deck plate (see Figure 29). Similarly, the survey reports did not identify that the secondary fuel tank vent was ineffective.

| Fuel filling, storage and transfer systems | | |
|---|---|---|
| Non-portable fuel tanks | S/S tank under floor inspected 2014 when deck lifted to fix sender by Kaikoura Marine. 150 litres petrol | |

- 3.46. Fuel systems on smaller vessels can be difficult to access and, like the *i-Catcher*, may require disassembly or destructive measures to gain access. Without specific regulatory requirements to survey the entire fuel system, Recognised Surveyors rely upon their judgement in determining the extent of inspection. This decision may be based on an overall visual appraisal of the vessel that may not accurately reflect the condition of hidden components. At the time of the accident there was little guidance for Recognised Surveyors as to how often, and to what extent, a fuel system should be inspected and/or tested.

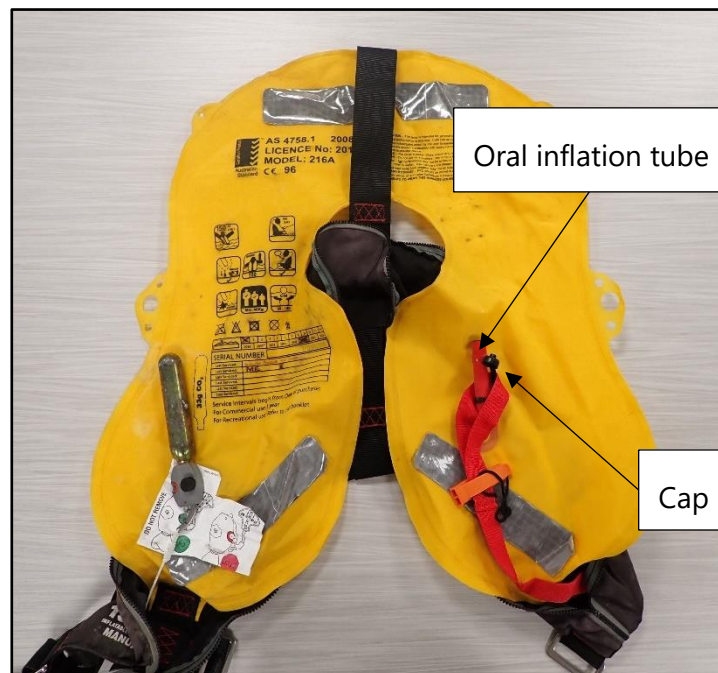
- 3.97. With the securing straps now tight it can be difficult for the occupant to unbuckle and remove the lifejacket once it is inflated. The level of difficulty significantly increases in cold water (if the wearer loses dexterity in their fingers) and if the inflated bladder is blocking the wearer's peripheral vision.

- 3.98. To improve visibility and ease tension in the straps, the bladder can be partially deflated by pressing down on the release valve in the oral inflation tube, which is ordinarily used for manually adding air to the bladder (see Figure 34). Attached to the top of the oral inflation tube is a cap that, when inverted, can be used to press down on the release valve located at the top of the tube. As the bladder deflates the straps will loosen around the body making it easier to unbuckle.

**Figure 34: Unpacked inflatable lifejacket**

- 3.99. Vessel operators and individual wearers must ensure that lifejackets are fitted in accordance with the manufacturer's instructions to prevent them from riding up and obstructing the wearer's face. All people wearing lifejackets should also have a complete understanding of its full operation, including how to remove it in water if need be. This information is best shared during predeparture safety briefings to ensure all vessel occupants are well informed.
- 3.100. On the day of the accident, the skipper of *i-Catcher* conducted a safety briefing before departure. Wearing a lifejacket was required by the skipper, who provided lifejackets to all passengers who needed one.
- 3.101. The skipper proceeded to help the passengers don their lifejackets and informed them of the general operation to inflate the lifejacket, instructing them to pull the
