Transport Accident
Investigation
Commission

Final Report

Maritime inquiry MO-2022-206
Charter fishing vessel, i-Catcher
Capsize
Goose Bay, New Zealand
10 September 2022

April 2025

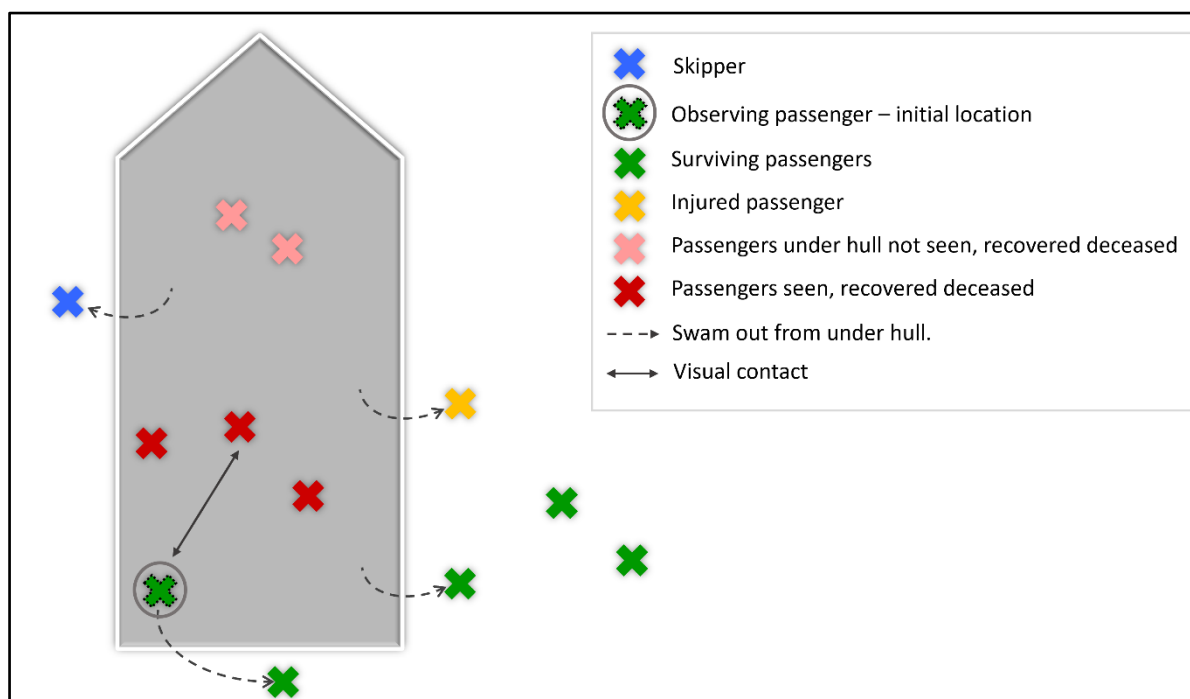
Figure 4: Approximate location of occupants immediately after *i-catcher* capsized

- 2.11. Eight passengers and the skipper were initially underneath the upturned hull. Two passengers swam out straightaway from underneath the vessel without inflating their lifejackets; the skipper took two attempts to swim out (see Figure 4).

- 2.13. While in the air pocket a passenger (referred to as the 'observing passenger' in Figure 4) who was positioned close to the stern looking forward, observed three other passengers within the air pocket. Two passengers were located on either side of

the vessel, facing away from the observing passenger while the third passenger was located amidships⁸, looking directly at the observing passenger. None of these passengers had their lifejackets inflated at that time.

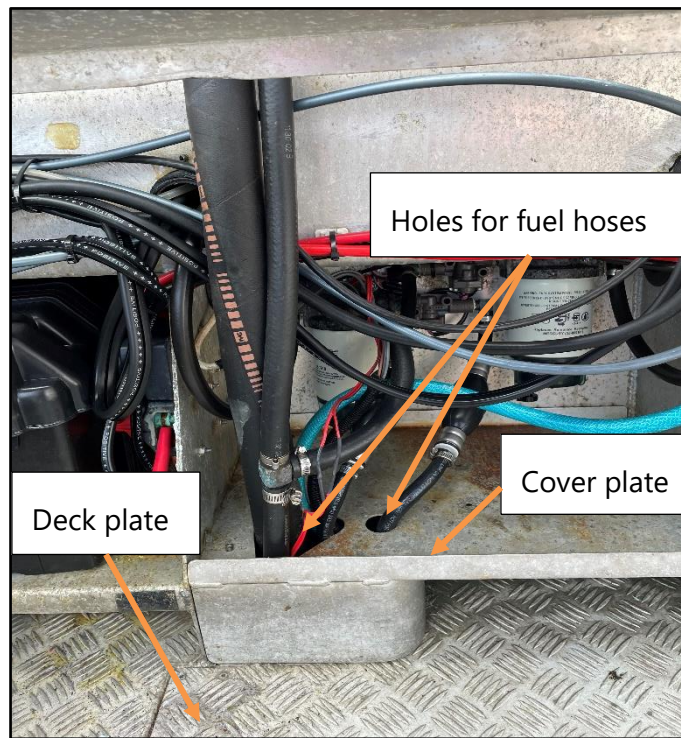
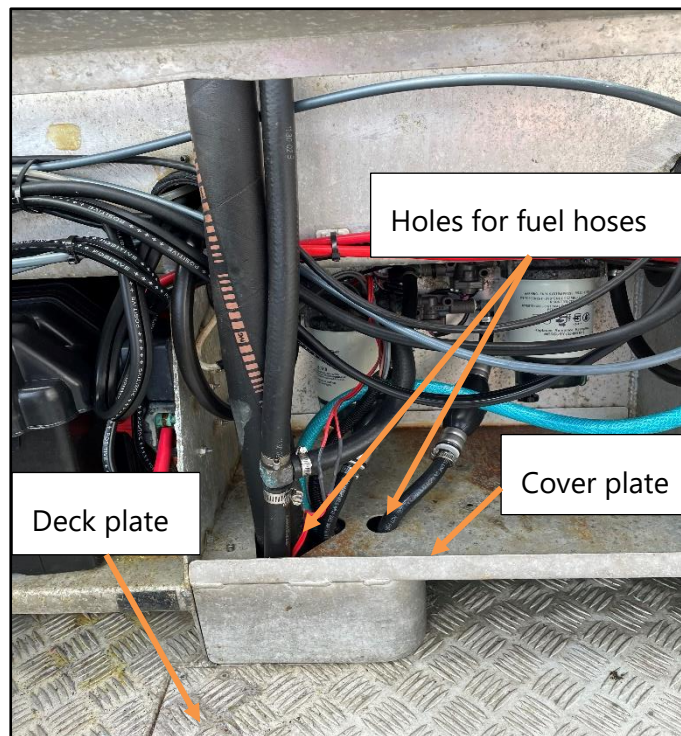
Figure 16: Disassembly of fuel system for TAIC inspection

2.63. The vessel's fuel-delivery hoses ran from the fuel tank through two holes in a cover plate (see

- 2.64. To enable inspection of the fuel tank and its connections, investigators removed the cover plate and the deck plate and partially disassembled the fuel system. Upon disassembly, investigators found the primary vent hose was not secured with a hose clamp, a critical component to ensure a secure connection to the fuel tank (see Figure 17).
- 2.65. A sealant had been applied around the plating where the fuel and vent hoses connected to the fuel tank. It was observed that a portion of the sealant had broken

away, leaving a section of the primary vent hose connection exposed. The fuel tank and its fuel hoses were pressure-tested by Commission investigators, which revealed a leak from the base of the primary vent hose.

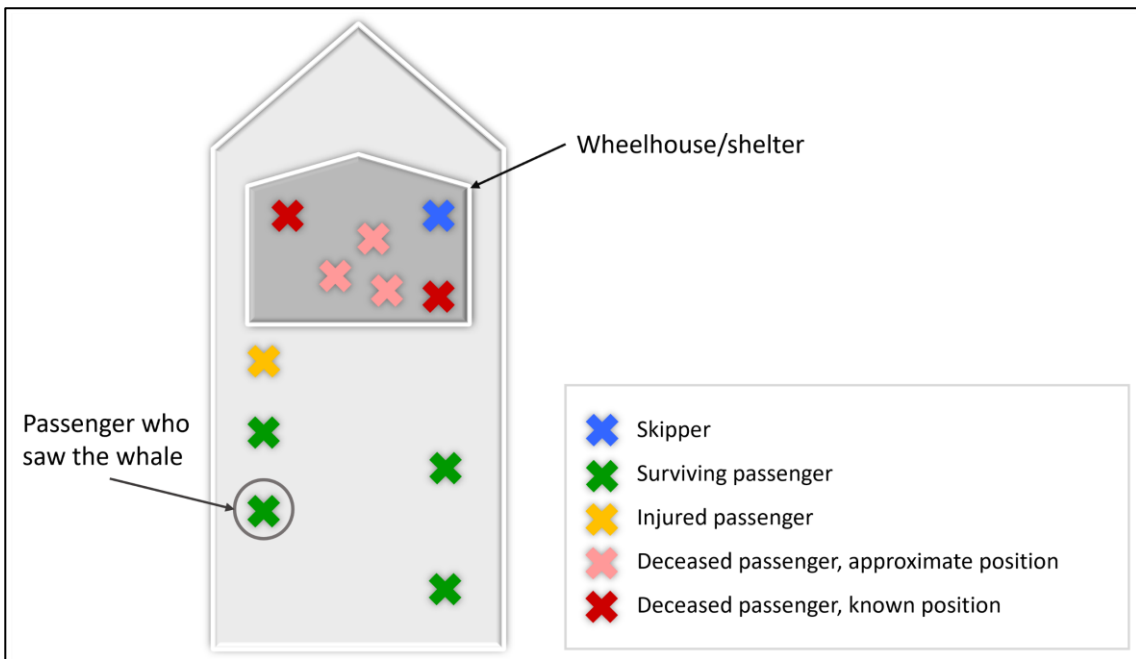
Figure 22: Likely position of passengers immediately before capsizing

- 3.6. Immediately before the accident, the passengers were evenly distributed throughout the vessel, having minimal impact on vessel stability (see Figure 22). The skipper was seated at the helm on the starboard side of the wheelhouse.
- 3.7. Passengers were generally limited to five people each side because of the size of the vessel. When wildlife was sighted nearby, the skipper would turn the vessel 180° allowing for both port and starboard side passengers to view and photograph the wildlife.
- 3.8. All five surviving passengers were located on the aft deck on the port and starboard sides. Survivors recalled that all the deceased passengers were located under the shelter of the wheelhouse before the capsizing.

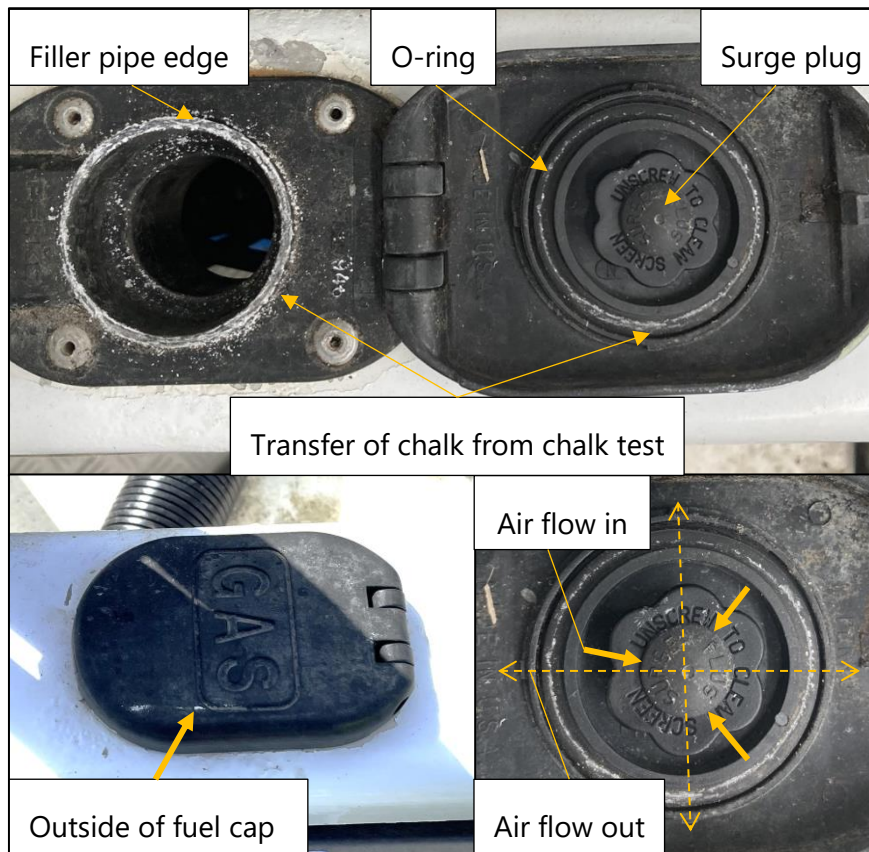
Figure 27: Fuel cap components

- 3.22. For the cap to seal, it requires that the surge plug is depressed, and the O-ring completes a seal with the edge of the filler pipe (see Figure 27). When inverted, head pressure from the fuel will apply a downward force on the surge plug and fuel cap, which may break the seal.

- 3.24. Commission investigators tested the seal of the fuel cap's O-ring by conducting a chalk test. The chalk test revealed that when the cap was closed, the O-ring contacted the entire edge of the filler pipe (see Figure 27).
- 3.25. If the fuel cap had leaked, a significant petrol sheen would have been visible outside the hull by the outboard motors and swim platform. Survivors who were sitting on the upturned hull for nearly forty minutes while awaiting rescue, reported seeing very little fuel in the water. Therefore, it is **unlikely** that the fuel cap contributed to the fuel leak.

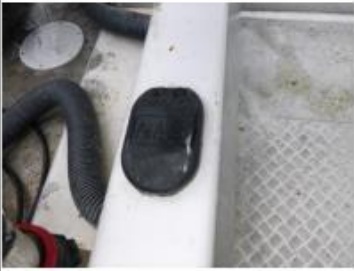
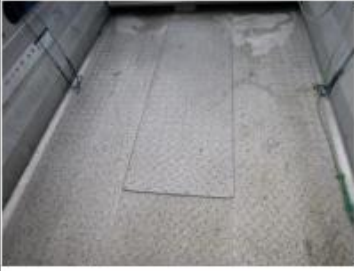
Figure 29: Example of survey report fuel system description for *i-Catcher*

- 3.45. All *i-Catcher's* survey reports provided minimal description of the vessel's fuel system and did not include details of any inspection of the fuel system below the deck plate (see Figure 29). Similarly, the survey reports did not identify that the secondary fuel tank vent was ineffective.

Non-portable fuel tanks	S/S tank under floor inspected 2014 when deck lifted to fix sender by Kaikoura Marine. 150 litres petrol

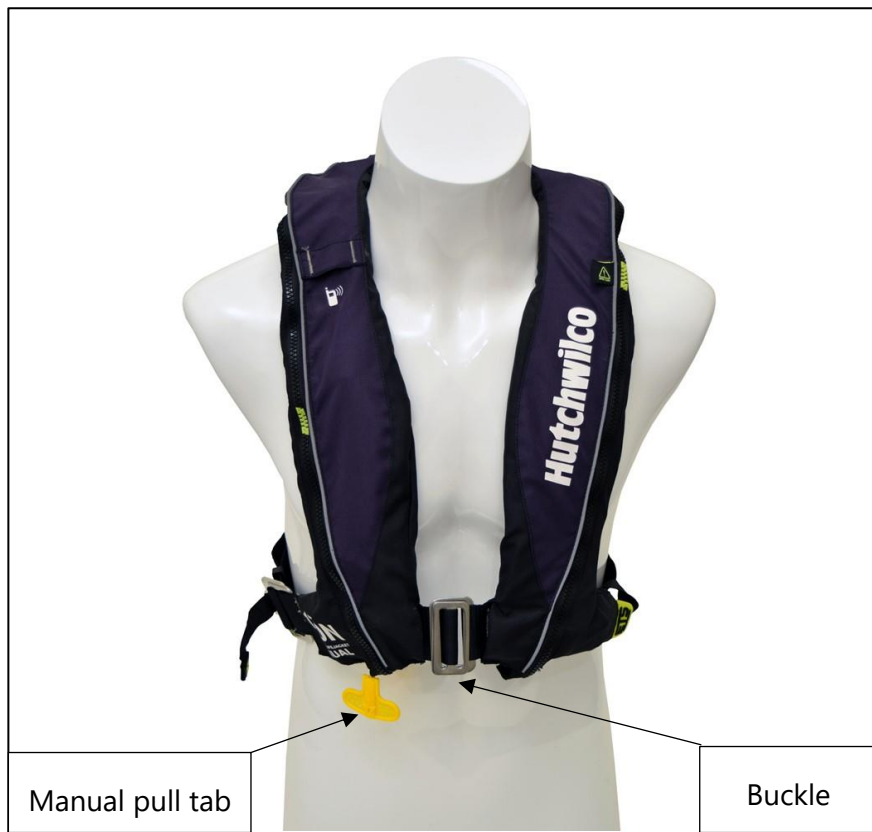
Figure 33: Manual inflatable lifejacket components

- 3.88. A survivor saw three other passengers underneath the hull, without their lifejackets inflated.
- 3.89. A manual inflatable lifejacket can be inflated by either the wearer or someone else pulling on the pull tab to activate the inflation mechanism (see Figure 33). The Commission could not determine at what point the manual inflatable lifejackets had been inflated.

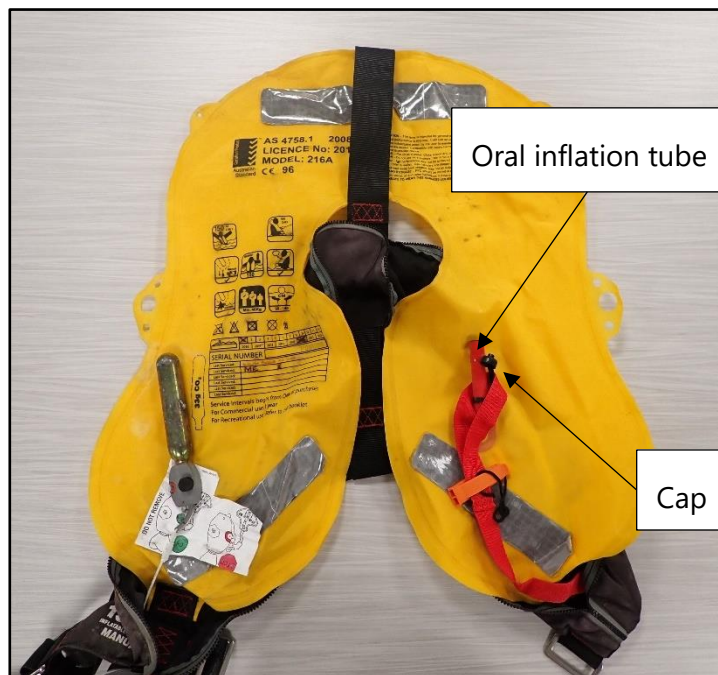
Figure 34: Unpacked inflatable lifejacket

- 3.98. To improve visibility and ease tension in the straps, the bladder can be partially deflated by pressing down on the release valve in the oral inflation tube, which is ordinarily used for manually adding air to the bladder (see Figure 34). Attached to the top of the oral inflation tube is a cap that, when inverted, can be used to press down on the release valve located at the top of the tube. As the bladder deflates the straps will loosen around the body making it easier to unbuckle.

- 3.99. Vessel operators and individual wearers must ensure that lifejackets are fitted in accordance with the manufacturer's instructions to prevent them from riding up and obstructing the wearer's face. All people wearing lifejackets should also have a complete understanding of its full operation, including how to remove it in water if need be. This information is best shared during predeparture safety briefings to ensure all vessel occupants are well informed.
- 3.100. On the day of the accident, the skipper of *i-Catcher* conducted a safety briefing before departure. Wearing a lifejacket was required by the skipper, who provided lifejackets to all passengers who needed one.
- 3.101. The skipper proceeded to help the passengers don their lifejackets and informed them of the general operation to inflate the lifejacket, instructing them to pull the
