Transport Accident  
Investigation  
Commission

# **Final report**

***Maritime inquiry MO-2023-205***  
***Bulk carrier, Achilles Bulker***  
***Loss of rudder***  
***Off the Port of Tauranga***  
***24 July 2023***

**July 2025**

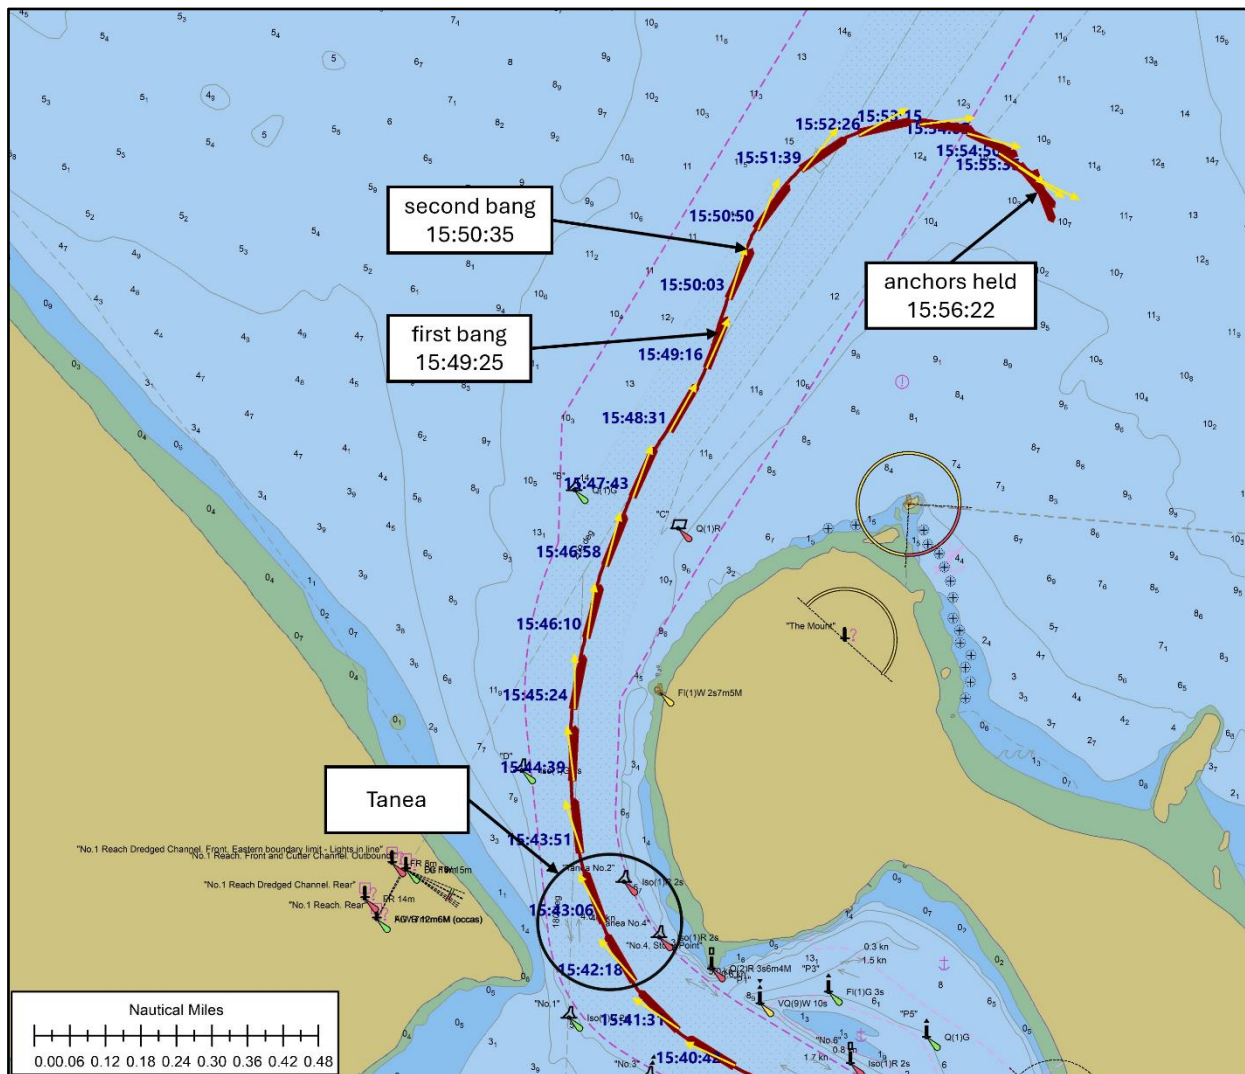
**Figure 3: Achilles Bulker's track**

- 2.4. At 1533 the pilot boat communicated to the pilots that the current at Tanea had reduced to 2.8 kt. By 1540 the *Achilles Bulker* had begun the turn to starboard around Tanea at a speed of 8.4 kt with the engine half ahead<sup>14</sup> (see Figure 3).

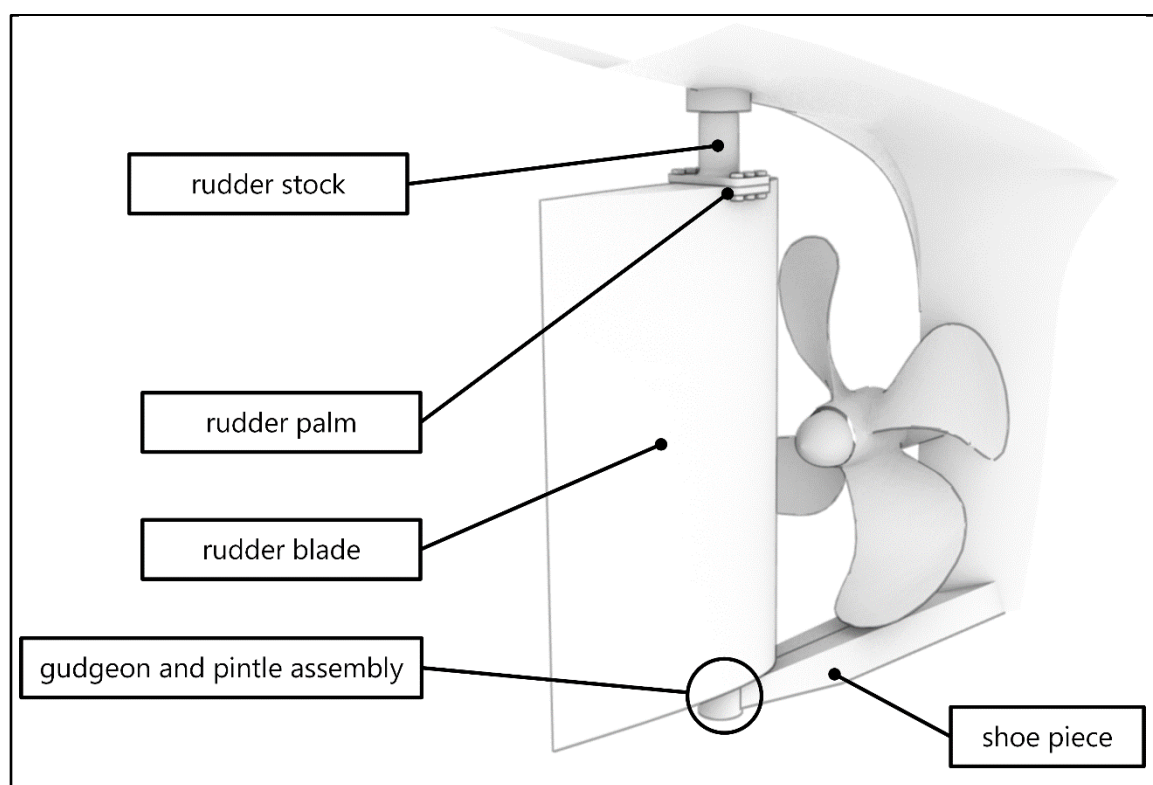
**Figure 4: Rudder system side view**

- 2.21. The rudder used on *Achilles Bulker* was a balanced rudder<sup>30</sup> supported by a shoe piece<sup>31</sup>. The rudder blade was hung from the ship via the rudder stock that connected the rudder blade to the ship's steering gear (see Figure 4).

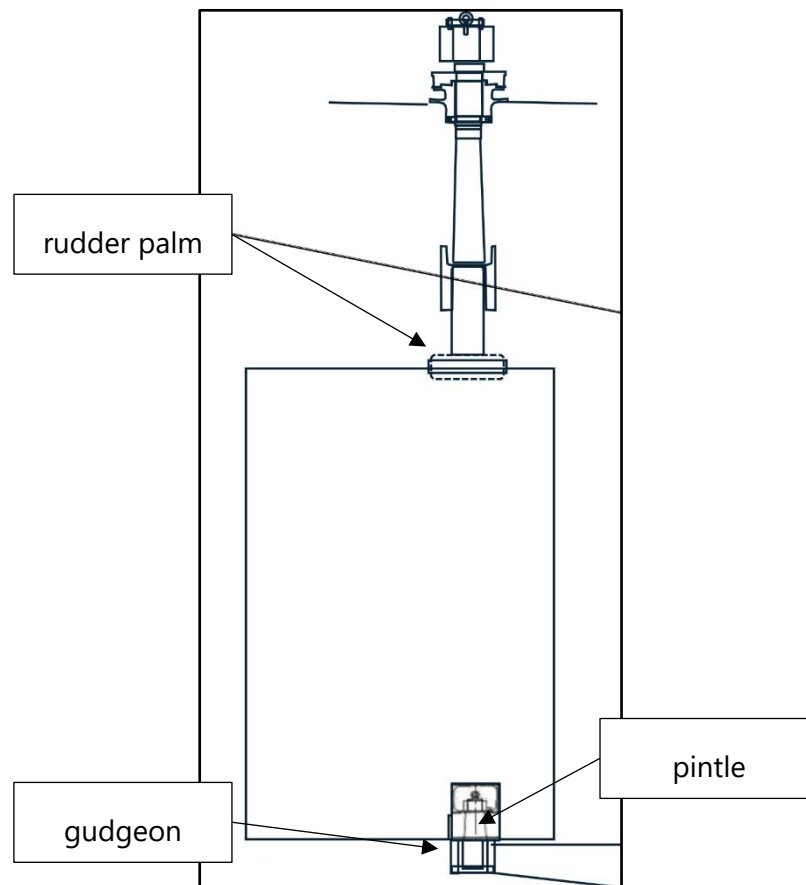
**Figure 5: Rudder components**

- 2.23. The bottom of the rudder blade was supported by a pintle<sup>33</sup> that extended down from the bottom of the rudder into a gudgeon<sup>34</sup> located at the end of the ship's shoe piece.
- 2.24. The rudder's pintle served as a pivot point at the bottom of the rudder. The pintle was secured in the bottom of the rudder in a fixed position and extended downward into a bushing<sup>35</sup> within the gudgeon (see Figure 4 and Figure 5). The bushing was water lubricated, enabling the pintle to rotate with the rudder without resistance.

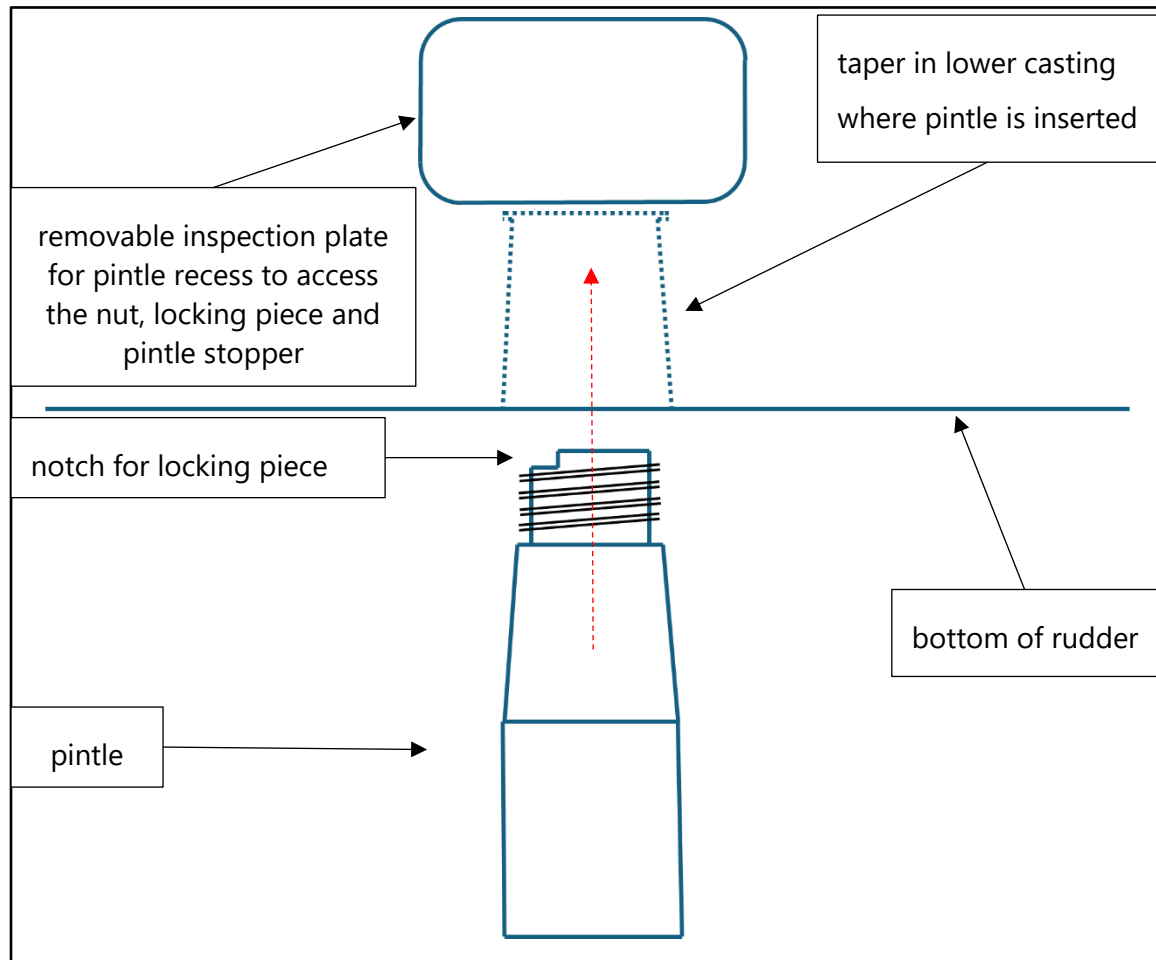
**Figure 6: Pintle fitting**

rudder, forming an interference fit<sup>37</sup>. To operate correctly, the interference fit required 80% surface contact between the pintle and the tapered surface in the lower casting (see Figure 6).

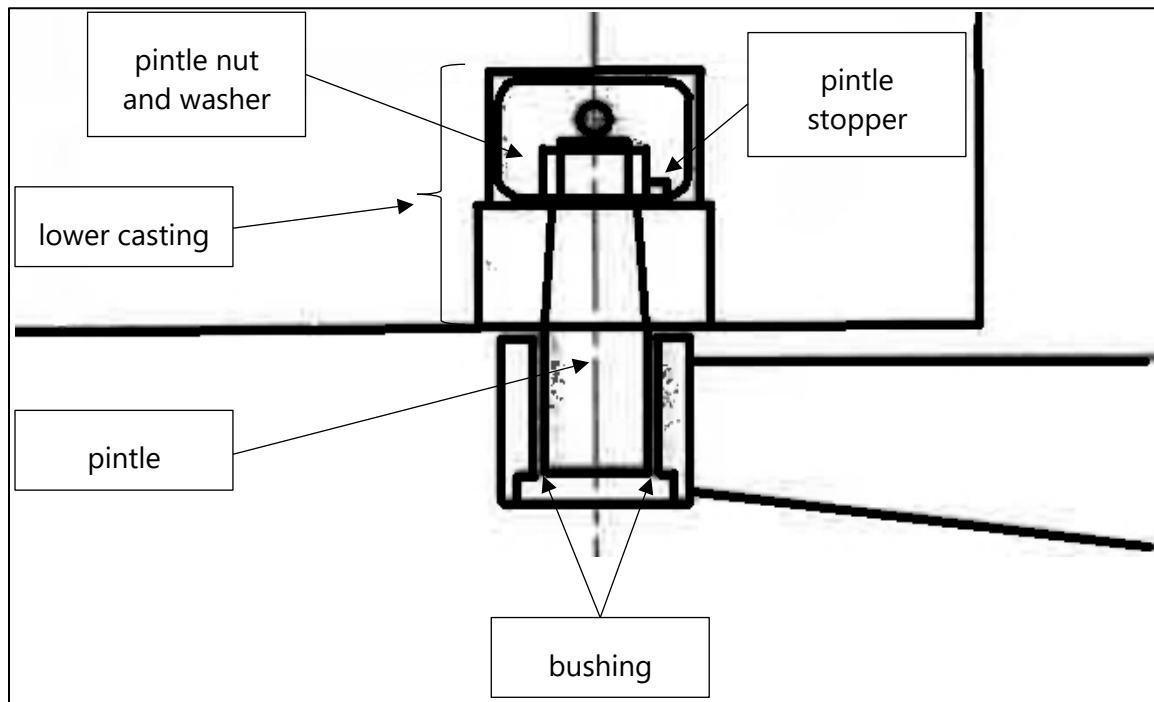
**Figure 7: Pintle installed**

- 2.27. To maintain the interference fit, the top of the pintle was threaded and secured in the lower casting using a large washer and nut (see Figure 7).

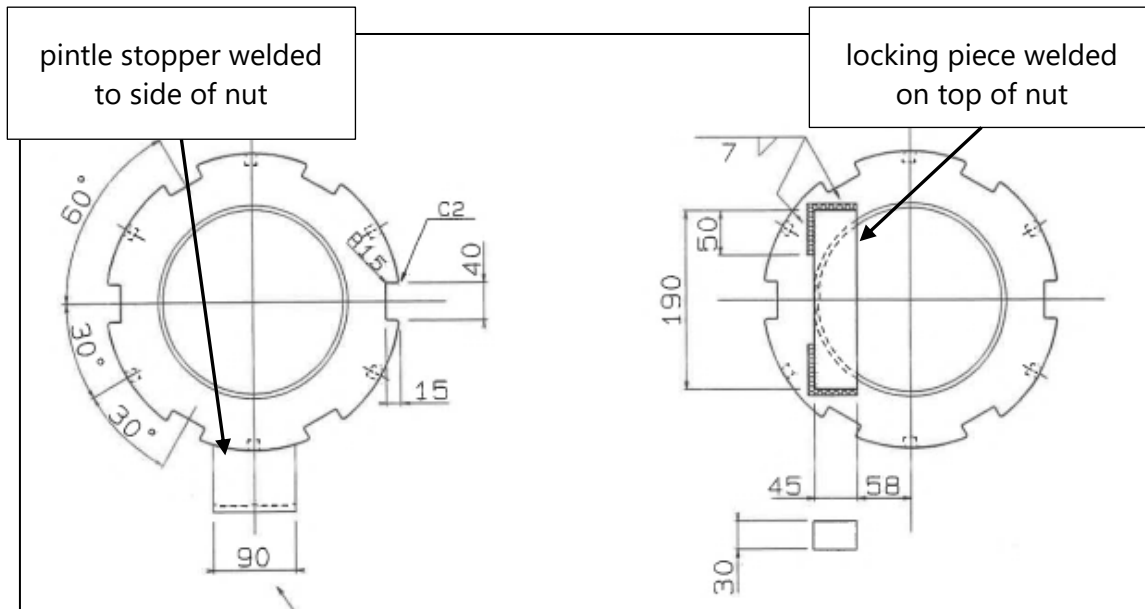
**Figure 8: Pintle nut with locking piece and pintle stopper**

- 2.28. A locking piece and pintle stopper were welded to the nut to prevent the pintle nut loosening. The pintle stopper was a piece of right-angle steel welded to the side of the pintle nut and the interior of the rudder. The locking piece was a steel bar that lay across the top of the pintle nut and sat inside a notch at the top of the pintle (see Figure 8). The locking piece was then welded in place.
