Final report RO-2017-104: Unauthorised immobilisation of passenger train  
at Baldwin Avenue Station, Avondale, 17 September 2017

Rail inquiry RO-2017-104  
Unauthorised immobilisation of passenger train  
at Baldwin Avenue Station, Avondale

17 September 2017

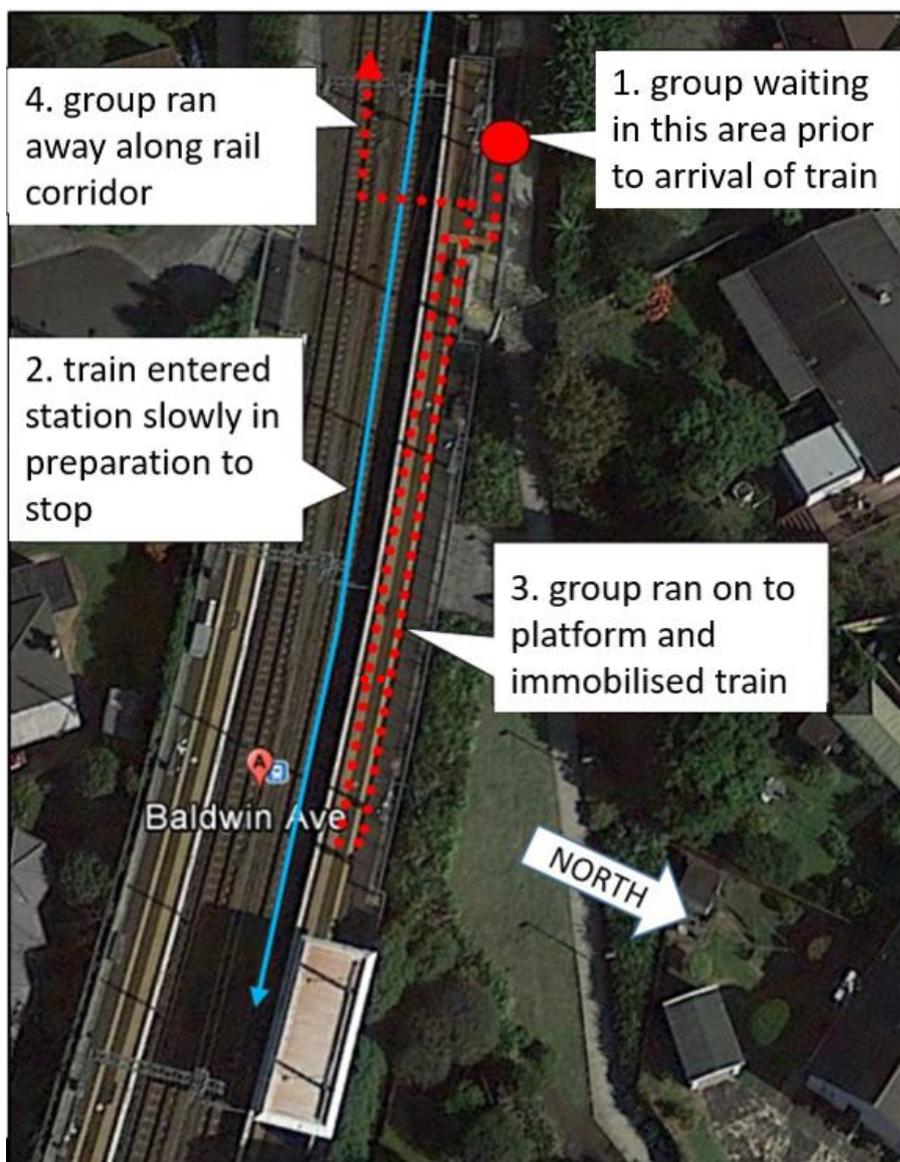
**Figure 4**  
Aerial view of Baldwin Avenue Station

- 3.1.12. The group of masked people continued spray-painting the side of the train for about seven minutes. They then escaped along the rail corridor towards Mount Albert (see Figure 4).
