Final report RO-2018-101: Metropolitan passenger train, derailment,
Britomart Transport Centre, Auckland, 9 May 2018

Rail inquiry R0-2018-101
Metropolitan passenger train

Derailment

Britomart Transport Centre, Auckland

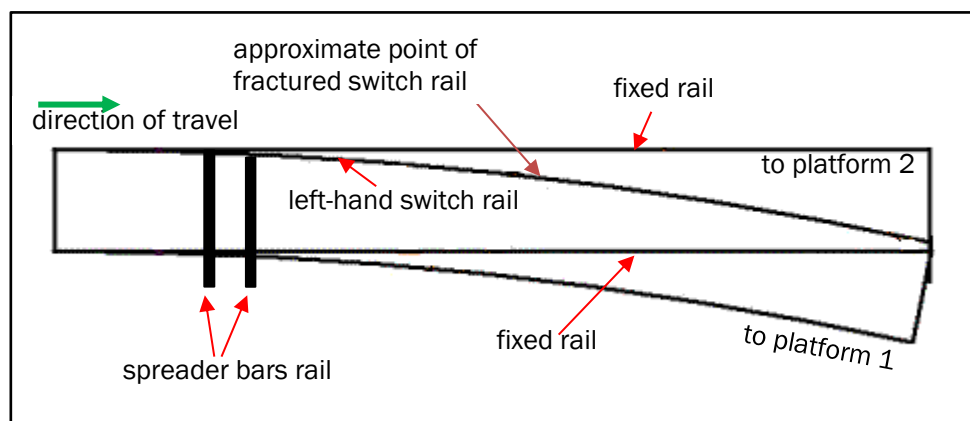
Figure 5
Simplified diagram of right-hand points

- 4.2.3. There was a complete lateral fracture in the left-hand switch rail, which likely occurred when it was placed into the 'normal'⁴ position for an incoming and outgoing train movement on platform 2. Neither of these train movements traversed the broken switch rail and they were therefore not at risk of derailment (see Figures 5 and 6).
