Transport Accident  
Investigation  
Commission

# **Final report**

***Rail inquiry RO-2021-104***  
***Passenger train 6205***  
***Train derailment***  
***Kāpiti***  
***17 August 2021***

**October 2024**

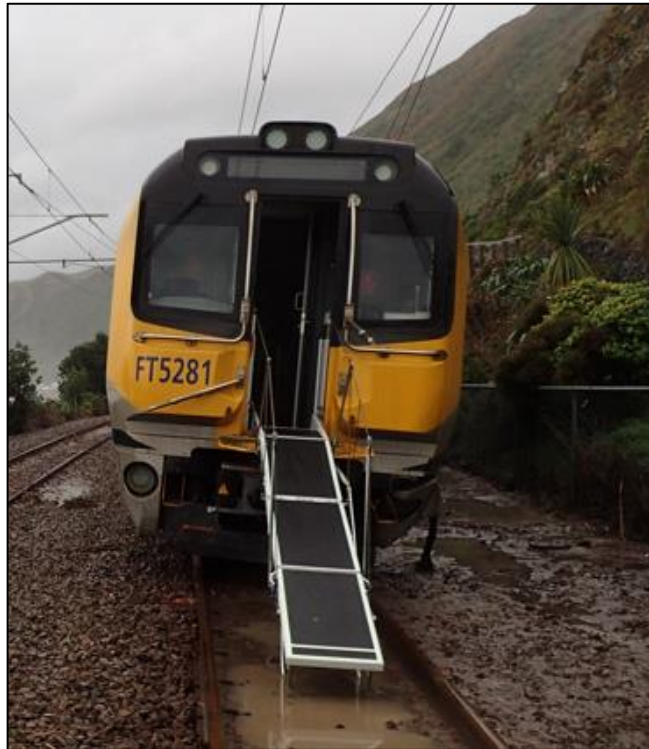
**Figure 7: Passenger evacuation egress point from the train**  
(Photographed at about 1215)

- 2.26. At about 0650 the RIC and train crew started the evacuation process for the 82 passengers. They prepared the train's four evacuation egress points, which were at each end of the train and at the centre door on carriages number two and four (see Figure 7).

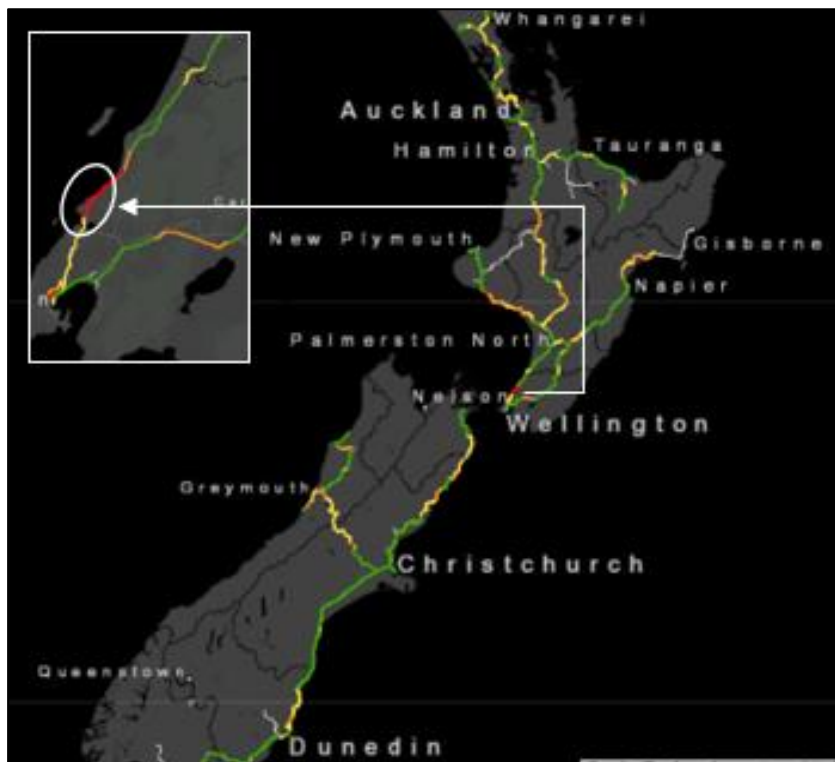
**Figure 14: Rail resilience map showing the risk profile across the network (red – very high risk, amber – high risk, yellow – medium risk and green – low risk)**

3.11. KiwiRail has a contract with a meteorological service provider to supply weather information across the rail network. The provider communicates rainfall predictions and weather-related information to KiwiRail in the days before an expected weather condition or event. This information is collated into areas corresponding to broad weather zones, then assessed in a weather risk matrix table. The table is used to calculate the potential risk of weather events on the rail corridor. KiwiRail also had at the time of the accident a rail resilience map that identified areas of the rail corridor subject to weather-related risks (see Figure 14).
