Transport Accident
Investigation
Commission

Final report

Rail inquiry RO-2022-102
L71 Mainline Shunt
Derailment and subsequent rollover
Tamaki
1 June 2022

December 2023

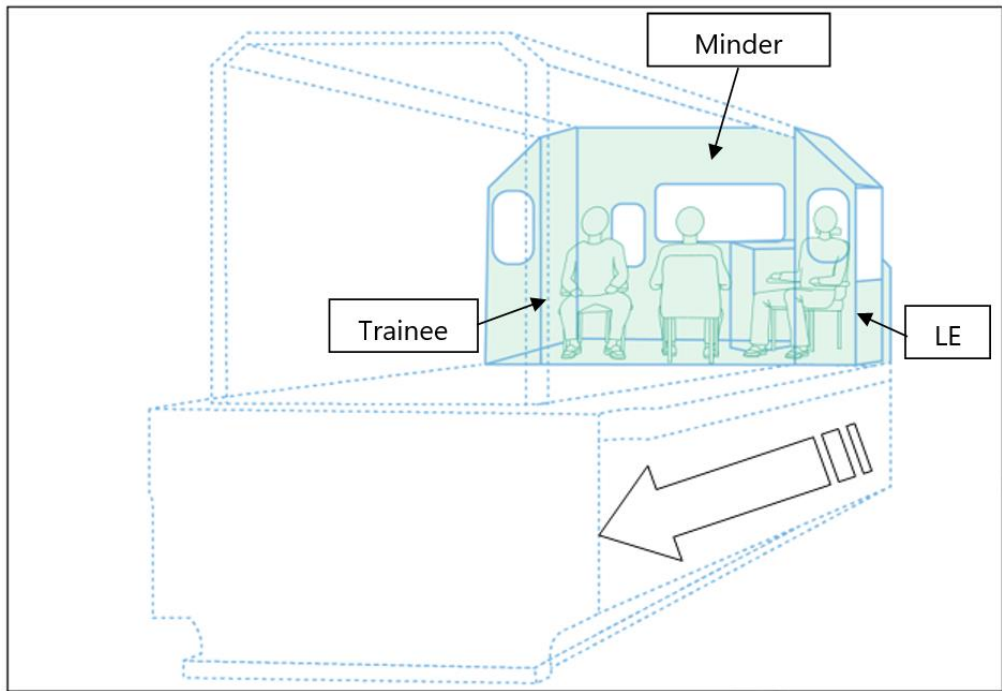
Figure 9: Positions of crew within the locomotive cab

- 2.18. The LE reminded the trainee and minder that there would be fewer signals on the return route to Westfield (see Figure 8) and to be alert for their locations as they would not be visible to the LE from their side of the cab (see Figures 9 and 10).

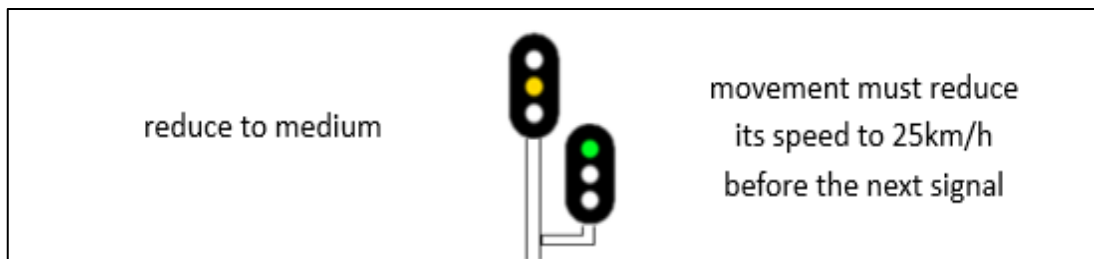
Figure 12: Signal aspect for 'reduce to medium'

- 2.19. In accordance with the departure signal (see Figure 11) the LE brought the locomotive up to a controlled line speed of 80 km/h. The next signal was positioned approximately 5.3 km along the track and was displaying 'reduce to medium', being a yellow top, green bottom light aspect (see Figure 12). This signal requires a speed reduction to 25 km/h before the next signal.

- 2.20. The trainee sighted the signal and called 'green'. The LE repeated the signal call back as 'green'. The LE continued at approximately 74 km/h, assuming the call was referring to a 'clear normal' signal, being a green top, red bottom light aspect.
- 2.21. The next signal (signal 507) was a further 1.8 km along the line. The signal was displaying a 'clear medium' aspect, being a red top, green bottom light (see Figure 13). This signal requires a speed no greater than 25 km/h as the signal is passed. The trainee sighted the signal and called 'green' and the LE repeated the signal call back as 'green'. The LE again assumed the call was referring to a 'clear normal' signal, being a green top, red bottom light aspect, and continued at approximately 76 km/h.

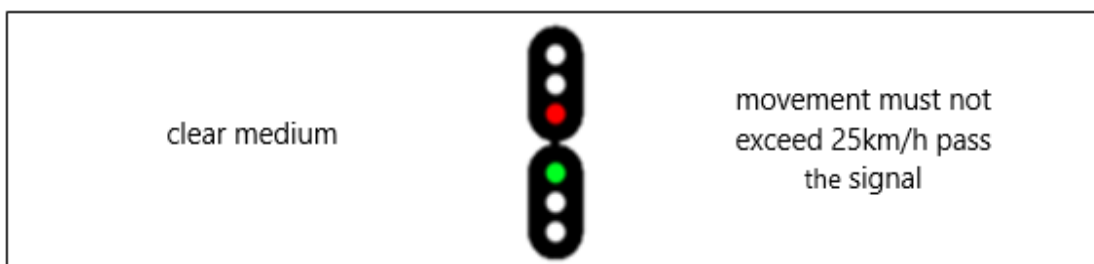
Figure 13: Signal aspect for 'clear medium'

- 2.22. At approximately 0103, the locomotive passed signal 507 at a speed of 76.8 km/h, rather than the required 25 km/h. The locomotive travelled a further 153m before entering a set of crossover points directing the locomotive from the up mainline across to the down mainline (see Figure 14).

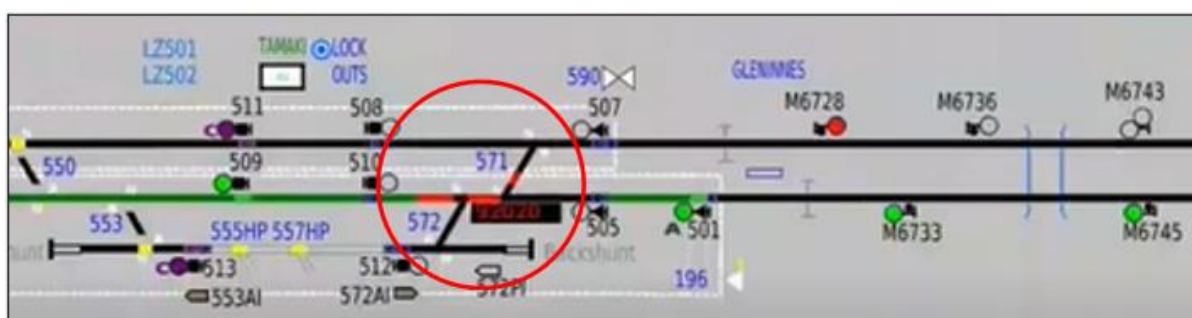
Figure 19: Train control display for Tamaki

- 2.29. The trainee helped the minder and LE to stand up before attempting to access the door, that was now above their head, and release the sliding windows. However, both were jammed closed.
- 2.30. Meanwhile, the train controller had observed on their monitor screen a loss of track circuit detection⁹ at the Tamaki crossover points (see Figure 19). At about the same time they received the emergency radio base call from the locomotive, as a result of the LE unintentionally depressing the emergency mushroom button. The train controller attempted to contact the crew via the radio system on several occasions but received no response.
