Transport Accident  
Investigation  
Commission

# **Final report**

***Rail inquiry RO-2023-102***  
***Freight train 360***  
***Derailment***  
***Te Puke***  
***29 January 2023***

**June 2024**

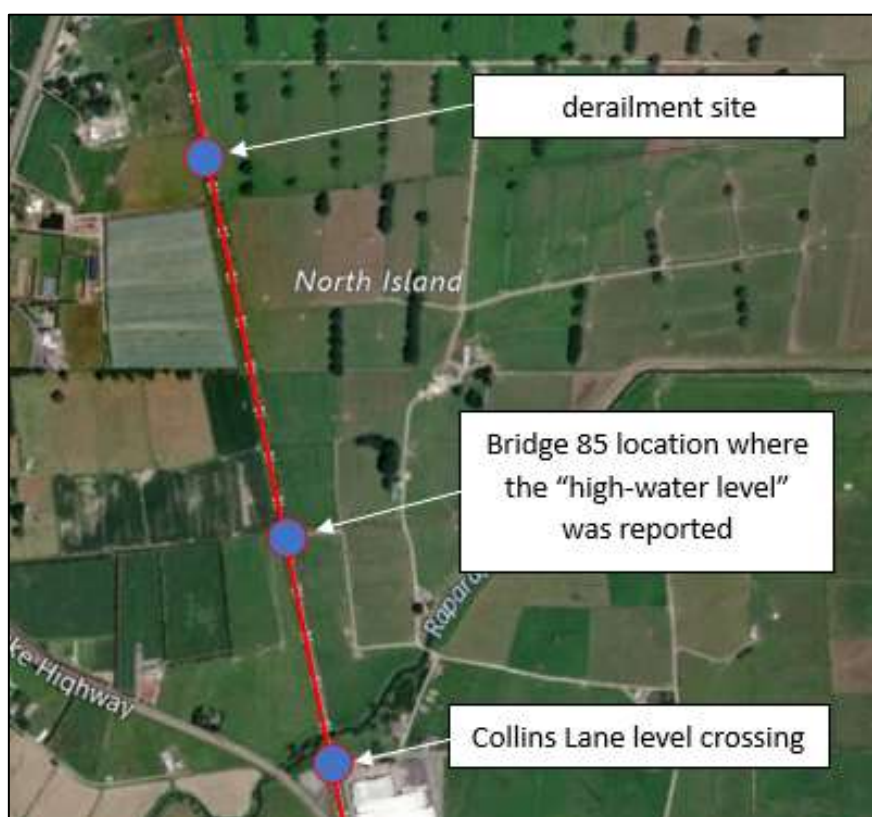
**Figure 4: Aerial map showing the location of bridge 85**

- 2.11. On 28 January at about 0630, the crew<sup>14</sup> of train 385 (the crew) observed a significantly high water level as they crossed rail bridge 85 north of Te Puke (see Figure 4).

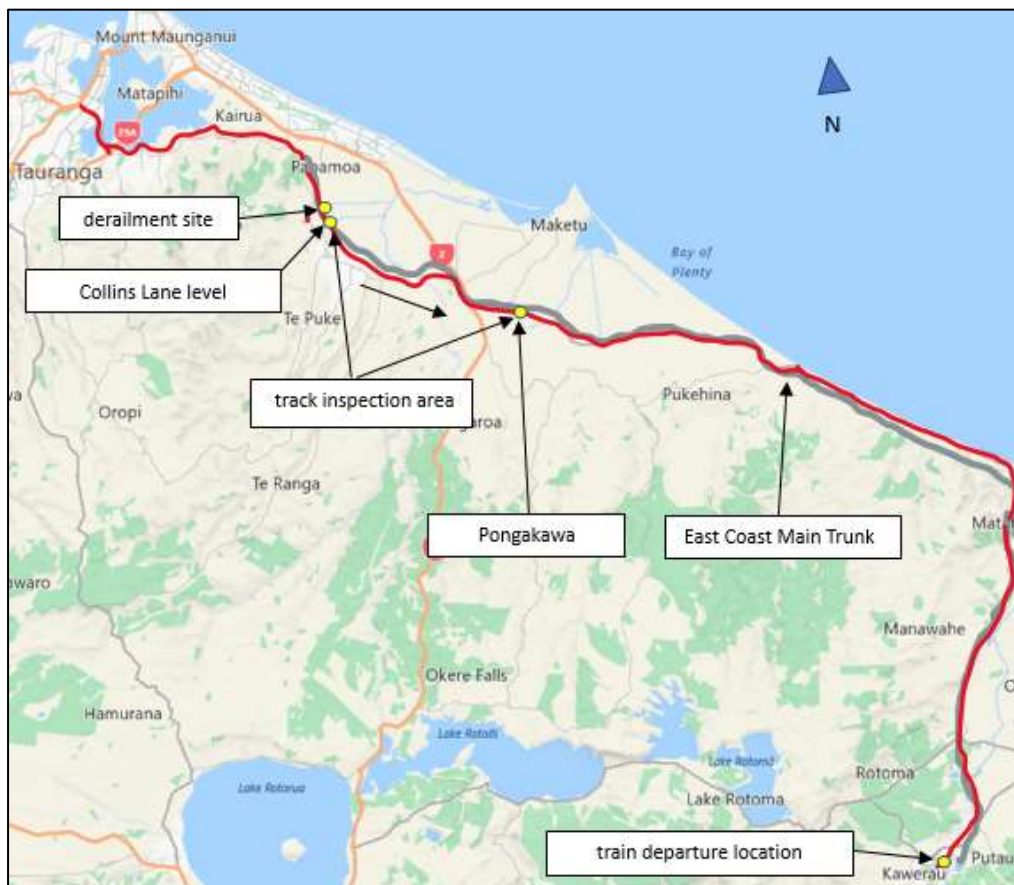
**Figure 5: Map of the ECMT between Tauranga and Kawerau**

- 3.33. Based on the information received, the track inspector started the inspection 2 km away from the observed high water level at bridge 85 and inspected an area in the opposite direction (see Figure 5).

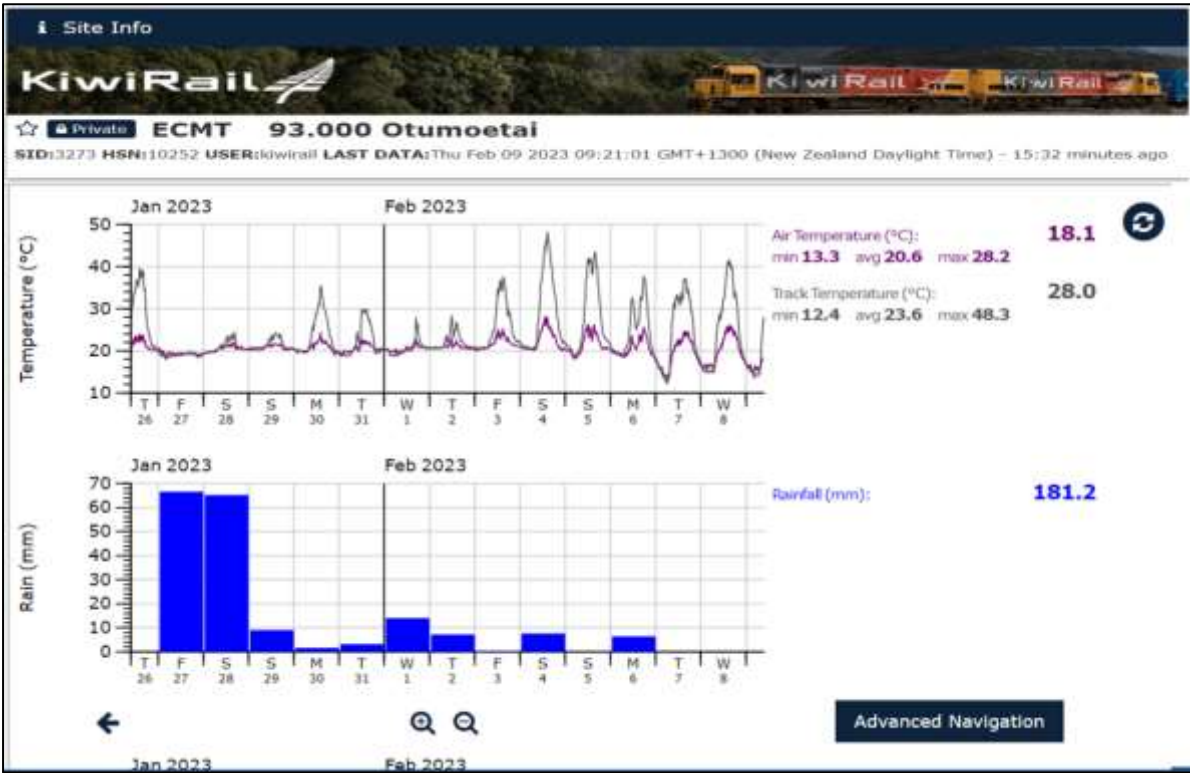
Figure 8: Rain and temperature data collected on the ECMT at Otumoetai, near the accident site (Credit: KiwiRail)

- 2.39. The Bay of Plenty region had experienced heavy rainfall, a total volume of 131.8 mm in the two-day period prior to the train derailment (see Figure 8).
- 2.40. The meteorological information received by KiwiRail is detailed in paragraphs 2.1 to 2.10.

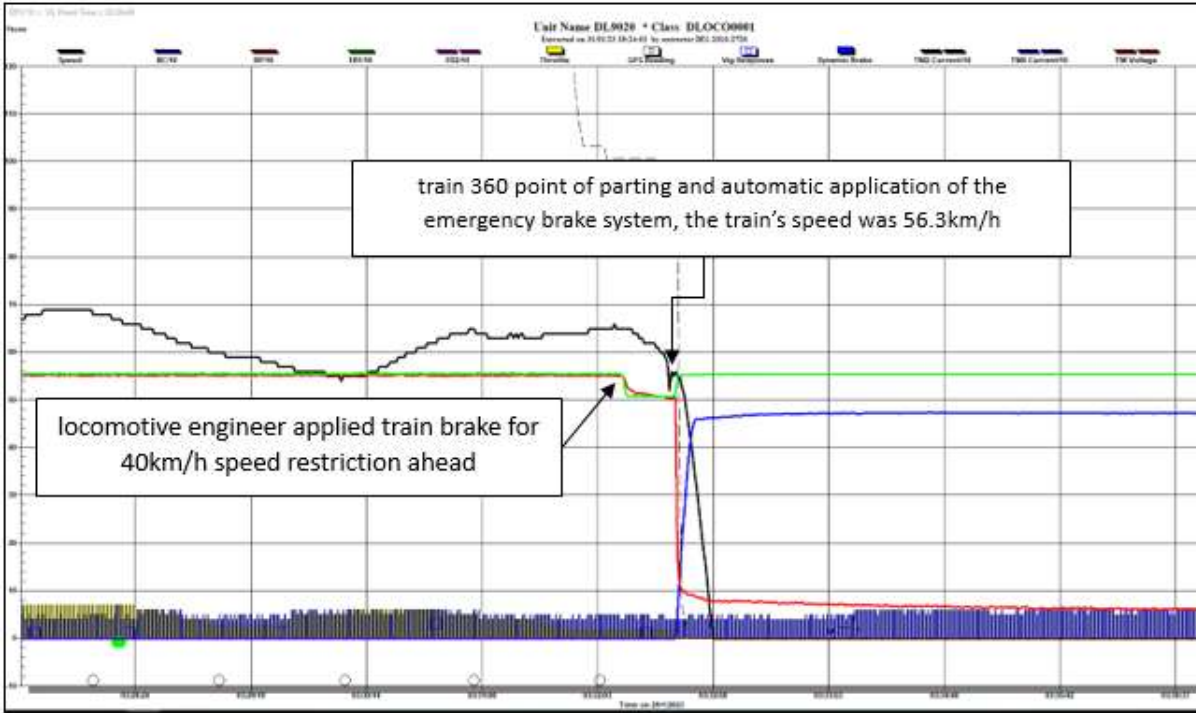
Figure 9: Tranzlog data for train 360

2.41. The locomotive was fitted with a Tranzlog data recorder. The Tranzlog download was obtained by the Transport Accident Investigation Commission (the Commission) and the verified data was used in this report (see Figure 9).

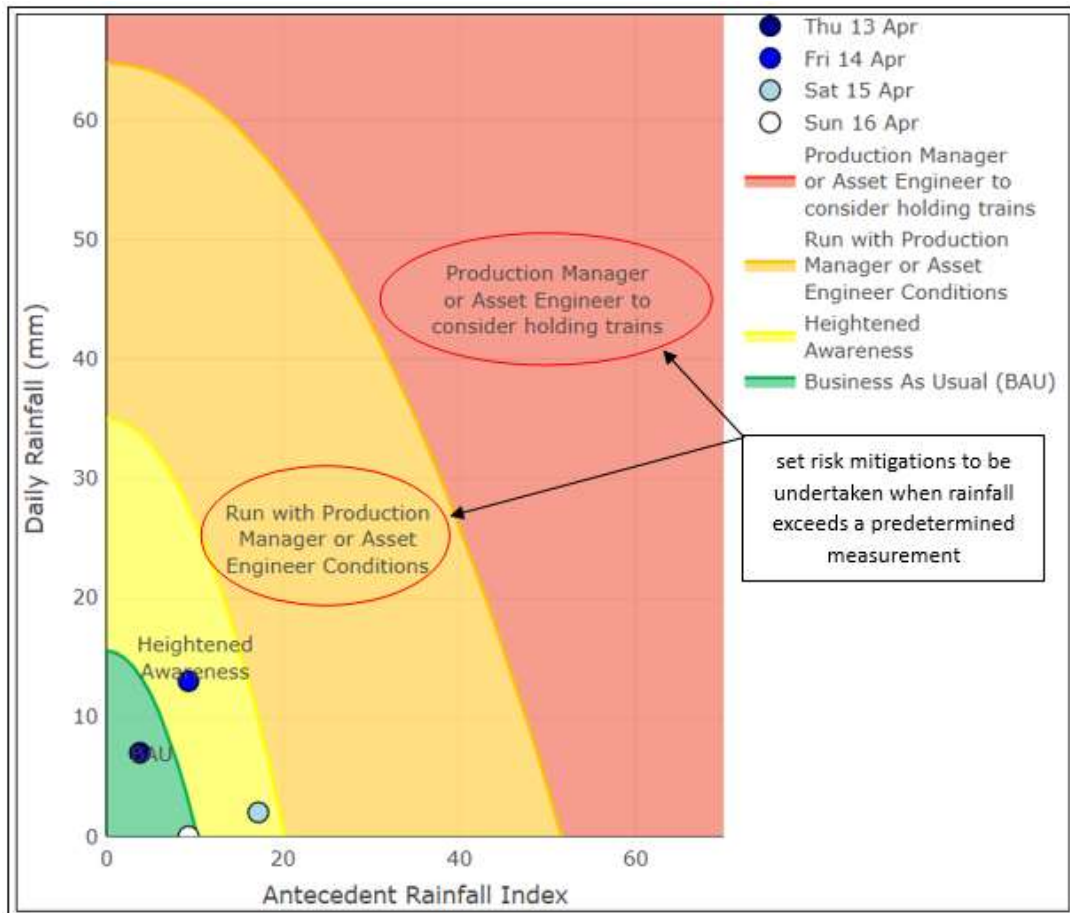
**Figure 18: Extract from South Island Main North line TARP**  
 (Credit: KiwiRail and MetSolutions)

3.17. The TARP provided clear guidance on the appropriate mitigation measures at varying rainfall volumes (see Figure 18).

3.18. Had there been a TARP in place in the Bay of Plenty region, it is **likely** the forecast rainfall would have triggered a heightened awareness and proactive rather than responsive track inspections and/or track closures.

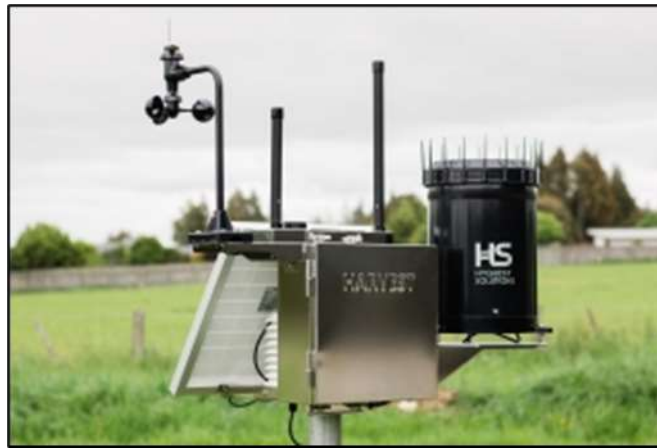
**Figure 19: Weather monitoring device**

3.20. KiwiRail has a number of heat and rainfall monitoring devices (see Figure 19) in place along the ECMT. The devices can be set to send alarms to Train Control when certain temperatures or rainfall volumes are reached.

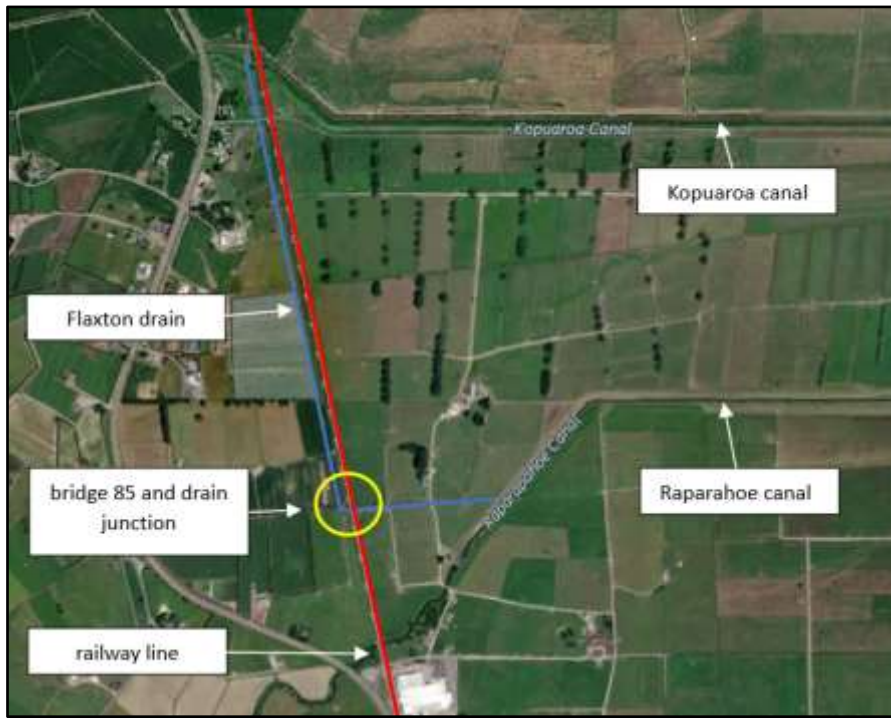
**Figure 20: Locations of drains and rail infrastructure**

- 3.35. Effective maintenance plans are a vital component of ensuring that infrastructure remains fit for purpose, particularly when it can be adversely affected by weather.
- 3.36. The Bay of Plenty Regional Council owned the drainage system adjacent to the section of rail corridor where the accident occurred. The drainage system was part of the Kaituna river catchment control scheme, which included the Flaxton drain (1308 m long) and the Collins drain (442 m long). Both drains flowed into a canal system (see Figure 20).
