**Report 08-002, Eurocopter AS355 F1, ZK-IAV, spherical thrust bearing failure,  
and subsequent severe vibration and forced landing,  
Mount Victoria, Wellington, 13 April 2008**

**Report 08-002**

**Eurocopter AS355 F1**

**ZK-IAV**

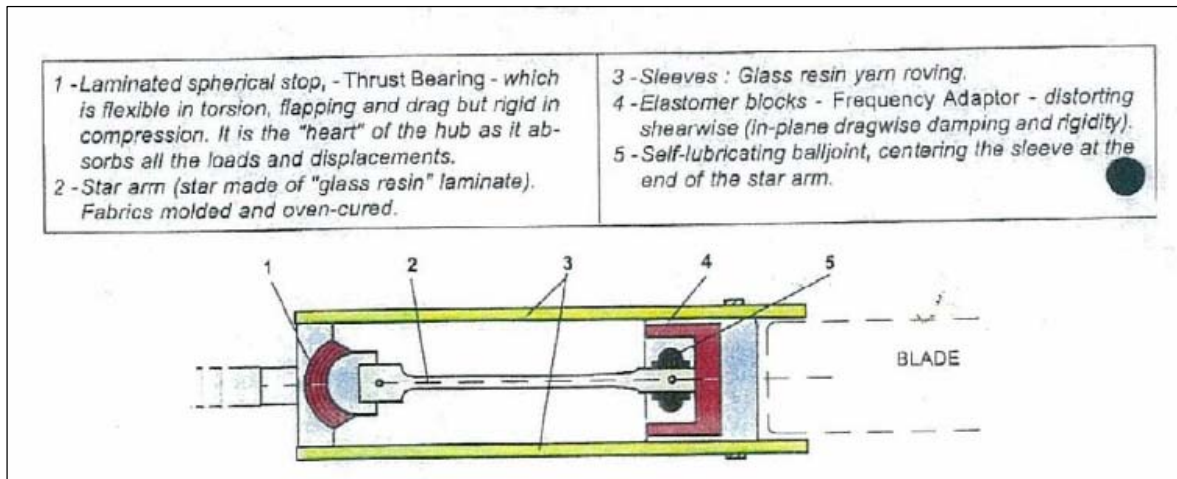
**Figure 2**  
**Cross-section of some components of the main rotor head (courtesy Eurocopter)**

- 1.4.4 The main rotor head contained 3 spherical thrust bearings, each with an elastomer (rubberised) centre that attached to the rotor hub (see Figures 2 and 3). Hydraulic control inputs were applied to each main rotor blade via the respective blade sleeve and spherical thrust bearings, which were flexible in torsion, flapping and drag, but rigid in compression.

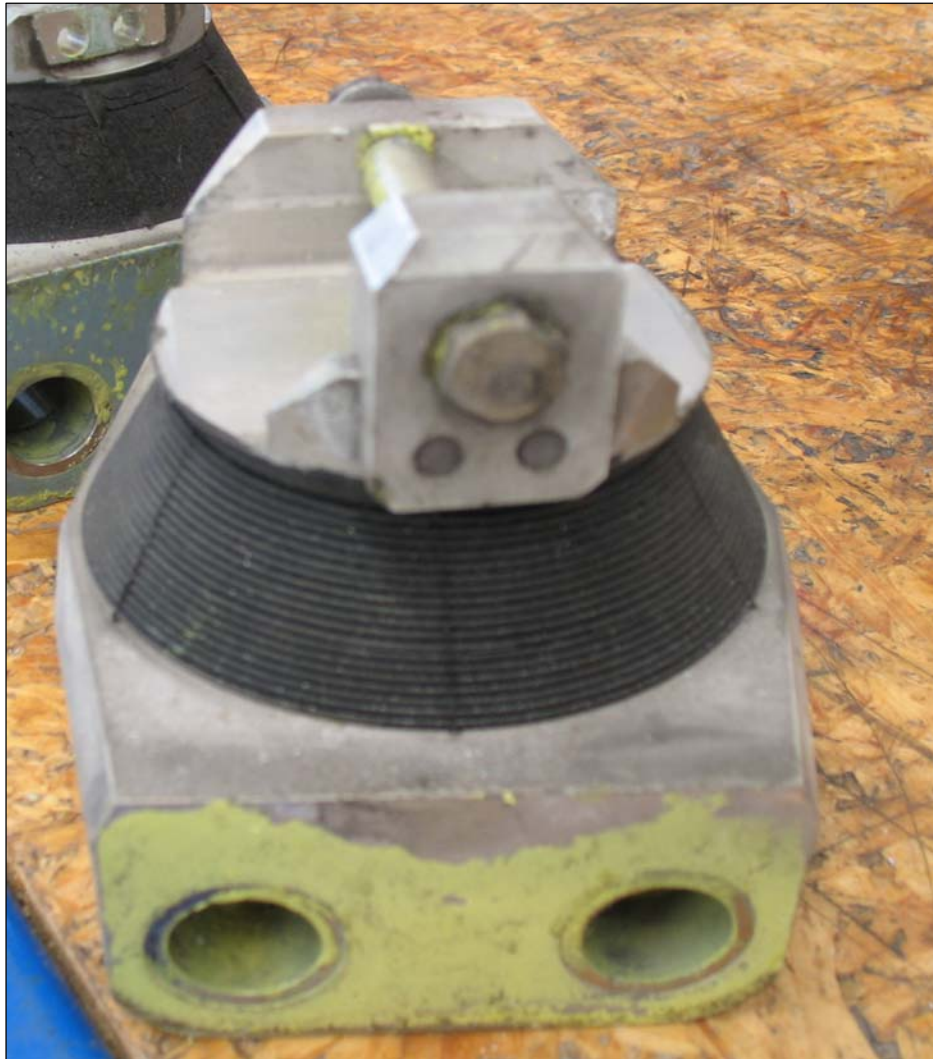
**Figure 3**  
**An intact spherical thrust bearing**

- 1.4.5 The 3 main rotor spherical thrust bearings, part number 704A33-633-030, serial numbers 154389, 154574 and 154637, that had been fitted to ZK-IAV since new were not replaced during the refurbishment because they reportedly met the service requirements. The bearings had rubberised elastomer centre sections laminated with stainless steel reinforcing discs, sandwiched between aluminium alloy attachment ends. The bearings had a finite life of 1200 flying hours for the metal components, but the elastomer portion was an on-condition<sup>2</sup> item. The bearings had no calendar life. They had a 60-month shelf storage life, but could be put back into storage or service if they passed inspection by the helicopter manufacturer. The shelf life was imposed as a means of control by checking that the storage environment itself or the packaging over time had not brought about any degradation. Items in storage were not subject to the routine inspection environment that was required when installed on a helicopter.

- 1.4.6 The spherical thrust bearings when fitted to the helicopter were subject to daily inspection by any person qualified to maintain the helicopter or by a suitably trained pilot. The flight manual said that no elastomer faults, de-bonding, scratches, blisters, extrusions or cracks were permissible. Should the daily inspection reveal any anomalies with the bearings, a maintenance engineer was to inspect them against the maintenance manual requirements before the helicopter could be flown. The bearings were also subject to inspections during routine scheduled maintenance checks. The maintenance manual detailed the inspection requirements for the bearings, and was prescriptive in outlining the conditions for rejection of the on-condition elastomer section of the bearings.
