**Report 08-005, Kawasaki-Hughes 369D, ZK-HWE, un-commanded yaw and loss of control,
Maori Saddle, near Haast, Westland, 11 August 2008**

Report 08-005

**Kawasaki-Hughes 369D
ZK-HWE**

un-commanded yaw and loss of control

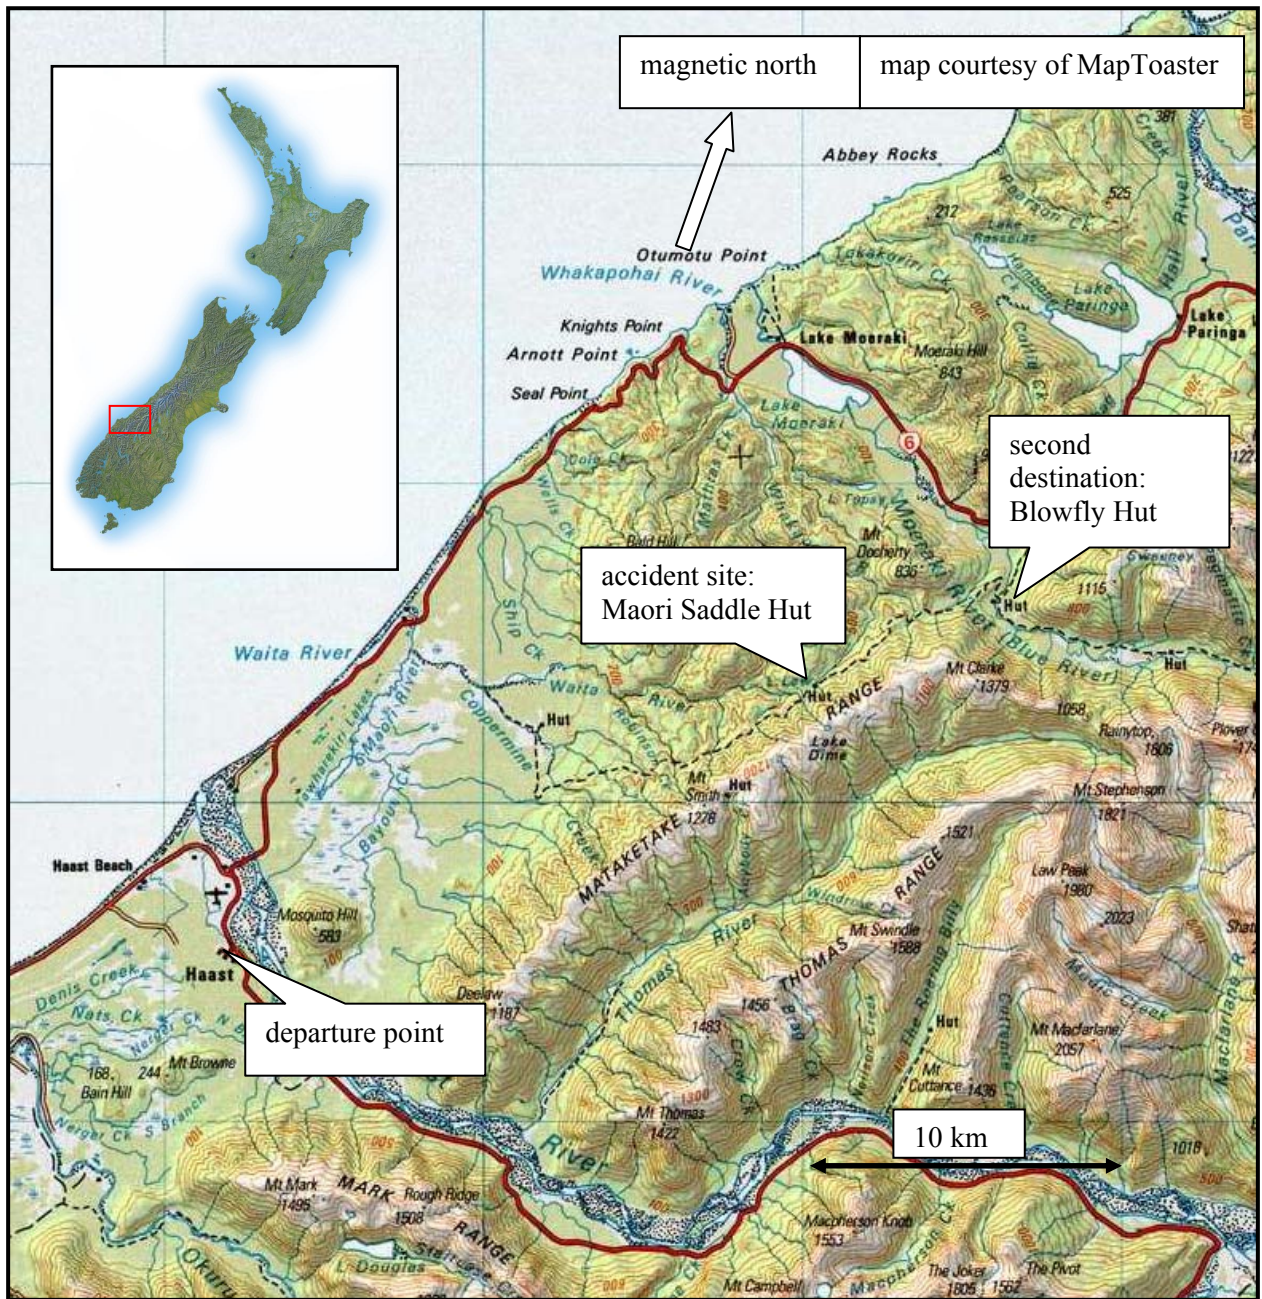
Figure 1
Accident location

- 1.1.2 The task was to fly 3 track-maintenance workers and their equipment to the Maori Saddle Hut, about 20 kilometres (km) north-east of the departure point, and other supplies to the Blowfly Hut, a further 6 km north-east (see Figure 1). In the previous week, the pilot had flown an almost identical task for DOC, including taking the same workers to the Maori Saddle Hut. The pilot said that he had landed at that site many times before.
