**Report 08-204, 6-metre workboat *Shikari*, collision with moored vessel,  
Waikawa Bay, Queen Charlotte Sound, 20 June 2008**

Distraction by cellphone and excessive speed within a speed restricted area were the major factors contributing to the fatal collision on 20 June 2008 in Waikawa Bay, Queen Charlotte Sound, of the 6 metre aluminium workboat *Shikari* with the stern of the moored *Flightless*, a 27 metre private vessel.

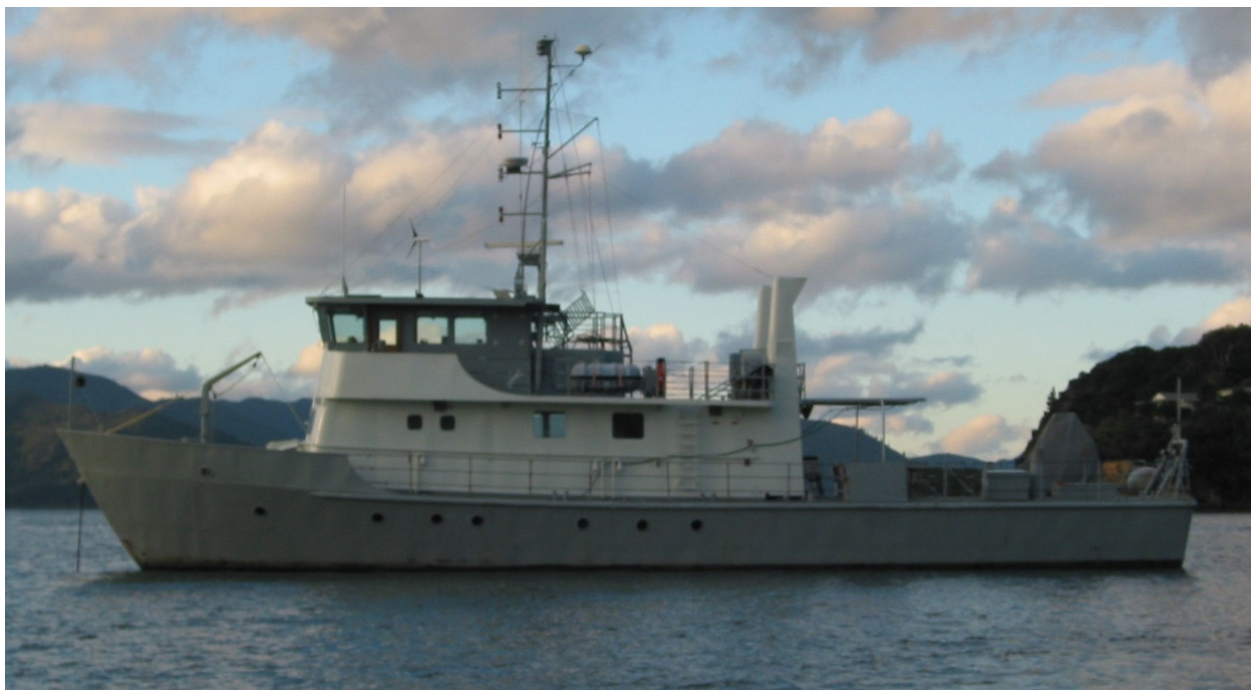
***The Flightless*** moored in Waikawa Bay

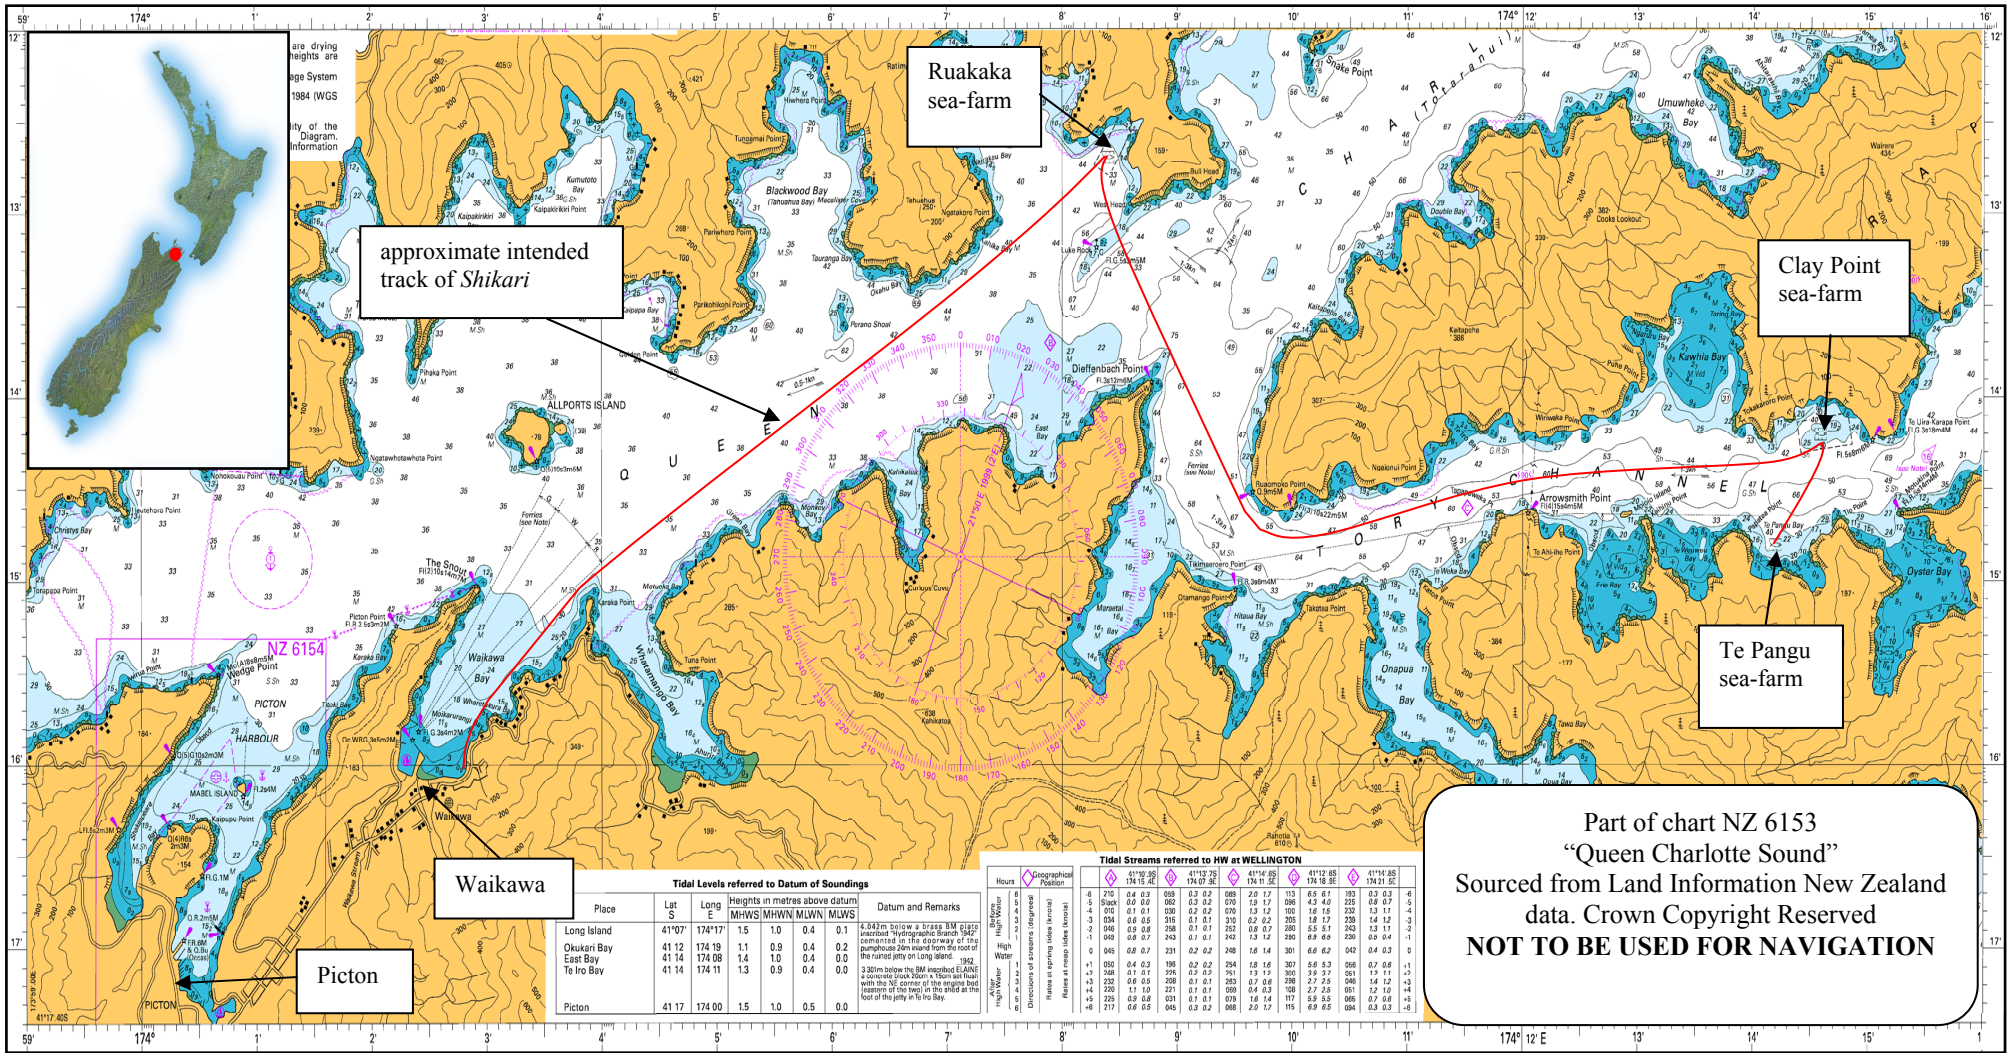
Figure 1  
 General area of the incident

- 1.1.1 At about 0700 on Friday 20 June 2008, the skipper of the *Shikari*, having readied the boat for the day's work departed Waikawa Marina for Te Pangu sea-farm in the Tory Channel. Also on board were 2 fish health assessors (Pax 1 and 2) who he was to drop off at Clay Point sea-farm, also in the Tory Channel (see Figure 1).
