Transport Accident
Investigation
Commission

Final report

Aviation inquiry AO-2024-004
Airbus A320, registration VH-VFF
Loss of control – ground (LOC-G)
Christchurch

31 May 2024

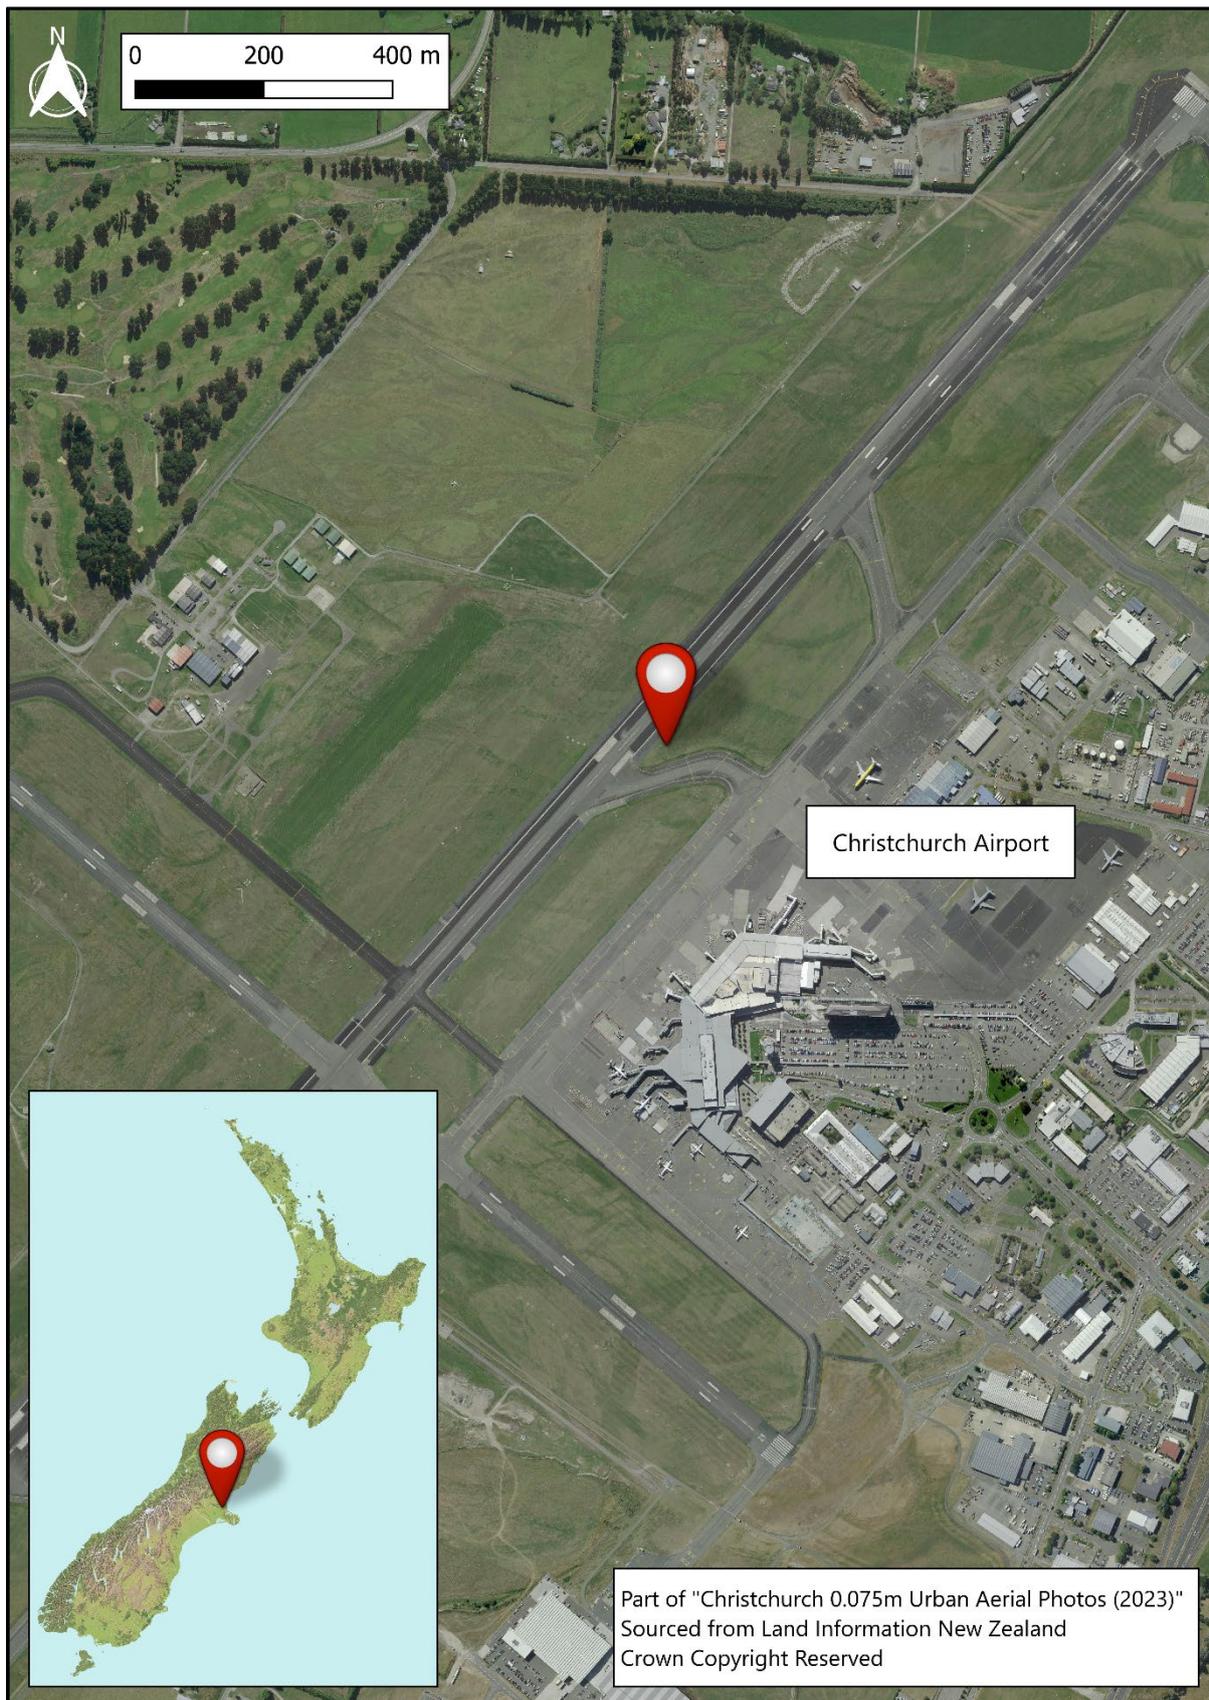
Figure 3: Location of accident

- 1.7. The pilot was **likely** startled by the engines accelerating to CLIMB power and as a result pulled the thrust levers back into REV MAX.³ Engine No. 1 developed reverse thrust while engine No. 2 continued to provide forward thrust but at a reduced level. This was as a consequence of the yellow hydraulic system failure disabling the thrust reverser on that engine. This resulted in asymmetric thrust and an associated turning moment, with the pilot losing directional control of the aeroplane. The aeroplane ran off the taxiway to the left and onto the grass.

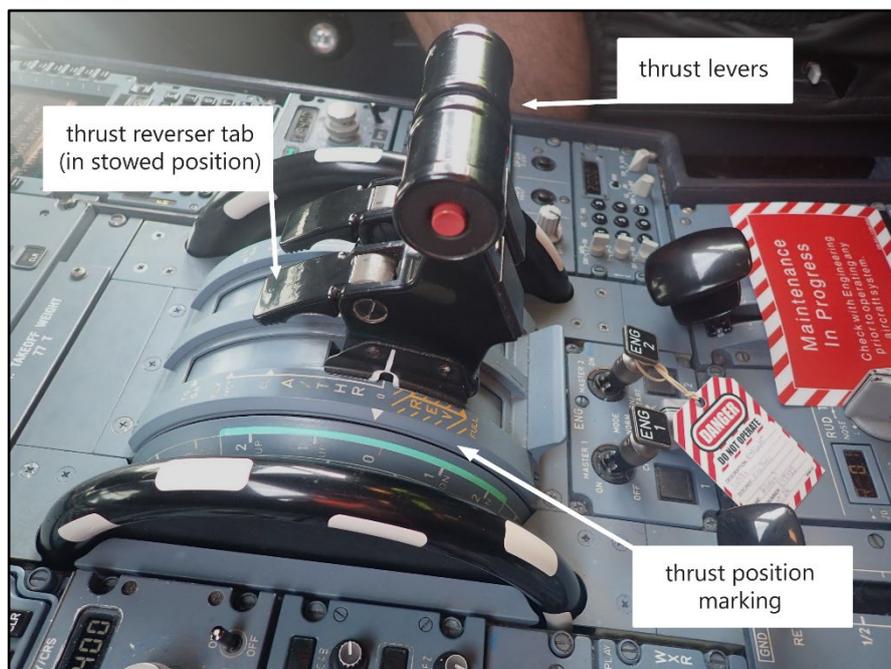
Figure 4: Thrust levers in FWD IDLE

- 2.28. Each of the engines is controlled by a full authority digital engine controller (FADEC), which takes its control inputs from the thrust levers that the pilot operates. The pilot sets the thrust level for the phase of flight, and the FADEC manages the fuel flow to maintain the selected power setting (see Figure 4 and Figure 5 for the different thrust lever positions).

²⁴ In the aircraft manual this is called the thrust reverser lever and is located on the front of the thrust lever (as shown in Figure 4). To avoid confusion, in this report it is referred to as thrust reverser tab.

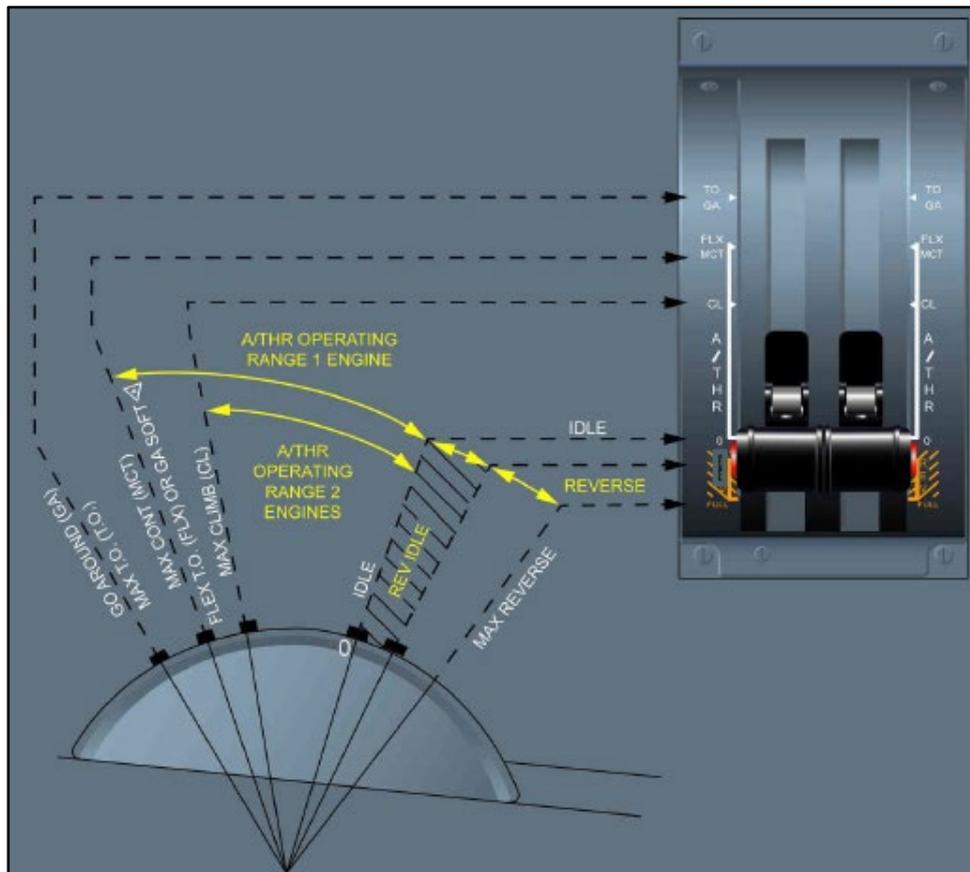
Figure 5: Thrust lever range of movement²⁵

- 2.29. The thrust levers can move forward to the TOGA (take-off/go around) position and back to the FWD IDLE position (depicted as 0 in Figure 5), with a detent that the pilot can feel as the lever passes each marked stage. The lever can only be moved back into reverse thrust positions if the thrust reverser tab²⁴ is lifted.
- 2.30. There are two reverse thrust positions: REV MAX and REV IDLE. When the thrust levers are moved from reverse to the forward thrust positions, the thrust reverser tabs

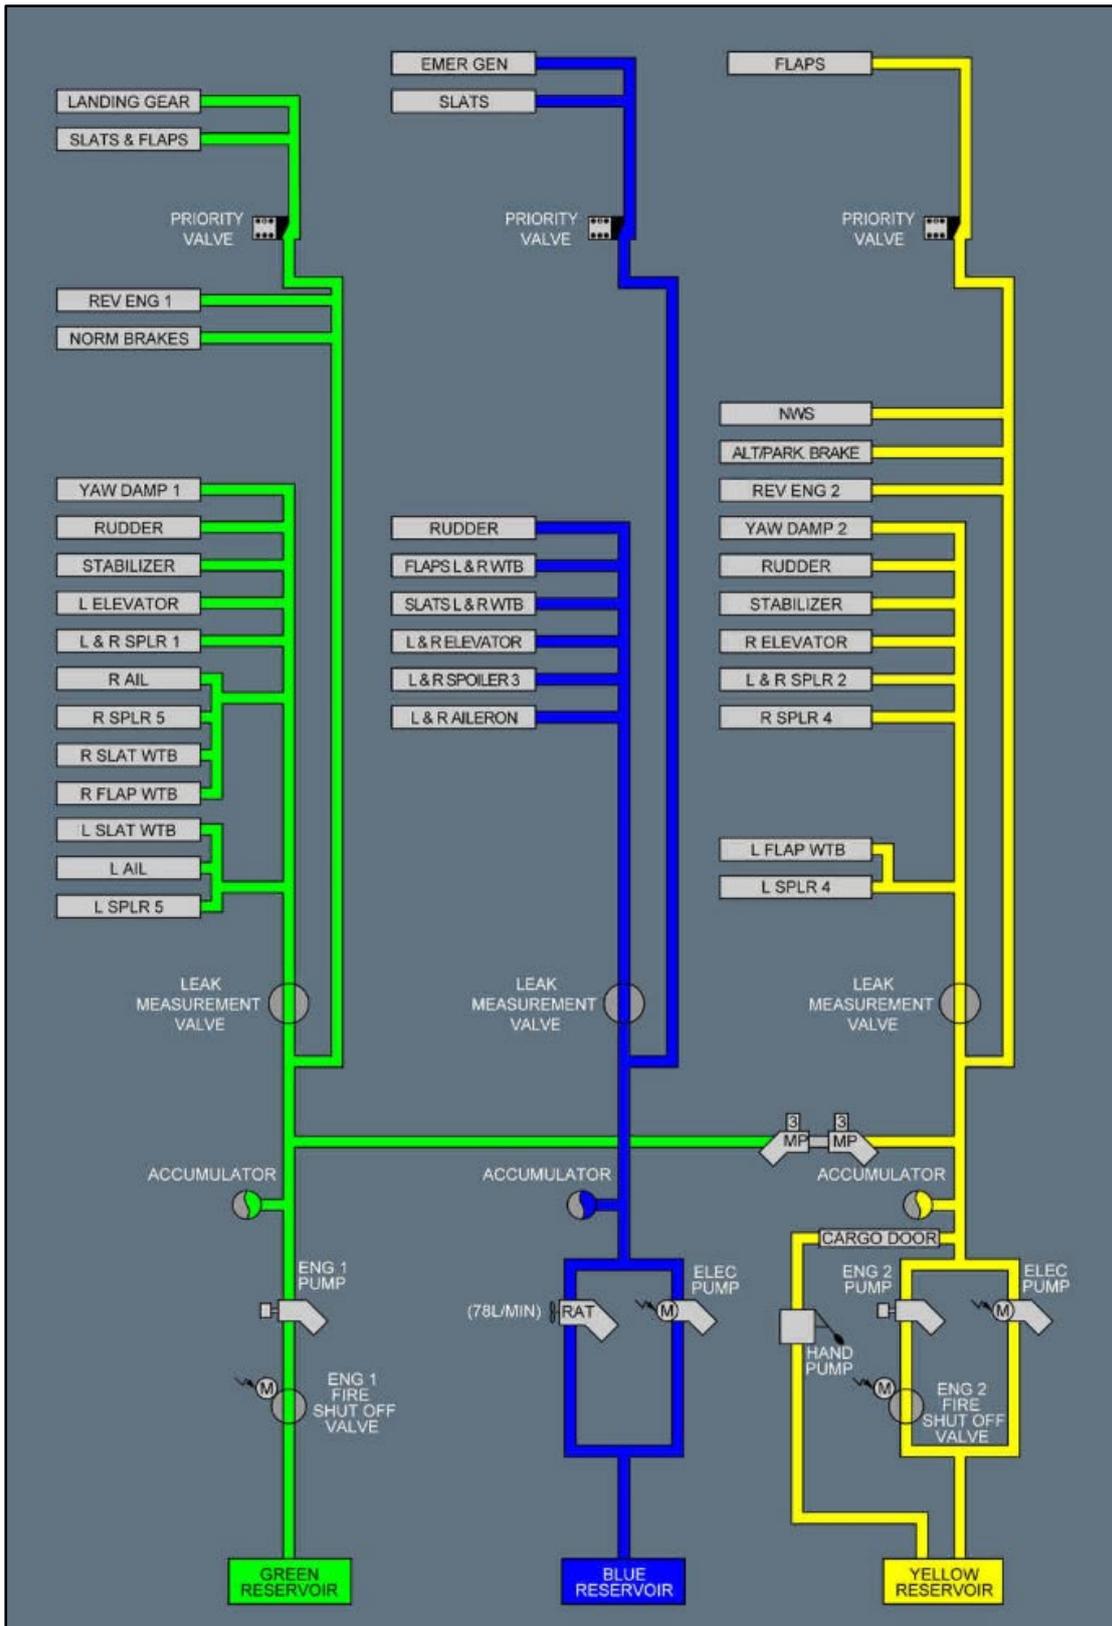
Figure 12: A320 hydraulic architecture

- 2.3. The flight crew then followed the standard operating procedure (SOP) for 'Abnormal' situations as displayed on the ECAM. The ECAM provided guidance to the flight crew for a yellow hydraulics system⁸ failure, helping them identify the problem and the aeroplane's subsequent limitations due to the failure. The caution 'Hydraulic, yellow, reservoir low level' had a checklist of actions that the flight crew started to work through, including switching the yellow hydraulic pumps off. The ECAM also listed all the systems that had become inoperative as a result of the loss of hydraulic fluid (see Appendix 1 for the hydraulics system diagram).

- 2.4. The fault indications showed that the yellow system had failed because of loss of hydraulic fluid. This had several consequences, including: the nosewheel steering would not be available to steer the aeroplane on the ground; the No. 2⁹ engine reverser would not be available to assist deceleration after landing; there would be fewer spoilers¹⁰ than normally available to reduce lift after touchdown; and the cargo doors and some other systems were affected.
