Transport Accident  
Investigation  
Commission

# **Final Report**

***Maritime inquiry MO-2022-206***  
***Charter fishing vessel, i-Catcher***  
***Capsize***  
***Goose Bay, New Zealand***  
***10 September 2022***

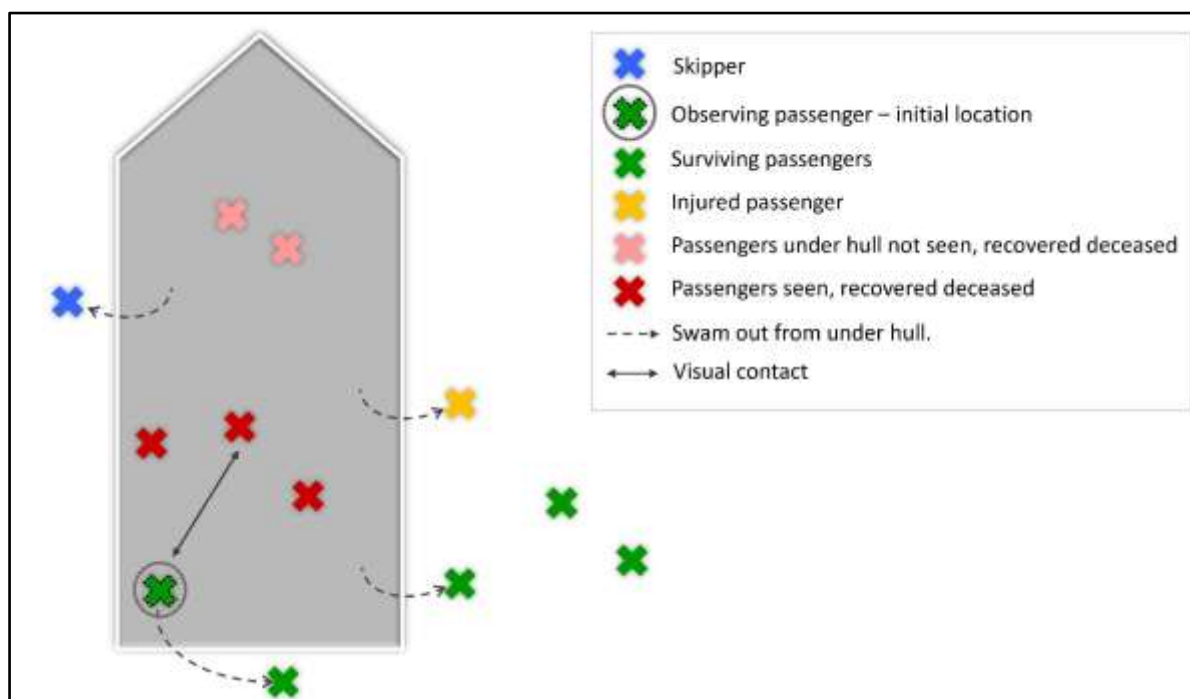
**Figure 4: Approximate location of occupants immediately after *i-catcher* capsized**

- 1.13. While in the air pocket a passenger (referred to as the 'observing passenger' in Figure 4) who was positioned close to the stern looking forward, observed three other passengers within the air pocket. Two passengers were located on either side of

the vessel, facing away from the observing passenger while the third passenger was located amidships<sup>8</sup>, looking directly at the observing passenger. None of these passengers had their lifejackets inflated at that time.

- 1.14. The observing passenger attempted to verbally instruct and signal to the passenger facing them, to swim out, but the passenger did not respond. Sensing that “the air did not feel good”,<sup>9</sup> the observing passenger swam out from under the vessel, joining the other five people on the surface.

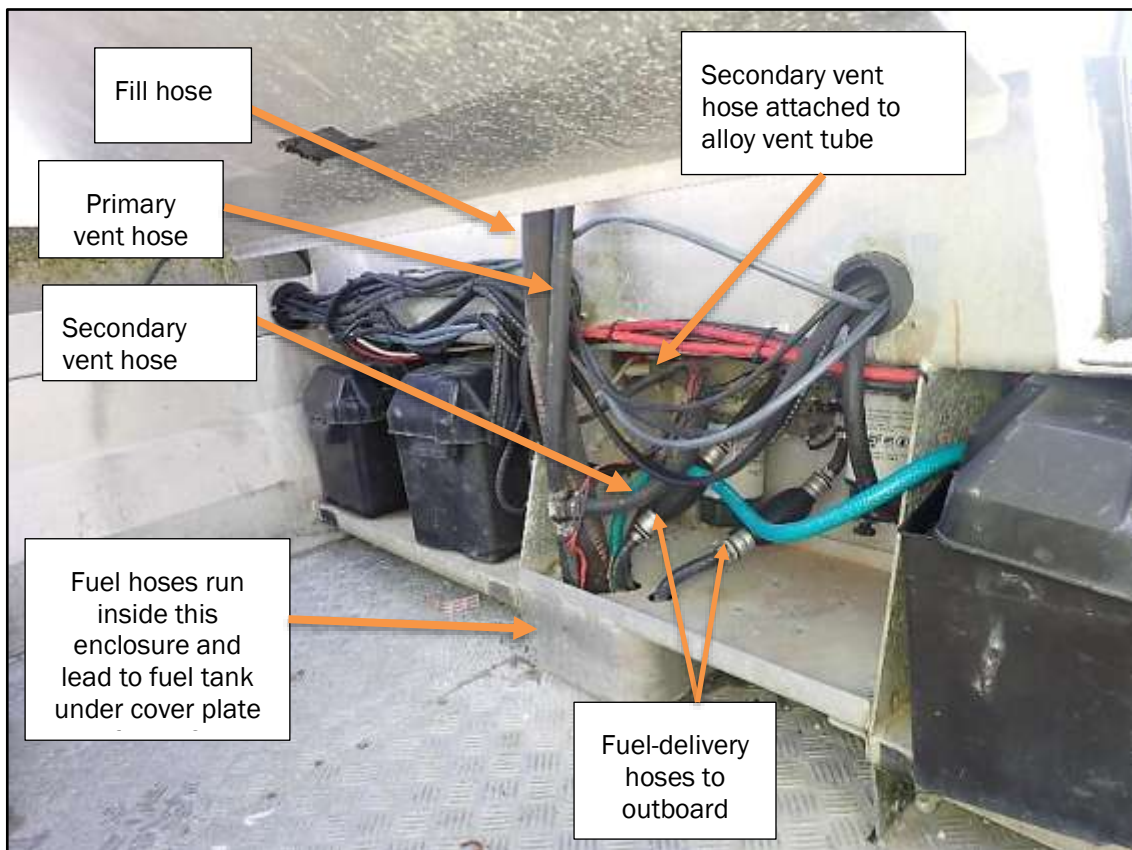
**Figure 10: The *i-Catcher's* fuel system components (after accident)**

- 1.58. Fish Kaikoura informed the Commission that no modifications had been made to the *i-Catcher's* fuel system since they purchased the vessel.
- 1.59. The fuel system on *i-Catcher* was made up of the following main components<sup>26</sup> in the stern of the vessel (see Figure 9 and Figure 10):
- 190 litre fixed centreline fuel tank located under the deck plate (fuel tank)
  - main fuel fill hose for refuelling the vessel (fill hose), which connected the fuel fill cap<sup>27</sup> and fuel tank
  - the fuel-tank venting arrangement comprising three components: a primary vent hose; a secondary vent hose that branched off the primary vent hose; and an alloy vent tube attached to the secondary vent hose, which passed up through the deck of the vessel
  - two fuel-delivery hoses, each leading to a fuel filter and one of the two outboard engines (fuel-delivery hose).

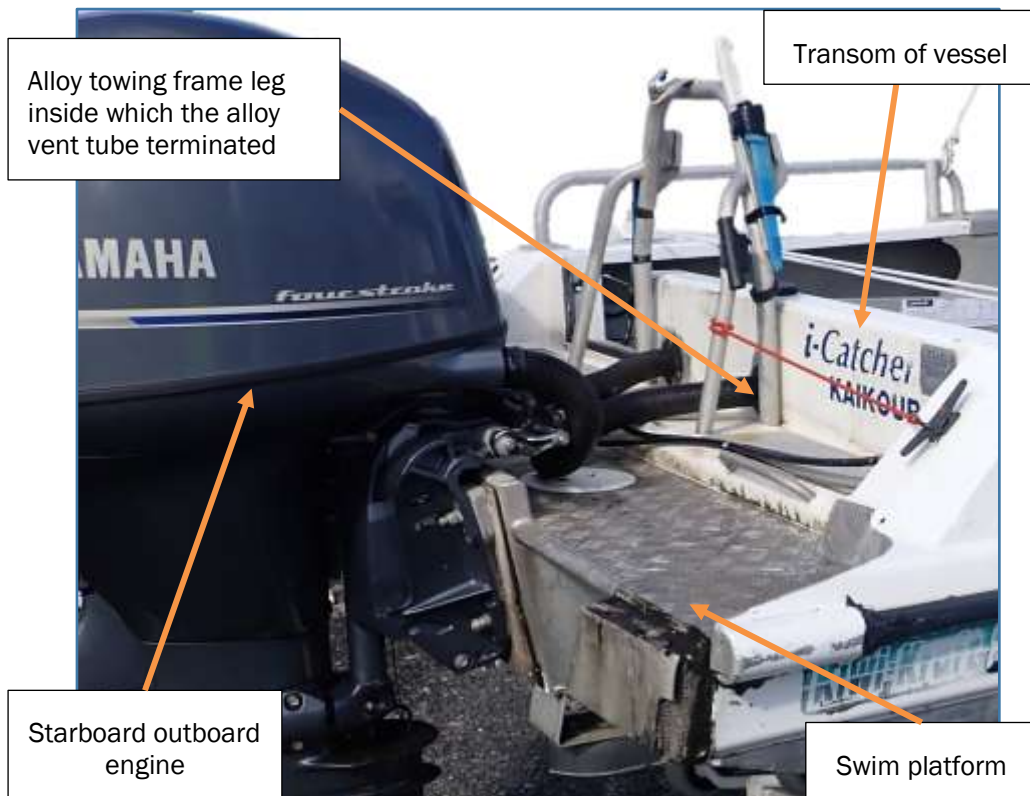
**Figure 15: Alloy towing frame on stern**

- 1.62. The alloy vent tube terminated inside an alloy towing frame on the transom just forward of the swim platform (see Figure 14 and Figure 15). A pressure test of the alloy frame revealed that it was closed off from the atmosphere, preventing fuel vapours from venting to open air and rendering it ineffective as a fuel-tank vent.

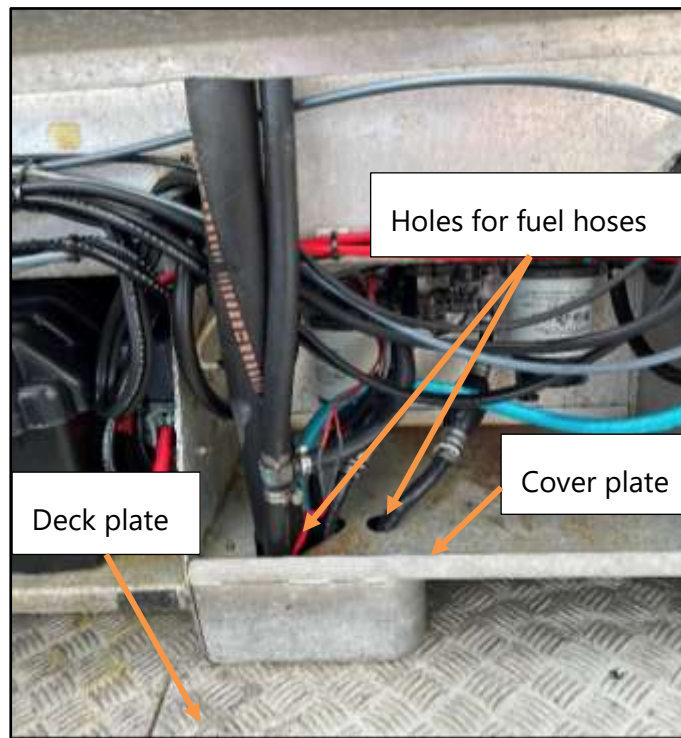
**Figure 16: Disassembly of fuel system for TAIC inspection**

- 1.63. The vessel's fuel-delivery hoses ran from the fuel tank through two holes in a cover plate (see Figure 16)

- 1.64. To enable inspection of the fuel tank and its connections, investigators removed the cover plate and the deck plate and partially disassembled the fuel system. Upon disassembly, investigators found the primary vent hose was not secured with a hose clamp, a critical component to ensure a secure connection to the fuel tank (see Figure 17).
- 1.65. A sealant had been applied around the plating where the fuel and vent hoses connected to the fuel tank. It was observed that a portion of the sealant had broken away, leaving a section of the primary vent hose connection exposed. The fuel tank and its fuel hoses were pressure-tested by Commission investigators, which revealed a leak from the base of the primary vent hose.

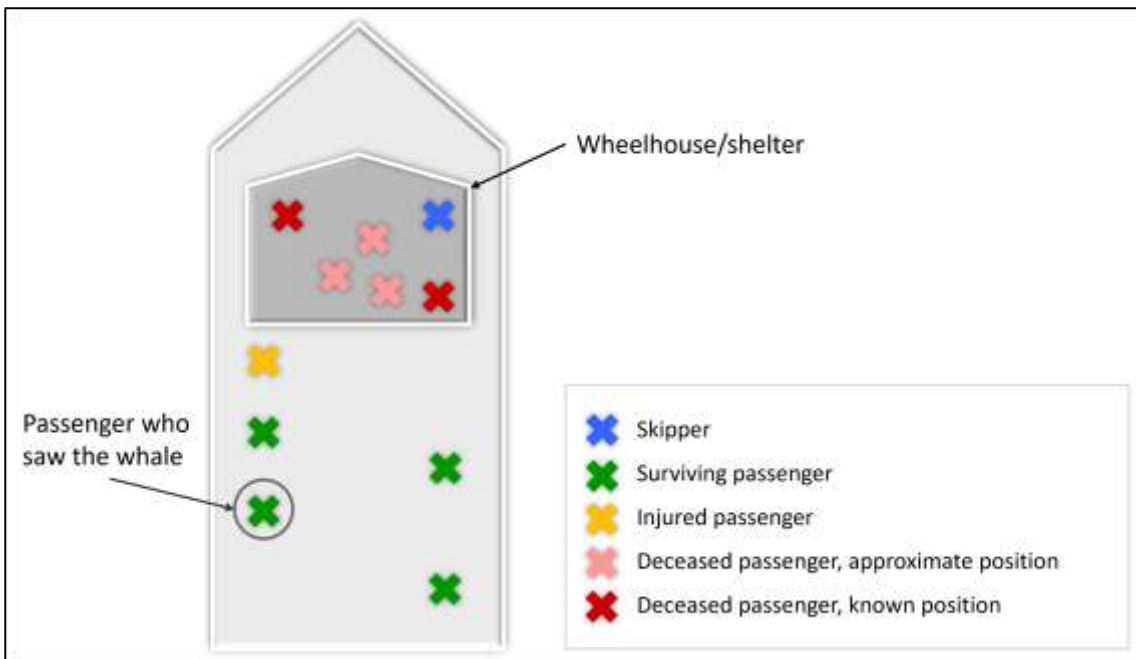
**Figure 22: Likely position of passengers immediately before capsizing**

- 2.6. Immediately before the accident, the passengers were evenly distributed throughout the vessel, having minimal impact on vessel stability (see Figure 22). The skipper was seated at the helm on the starboard side of the wheelhouse.
- 2.7. Passengers were generally limited to five people each side because of the size of the vessel. When wildlife was sighted nearby, the skipper would turn the vessel 180° allowing for both port and starboard side passengers to view and photograph the wildlife.
- 2.8. All five surviving passengers were located on the aft deck on the port and starboard sides. Survivors recalled that all the deceased passengers were located under the shelter of the wheelhouse before the capsizing.

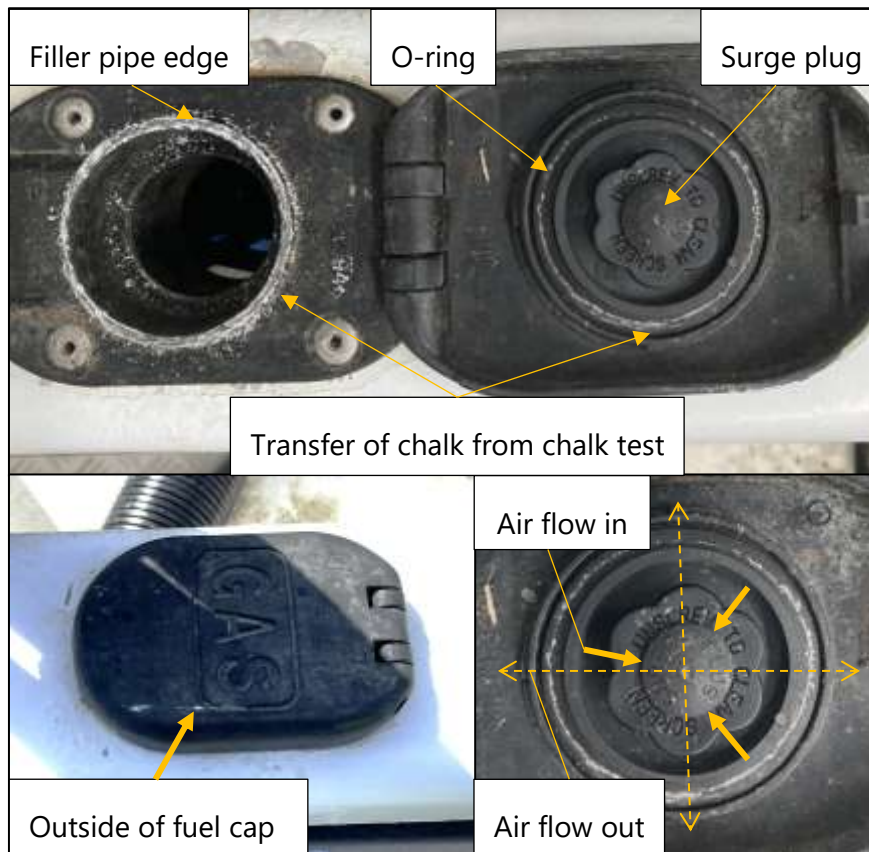
**Figure 27: Fuel cap components**

- 2.22. For the cap to seal, it requires that the surge plug is depressed, and the O-ring completes a seal with the edge of the filler pipe (see Figure 27). When inverted, head pressure from the fuel will apply a downward force on the surge plug and fuel cap, which may break the seal.

- 2.24. Commission investigators tested the seal of the fuel cap's O-ring by conducting a chalk test. The chalk test revealed that when the cap was closed, the O-ring contacted the entire edge of the filler pipe (see Figure 27).
- 2.25. If the fuel cap had leaked, a significant petrol sheen would have been visible outside the hull by the outboard motors and swim platform. Survivors who were sitting on the upturned hull for nearly forty minutes while awaiting rescue, reported seeing very little fuel in the water. Therefore, it is **unlikely** that the fuel cap contributed to the fuel leak.

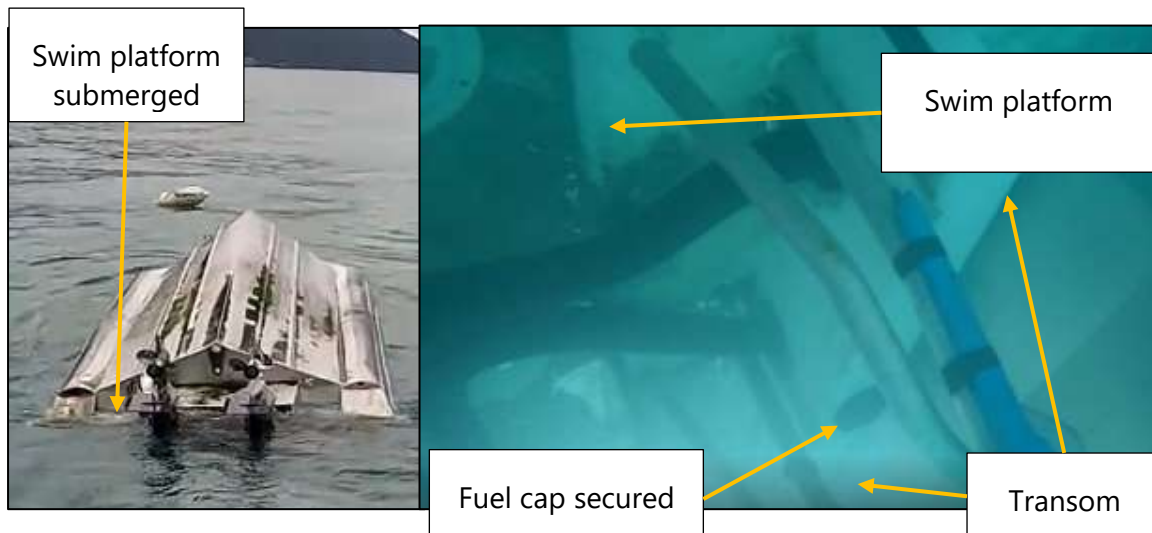
**Figure 28: Photo on left: *i-Catcher* capsized, Photo on right: Fuel cap secured**

- 2.23. When an inverted cap is submerged in sea water, the sea water applies an upward force to the surface area on the outside of the cap, countering the force applied by the fuel. The *i-Catcher's* fuel cap was mounted on the transom, which remained submerged with the vessel capsized in relatively calm conditions. Inspection of the vessel by the Police dive squad immediately following the accident found that the fuel cap was secured (see Figure 28).

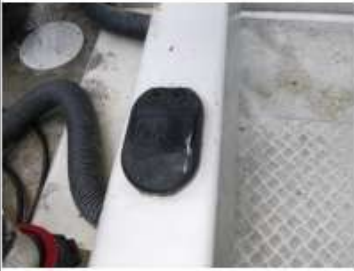
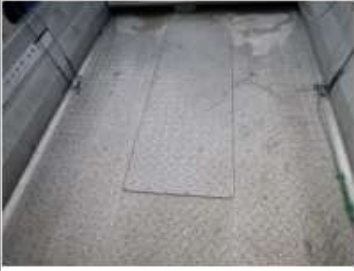
**Figure 29: Example of survey report fuel system description for *i-Catcher***

- 2.45. All *i-Catcher's* survey reports provided minimal description of the vessel's fuel system and did not include details of any inspection of the fuel system below the deck plate (see Figure 29). Similarly, the survey reports did not identify that the secondary fuel tank vent was ineffective.

Non-portable fuel tanks	S/S tank under floor inspected 2014 when deck lifted to fix sender by Kaikoura Marine. 150 litres petrol

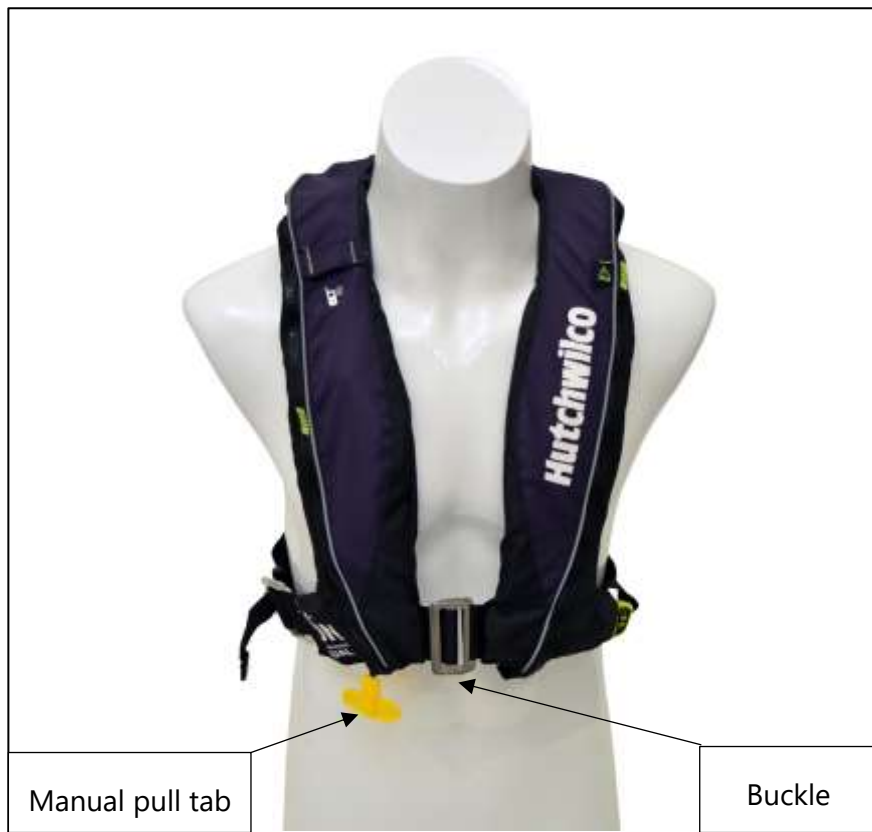
**Figure 33: Manual inflatable lifejacket components**

- 2.88. A survivor saw three other passengers underneath the hull, without their lifejackets inflated.
- 2.89. A manual inflatable lifejacket can be inflated by either the wearer or someone else pulling on the pull tab to activate the inflation mechanism (see Figure 33). The Commission could not determine at what point the manual inflatable lifejackets had been inflated.

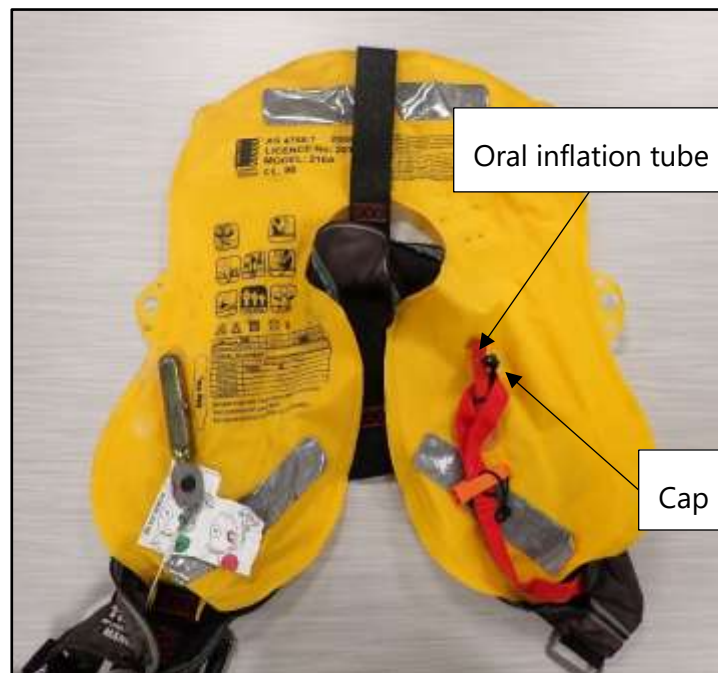
**Figure 34: Unpacked inflatable lifejacket**

- 2.98. To improve visibility and ease tension in the straps, the bladder can be partially deflated by pressing down on the release valve in the oral inflation tube, which is ordinarily used for manually adding air to the bladder (see Figure 34). Attached to the top of the oral inflation tube is a cap that, when inverted, can be used to press down on the release valve located at the top of the tube. As the bladder deflates the straps will loosen around the body making it easier to unbuckle.

- 2.99. Vessel operators and individual wearers must ensure that lifejackets are fitted in accordance with the manufacturer's instructions to prevent them from riding up and obstructing the wearer's face. All people wearing lifejackets should also have a complete understanding of its full operation, including how to remove it in water if need be. This information is best shared during predeparture safety briefings to ensure all vessel occupants are well informed.
- 2.100. On the day of the accident, the skipper of *i-Catcher* conducted a safety briefing before departure. Wearing a lifejacket was required by the skipper, who provided lifejackets to all passengers who needed one.
- 2.101. The skipper proceeded to help the passengers don their lifejackets and informed them of the general operation to inflate the lifejacket, instructing them to pull the
