# Final report

***Rail inquiry RO-2024-104***

***Freight train MR1***

***Signal passed at danger and near miss with HRV***

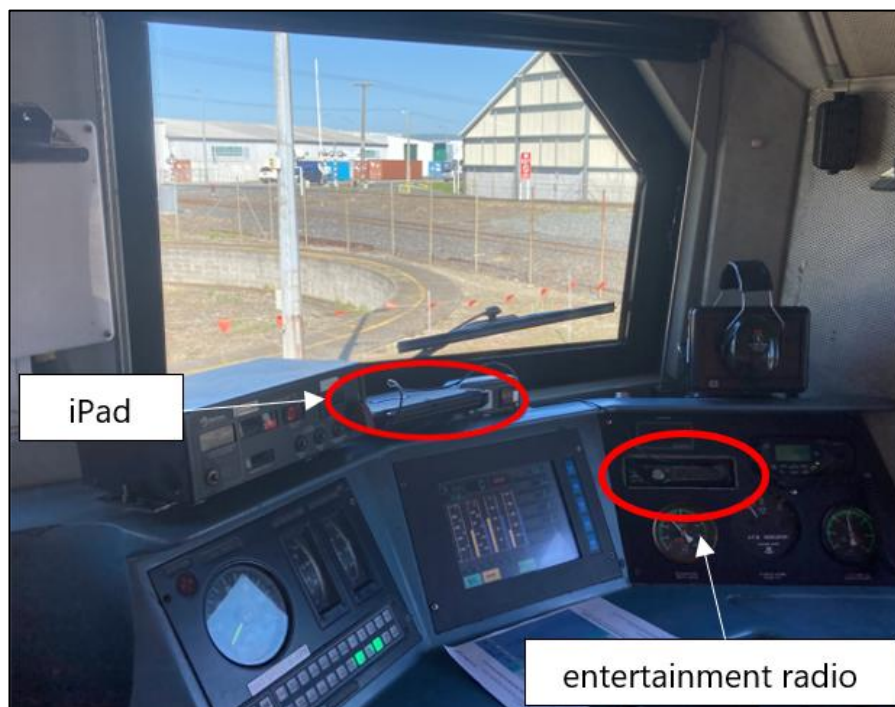
**Figure 3: iPad and entertainment radio positions in the cab**

- 2.13. The LE obtained an SWA from the TTC and departed the inland port. At 1108 the train re-entered the main line.
- 2.14. The LE opened the locomotive's window as it was a warm and sunny day, and listened to music on the work iPad which was directly connected to the locomotive's in-cab entertainment radio system<sup>16</sup> (see Figure 3).

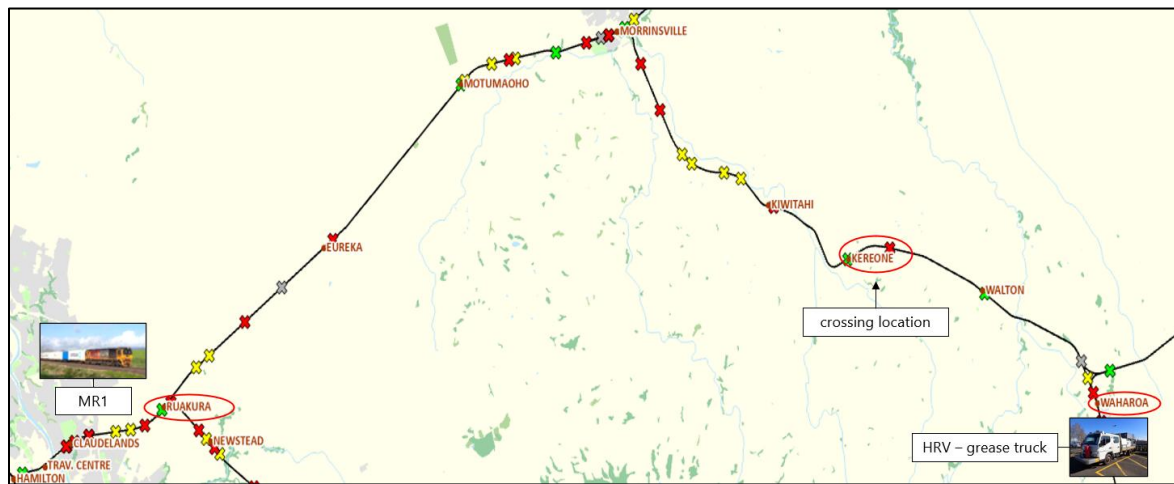
**Figure 4: MR1 and HRV movements on the ECMT**

- 2.16. At 1120, a hi-rail vehicle (HRV) operator of a 'grease truck'<sup>18</sup> called train control to request a track occupancy authority to travel towards Hamilton.<sup>19</sup>
- 2.17. At 1121, while driving the train, the LE used their personal mobile phone to write and send a text message. The use of mobile phones while driving a locomotive contravenes KiwiRail's Rail Operating Rules and Procedures, General Rule 25 (see Appendix 1).
- 2.18. At 1122, a conversation between the HRV operator and the TTC took place over the open VHF<sup>20</sup> radio channel 2. This enabled the HRV operator to complete a track occupation form<sup>21</sup> (known as a Mis 71 form, see Appendix 2) with the TTC to travel west from Waharoa to Kereone station, towards the approaching train (Figure 3 4).

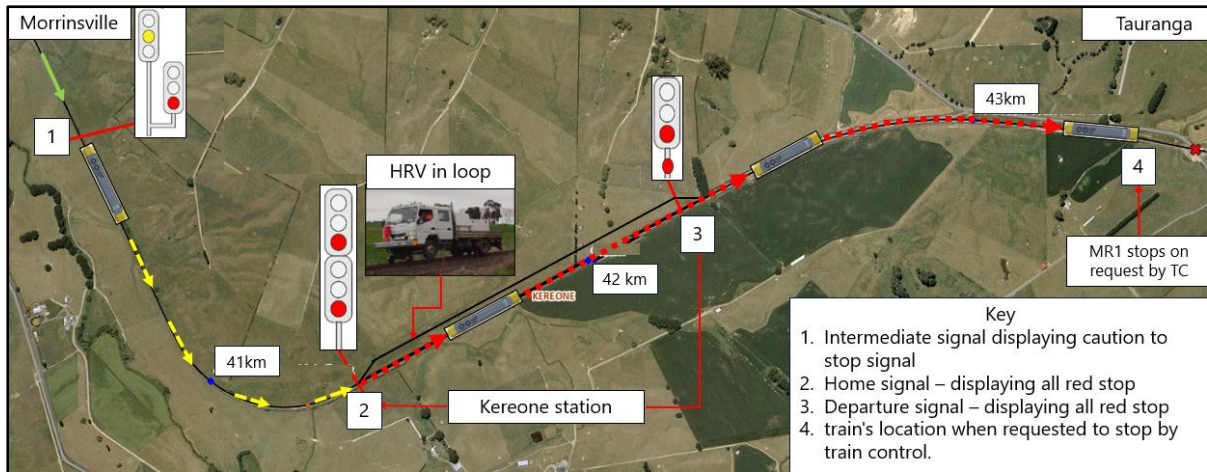
**Figure 10: HRV and train location once train stopped**

- 2.37. At 1146:23 the train stopped 2.057 km past the first red signal (signal 8L) (see Figure 10). A rail incident coordinator<sup>26</sup> (RIC) and a signal technician<sup>27</sup> travelled to the site to investigate.

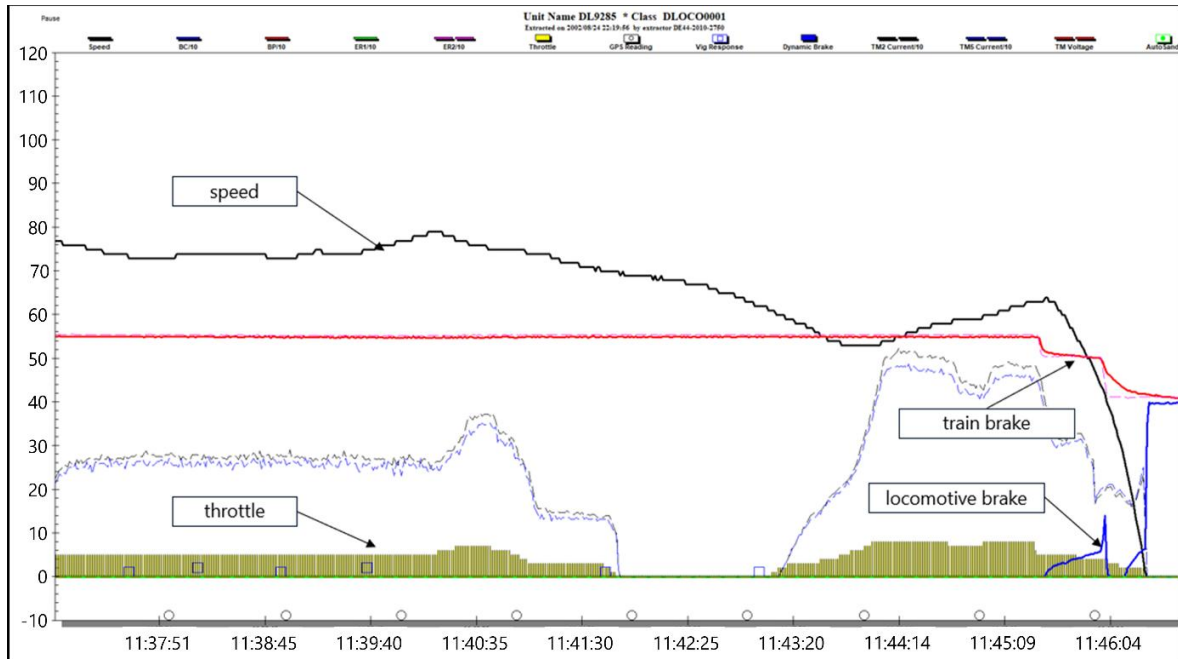
**Figure 12: Tranzlog data from the train**

2.48. The train's locomotive was fitted with a Tranzlog data recording system.<sup>29</sup> The data pertaining to this incident was obtained by the Commission and used in this report (see Figure 12).

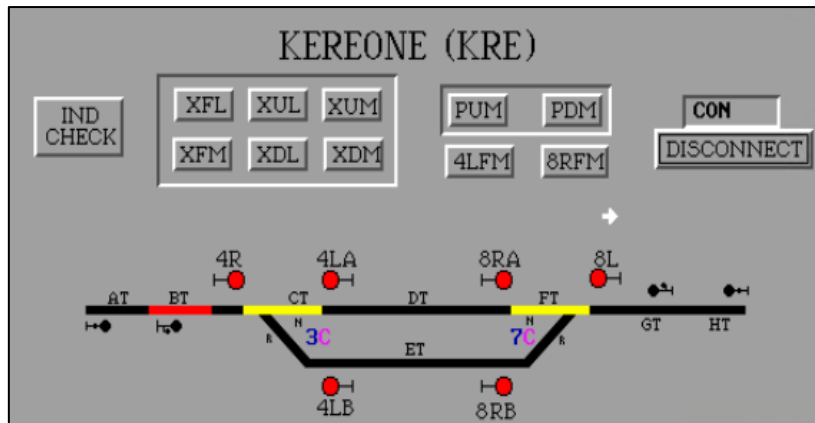
**Figure 13: Train control signal log post-incident**  
(Credit: KiwiRail)

2.50. The train control signal logs<sup>30</sup> and data from the train control system mimic screen were obtained by the Commission and used in this report (see Figure 13).

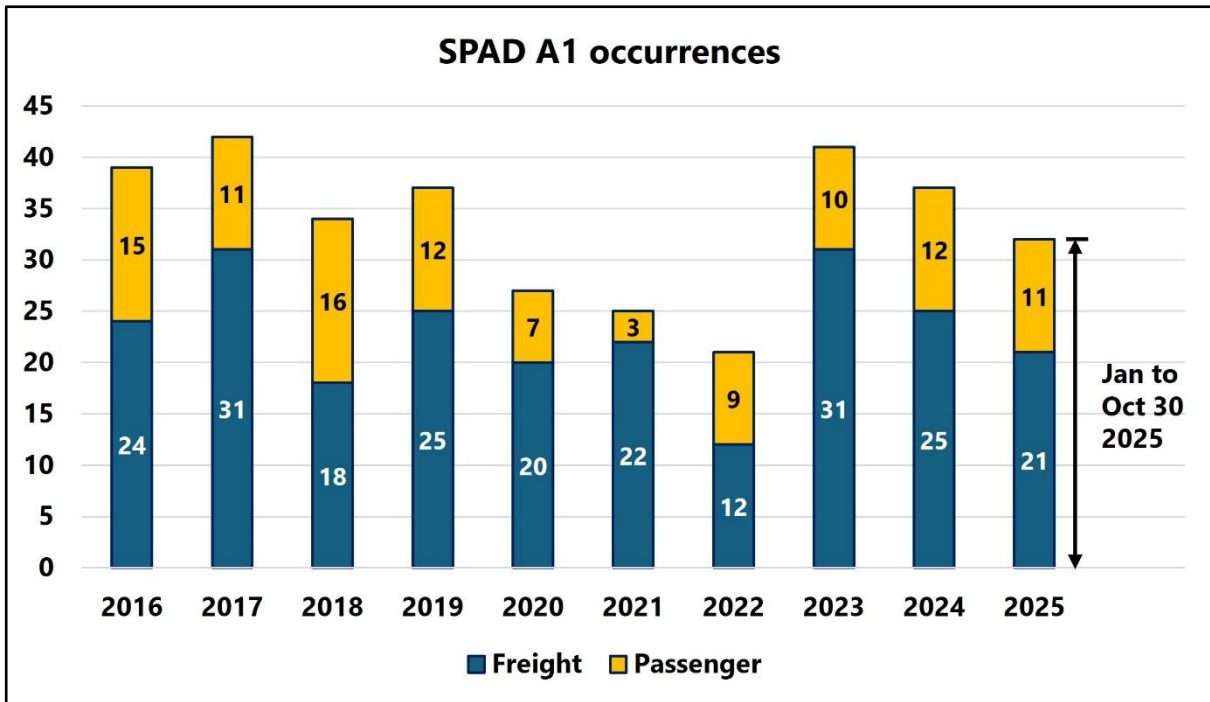
Figure 14: Frequency of freight and passenger train SPADs

The Commission obtained KiwiRail's SPAD occurrence data for the period 2016 to 2025. The data captured freight and passenger operations, including metro passenger operations in Auckland and Wellington (see Figure 14).

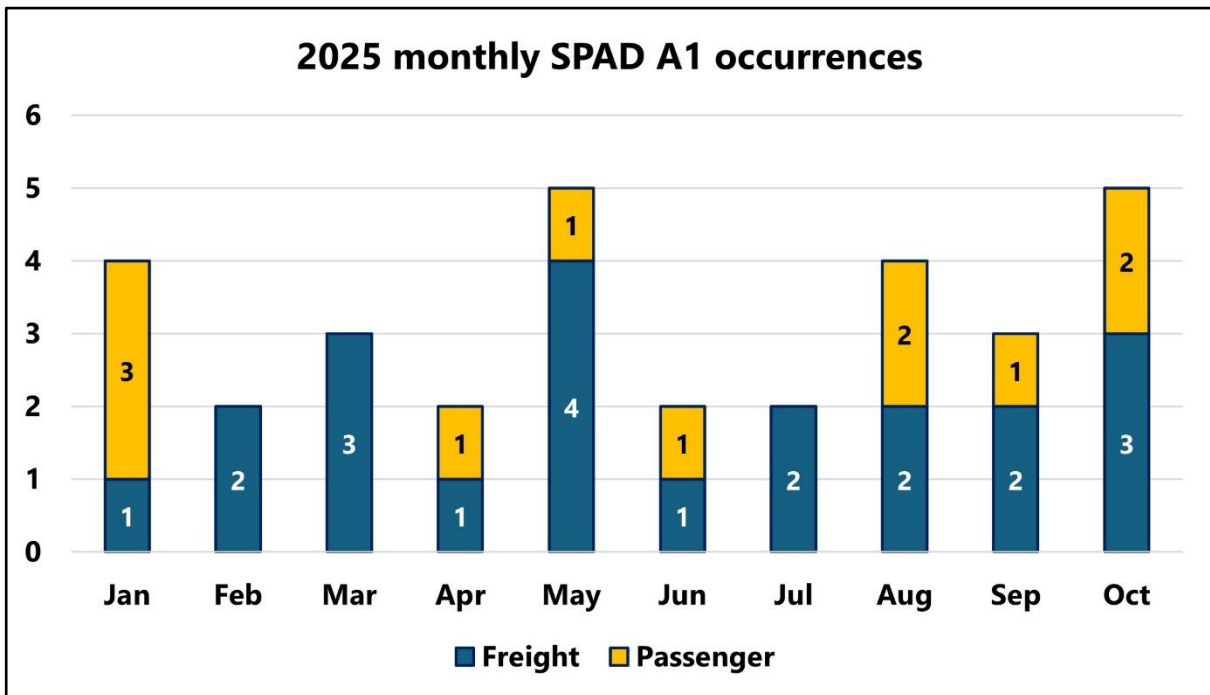
Figure 15: Monthly SPAD data from 1 January to 31 October 2025

2.54. Figure 15 shows the number of SPADs occurring monthly between 1 January 2025 and 31 October 2025.

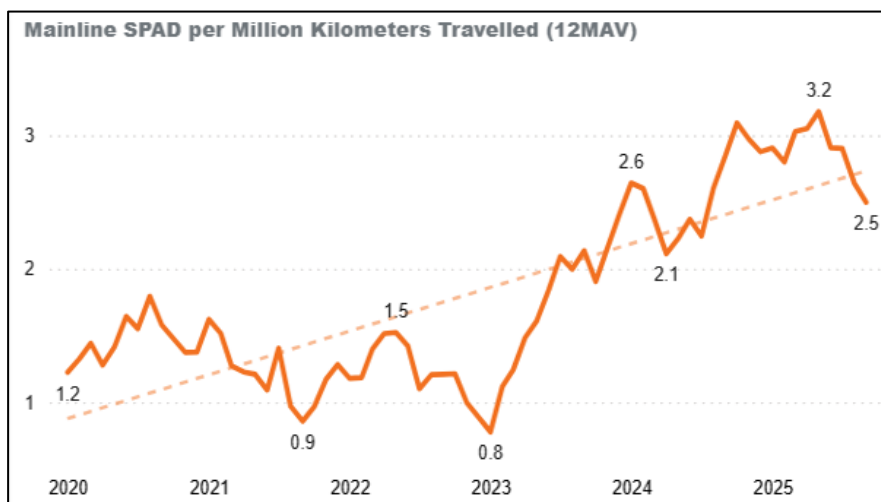
**Figure 28: KiwiRail mainline train SPAD ratio graph**

3.50. The Commission obtained KiwiRail’s mainline train SPAD data, which showed that in 2025 the SPAD ratio had increased to 3.2 SPADs per million kilometres, despite engineering controls being added to some of their locomotive fleet (see Figure 28). The SPAD ratio KiwiRail has set as a benchmark is 1.0 SPAD per million kilometres, which is consistent with international practice.

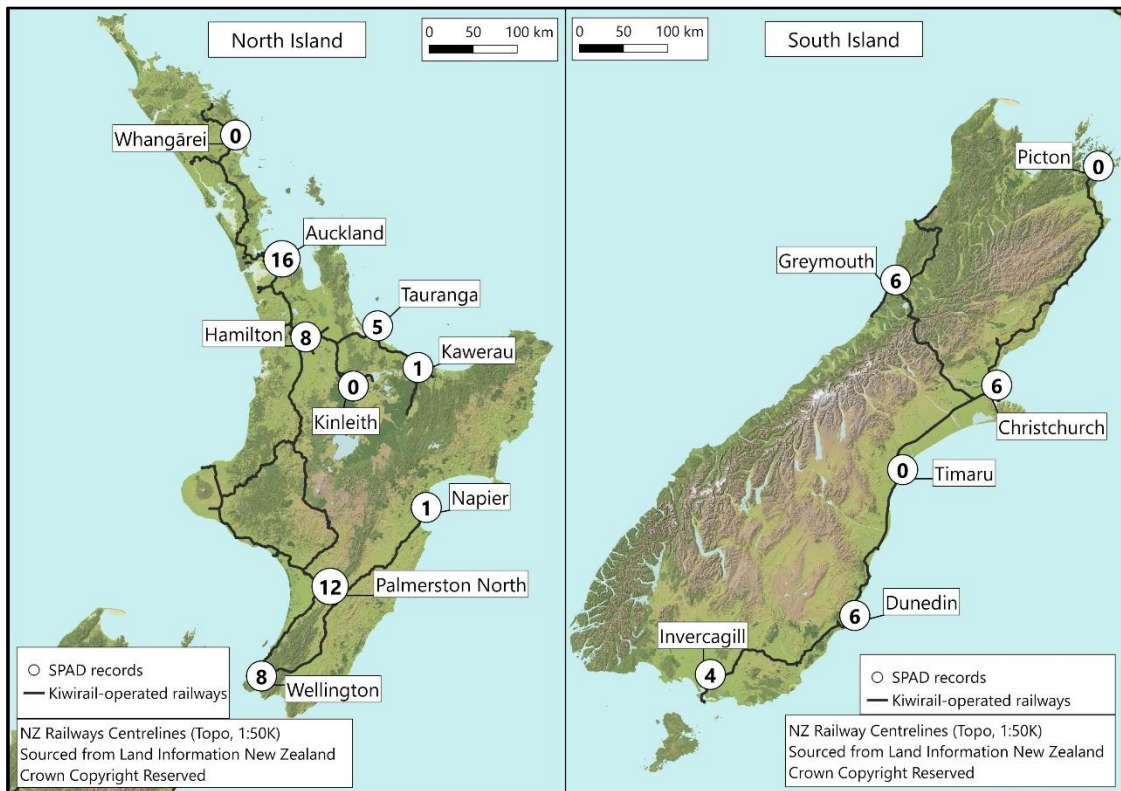
**Figure 30: Location of KiwiRail’s SPADs between 2020 and September 2025**

3.51. This investigation reviewed five years<sup>43</sup> of KiwiRail’s national SPAD data to identify where incidents were occurring across its operations. The analysis showed that SPADs were not confined to a single location but occurred throughout the rail network, across both the North and South Islands (see Figure 30).
