# **Final report**

***Rail inquiry RO-2025-102***

***Runaway rail-vehicle collision and near miss with  
rail crew***

***Port Chalmers, Dunedin***

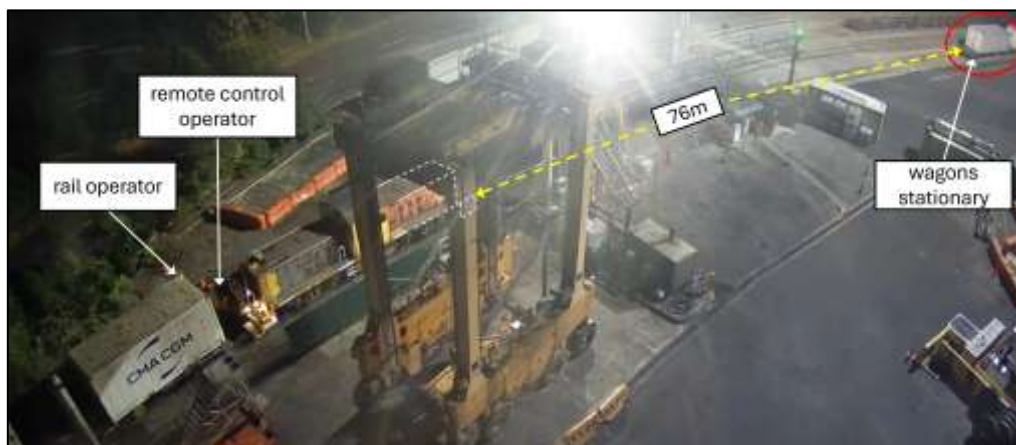
**Figure 5: Position of wagons and shunt crew at 0128:38**

- 2.26. On arrival back at the connection area, the RCO and RO both attempted to couple the remaining wagons to the shunt locomotive.
- 2.27. At 0128:38, the nine wagons on road 1 started rolling down the descending gradient towards the crew's location (see

2.28. Figure 5).

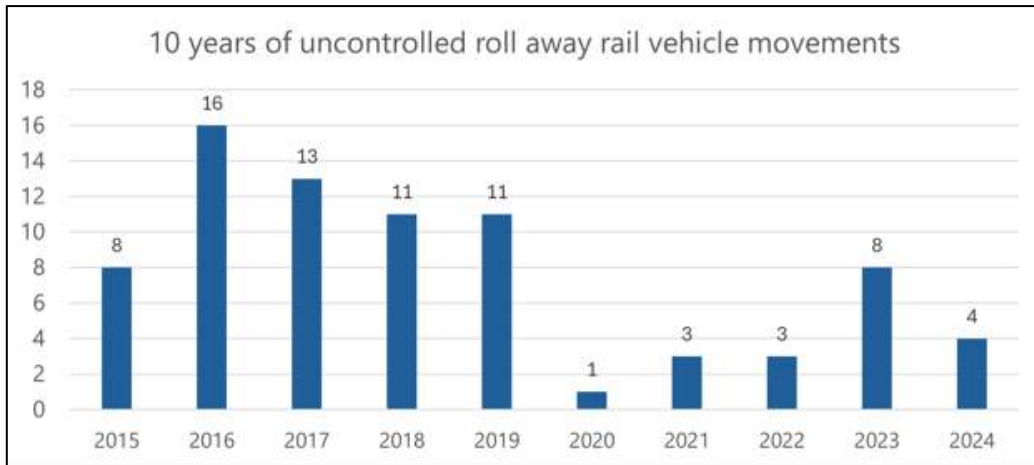
**Figure 11: KiwiRail roll away occurrences between 2015 and 2024**

2.45. The Commission obtained KiwiRail's uncontrolled roll away data, for 2015 to 2024 (see Figure 11).

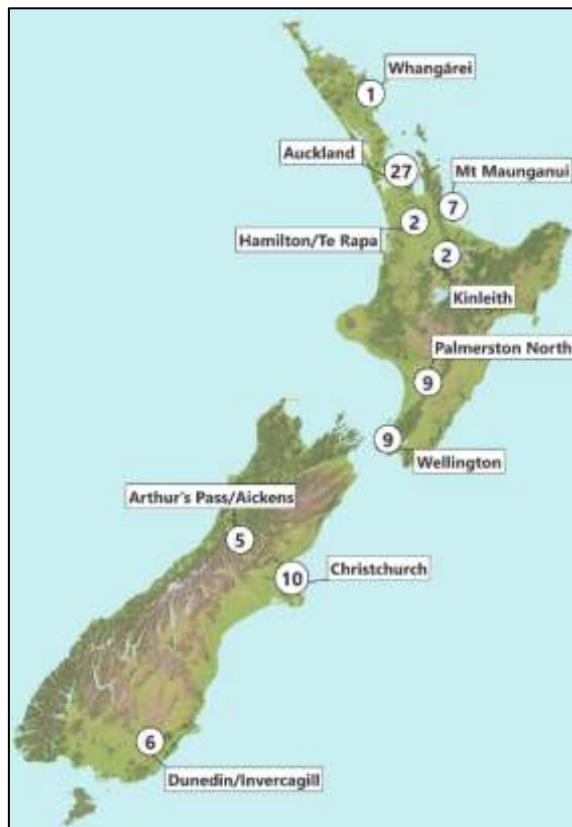
**Figure 12: KiwiRail's national roll away numbers by location from 2015 to 2024**

2.46. The locations of the uncontrolled roll away occurrences are shown in Figure 12.

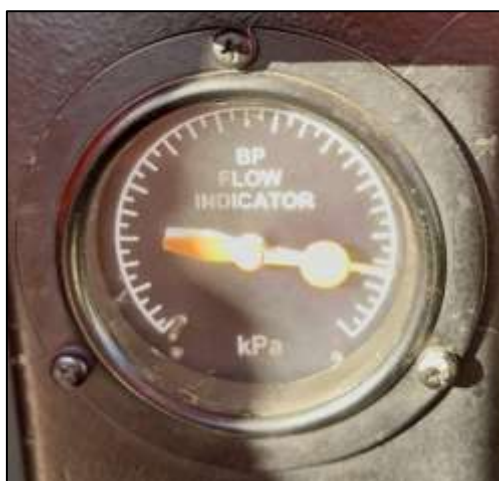
**Figure 23: In-cab air-flow gauge at point of equalisation**

- 3.28. The Commission found from interviewing the crew that during their communications the RO and RCO did not verbally confirm with each other what tasks each was doing and whether those tasks were complete. A breakdown of clear radio communication resulted in a misunderstanding and led to the RO assuming the RCO had applied the hand brakes, which they hadn't.
- 3.29. KiwiRail's locomotive fleets are equipped with air-flow gauges in the cab to assist locomotive engineers in determining when equalisation has been achieved. This is when the white and orange needles in the gauge align with each other and stop moving (see Figure 23).

- 3.30. The RCO's remote-control unit did not include any visual indicators to assist the RCO determine when brake-pipe reduction had fully equalised. In the absence of such aids, the RCO had to rely on their judgement and experience to estimate when equalisation had occurred, and the stabling process could begin, and the air tap could be lifted. This increased the likelihood of incomplete equalisation and an unintended release of air.
