Transport Accident  
Investigation  
Commission

# Final report

***Aviation inquiry AO-2024-001***

***Runway excursion (overrun)***

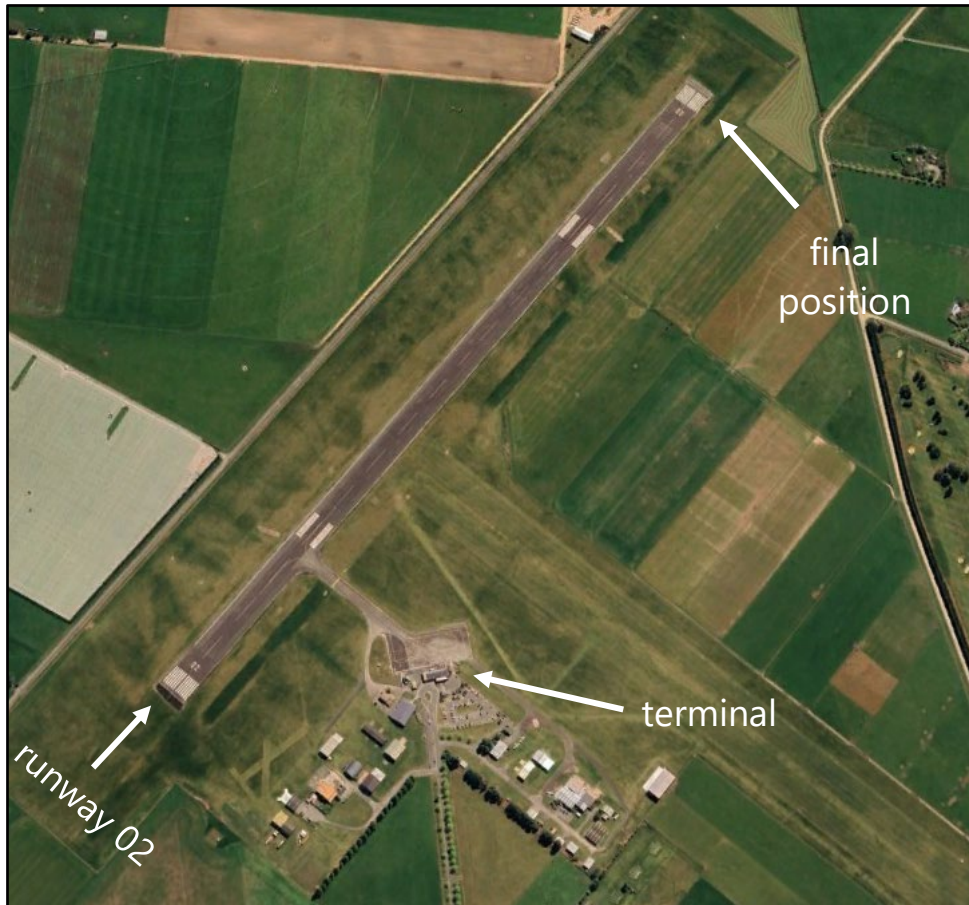
**Figure 4: Timaru Aerodrome**

- 2.4. The captain taxied the aeroplane from the terminal to line up on runway 02,<sup>6</sup> the main sealed runway (see Figure 4). At 0648:52, the FO, after making the take-off and departure radio call on the local aerodrome frequency, took control of the aeroplane and advanced the power levers to start the take-off. The FO then called 'Set power'. In response, the captain fine-tuned the power setting while the FO focused on remaining aligned with the runway centreline. At 0649:13, the captain called '70 knots' and the FO replied 'Checked'.<sup>7</sup>
