Transport Accident
Investigation
Commission

Final report

Aviation inquiry AO-2024-001
Bombardier DHC-8-311, ZK-NEF
Runway excursion (overrun)
Timaru Aerodrome
7 February 2024

May 2026

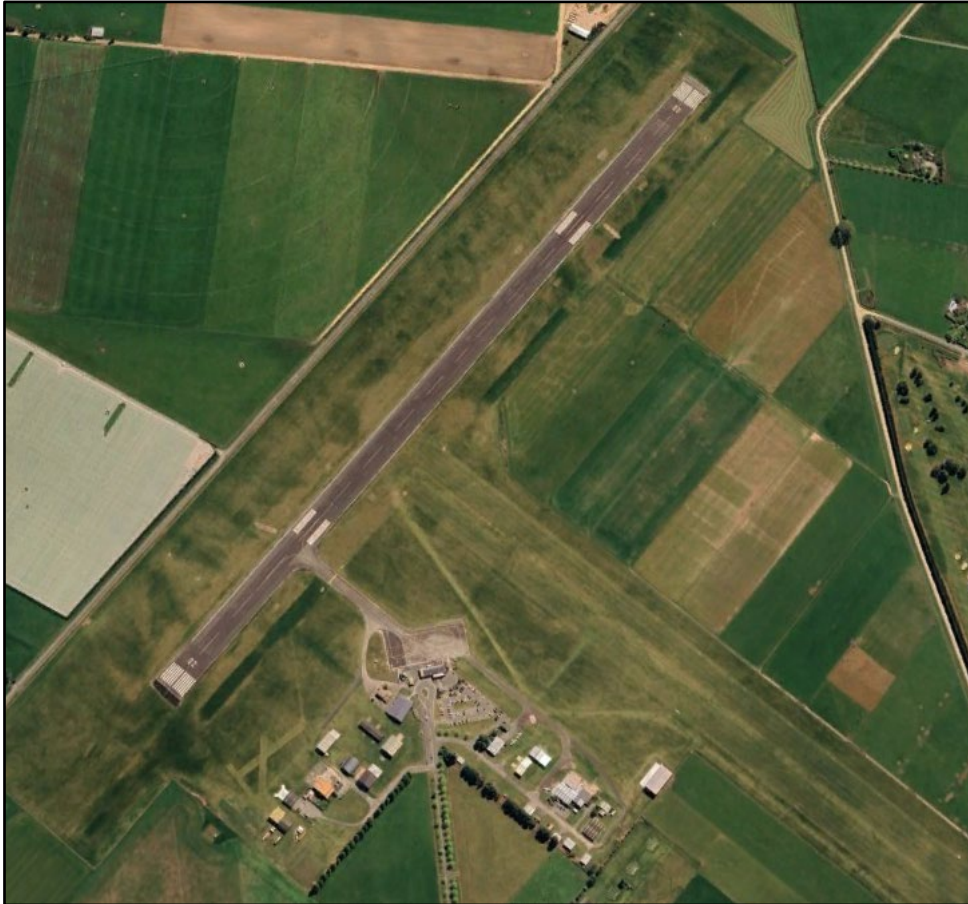
Figure 4: Timaru Aerodrome

- 2.4. The captain taxied the aeroplane from the terminal to line up on runway 02,⁶ the main sealed runway (see Figure 4). At 0648:52, the FO, after making the take-off and departure radio call on the local aerodrome frequency, took control of the aeroplane and advanced the power levers to start the take-off. The FO then called 'Set power'. In response, the captain fine-tuned the power setting while the FO focused on remaining aligned with the runway centreline. At 0649:13, the captain called '70 knots' and the FO replied 'Checked'.⁷
