Transport Accident  
Investigation  
Commission

# **Final report**

***Aviation inquiry A0-2025-003***  
***Bell Textron Canada Limited 206L-3 helicopter,***  
***ZK-IGD***  
***Loss of control – ground***  
***4.5 NM west of Whakatāne***  
***27 July 2025***

**May 2026**

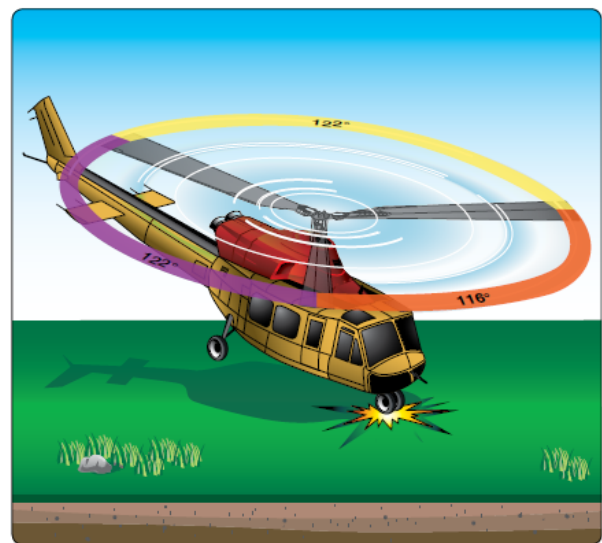
Figure 11-4. Ground resonance.

Hard contact with the ground on one corner (and usually with wheel-type landing gear) can send a shockwave to the main rotor head, resulting in the blades of a three-blade rotor disk moving from their normal  $120^\circ$  relationship to each other. This movement occurs along the drag hinge and could result in something like  $122^\circ$ ,  $122^\circ$ , and  $116^\circ$  between blades. [Figure 11-4] When another part of the landing gear strikes the surface, the unbalanced condition could be further aggravated.

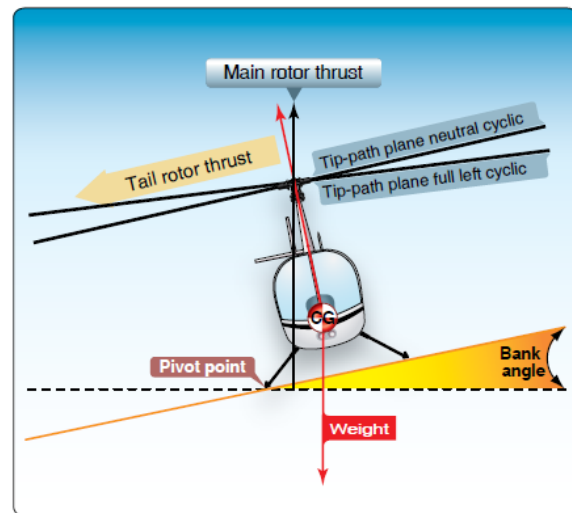
**Figure 11-5.** Forces acting on a helicopter with right skid on the ground.

Refer to *Figure 11-5*. The following conditions are most critical for helicopters with counterclockwise rotor rotation:

When maneuvering with one skid or wheel on the ground, care must be taken to keep the helicopter cyclic control carefully adjusted. For example, if a slow takeoff is attempted and the cyclic is not positioned and adjusted to account for translating tendency, the critical recovery angle may be exceeded in less than two seconds. Control can be maintained if the pilot maintains proper cyclic position and does not allow the helicopter's roll and pitch rates to become too great. Fly the helicopter into the air smoothly while keeping movements of pitch, roll, and yaw small; do not allow any abrupt cyclic pressures.

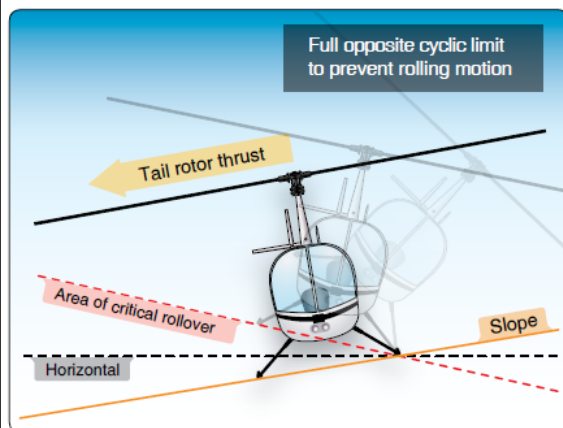
Figure 11-6. Upslope rolling motion.

During slope operations, excessive application of cyclic control into the slope, together with excessive collective pitch control, can result in the downslope skid or landing wheel rising sufficiently to exceed lateral cyclic control limits, and an upslope rolling motion can occur. [Figure 11-6]

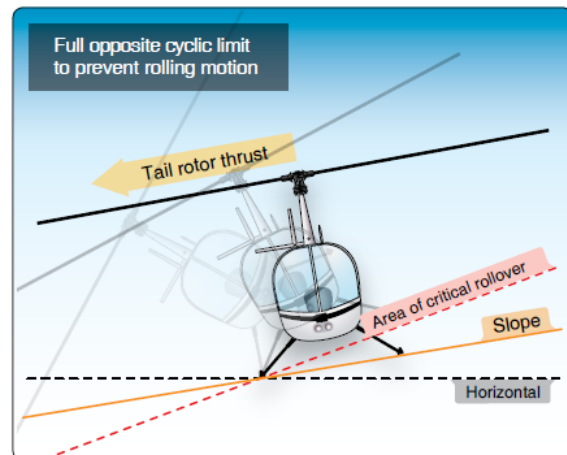
Figure 11-7. Downslope rolling motion.

thrust (lift). A smooth, moderate collective reduction, at a rate of less than approximately full up to full down in two seconds, may be adequate to stop the rolling motion. Take care, therefore, not to dump collective at an excessively high rate, as this may cause a main rotor blade to strike the fuselage. Additionally, if the helicopter is on a slope and the roll starts toward the upslope side, reducing collective too fast may create a high roll rate in the opposite direction. When the upslope skid or wheel hits the ground, the dynamics of the motion can cause the helicopter to bounce off the upslope skid or wheel, and the inertia can cause the helicopter to roll about the downslope ground contact point and over on its side. [Figure 11-7]

To help avoid dynamic rollover:

1. Always practice hovering autorotations into the wind, and be wary when the wind is gusty or greater than 10 knots.
2. Use extreme caution when hovering close to fences, sprinklers, bushes, runway/taxi lights, tiedown cables, deck nets, or other obstacles that could catch a skid or wheel. Aircraft parked on hot asphalt overnight might find the landing gear sunk in and stuck as the ramp cooled during the evening.

3. Always use a two-step lift-off. Pull in just enough collective pitch control to be light on the skids or landing wheels and feel for equilibrium, then gently lift the helicopter into the air. 4. Hover high enough to have adequate skid or landing wheel clearance from any obstacles when practicing hovering maneuvers close to the ground, especially when practicing sideways or rearward flight.
