Transport Accident
Investigation
Commission

Final report

Maritime inquiry MO-2023-201
Passenger vessel, Kaitaki
Loss of power
Cook Strait, New Zealand
28 January 2023

May 2026

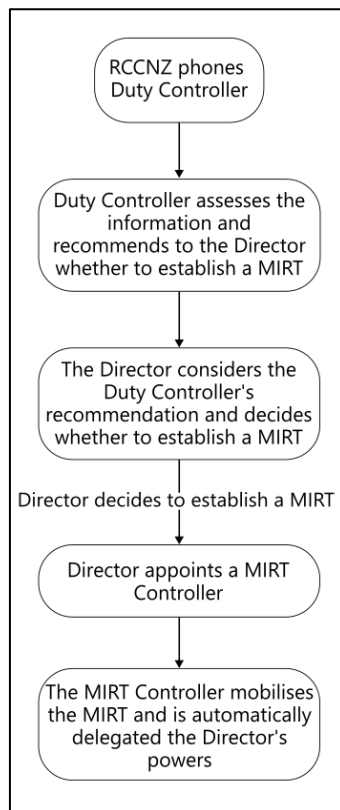
Figure 7: MIRT decision tree

- 2.45. The MIRT controller mobilises the MIRT, which leads to an activation phase in which staff with appropriate capabilities (for example, legal, policy, salvage and other aspects under the CIMS framework) are called into the response. This phase requires staff to relocate from wherever they are to the appropriate response hubs, which takes time. See Figure 7 below for the MIRT decision tree.

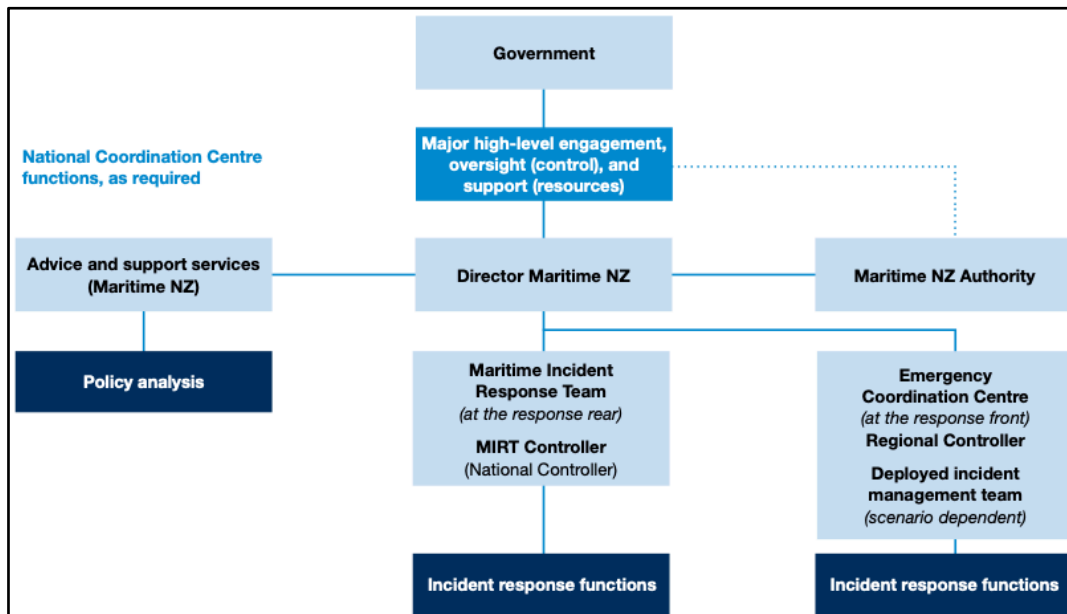
Figure 8: Maritime New Zealand's major maritime incident response

2.47. Figure 8 shows how MIRT integrates with MNZ’s incident response structure during a major maritime incident.

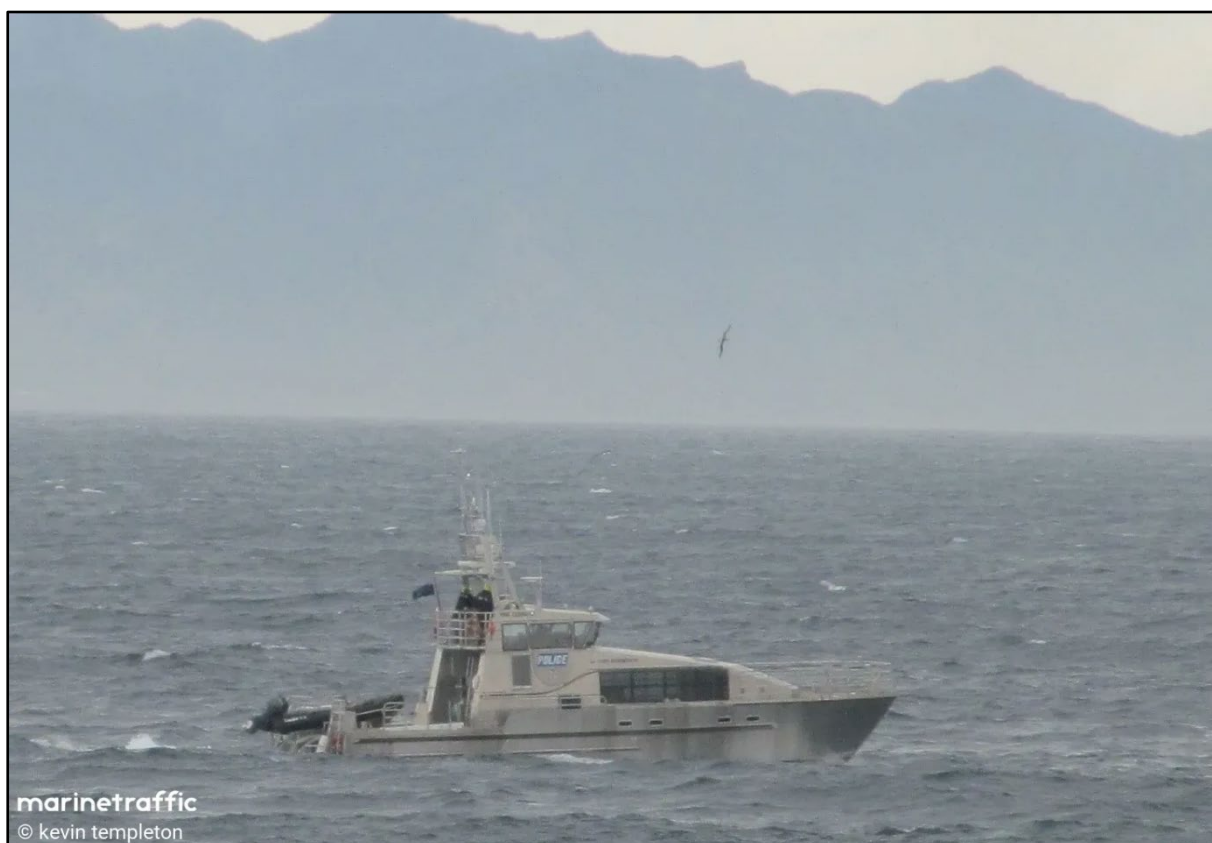
Figure 9: Wellington Police Maritime Unit launch, *Lady Elizabeth IV*, in the Cook Strait
(Credit: Kevin Templeton)

- 3.61. When selecting an on-scene coordinator it is important for SAR coordinators to consider the operational profile of all available assets. The Police Coastal Master was appointed on-scene coordinator by RCCNZ. The WPMU launch, *Lady Elizabeth IV*, was purpose-built for Cook Strait operations and well-equipped for SAR, but experienced challenging environmental conditions on the day of the incident.
- 3.62. The Interislander ferry, *Aratere*, also responded to the Mayday and was stationed about 1.3 nautical miles (NM) southwest of the *Kaitaki*. The *Aratere* master was

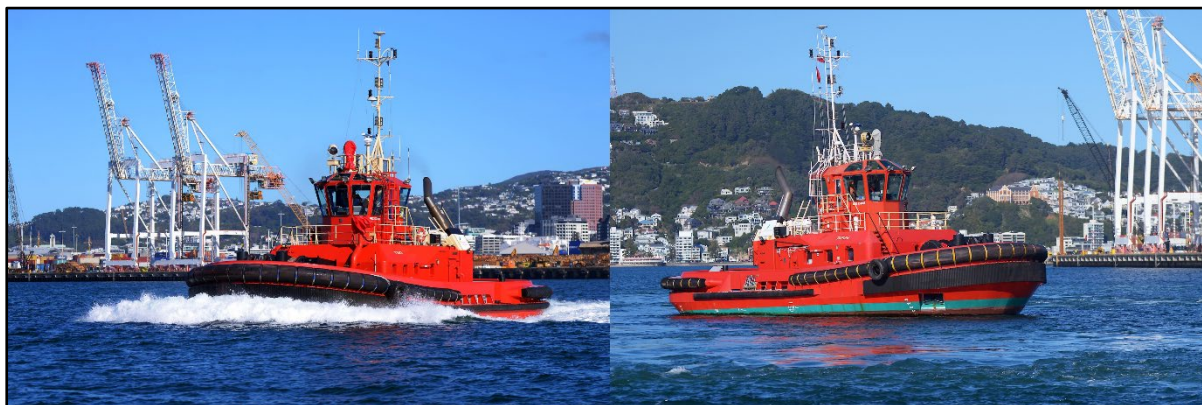
Figure 10: Wellington harbour tugs *Tiaki* (left) and *Tapuhi* (right)
(Credit: CentrePort Limited)

- 3.103. CentrePort has two harbour tugs (see Figure 10) that are ideally suited for their tasks: primarily the safe berthing, unberthing and manoeuvring of ships within the port. The ports of Picton and Nelson, on the other side of Cook Strait, are similarly equipped with harbour tugs.

- 3.104. Harbour tugs lack the characteristics required of an emergency towage vessel. Nonetheless, CentrePort, appreciating the seriousness of this evolving incident, directed both tugs to the *Kaitaki* to offer any assistance they could safely provide.
