Transport Accident
Investigation
Commission

Final report Tuhinga whakamutunga

***Maritime inquiry MO-2024-204
Passenger and freight ferry Aratere
Grounding
Titoki Bay, Picton
21 June 2024***

May 2026

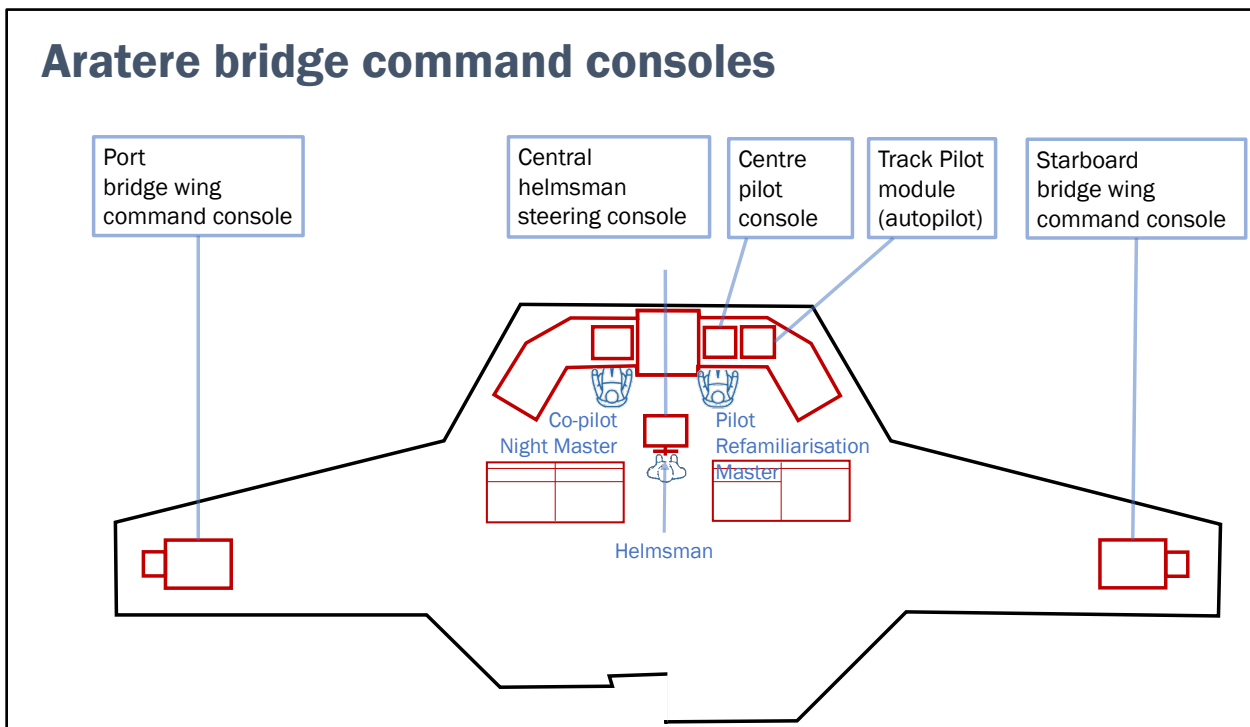
Figure 3: General arrangement of Aratere's bridge

- 2.3. On the bridge, steering could be controlled from any one of five command consoles (see Figure 3):
 - the port⁵ bridge wing console
 - the starboard⁶ bridge wing console

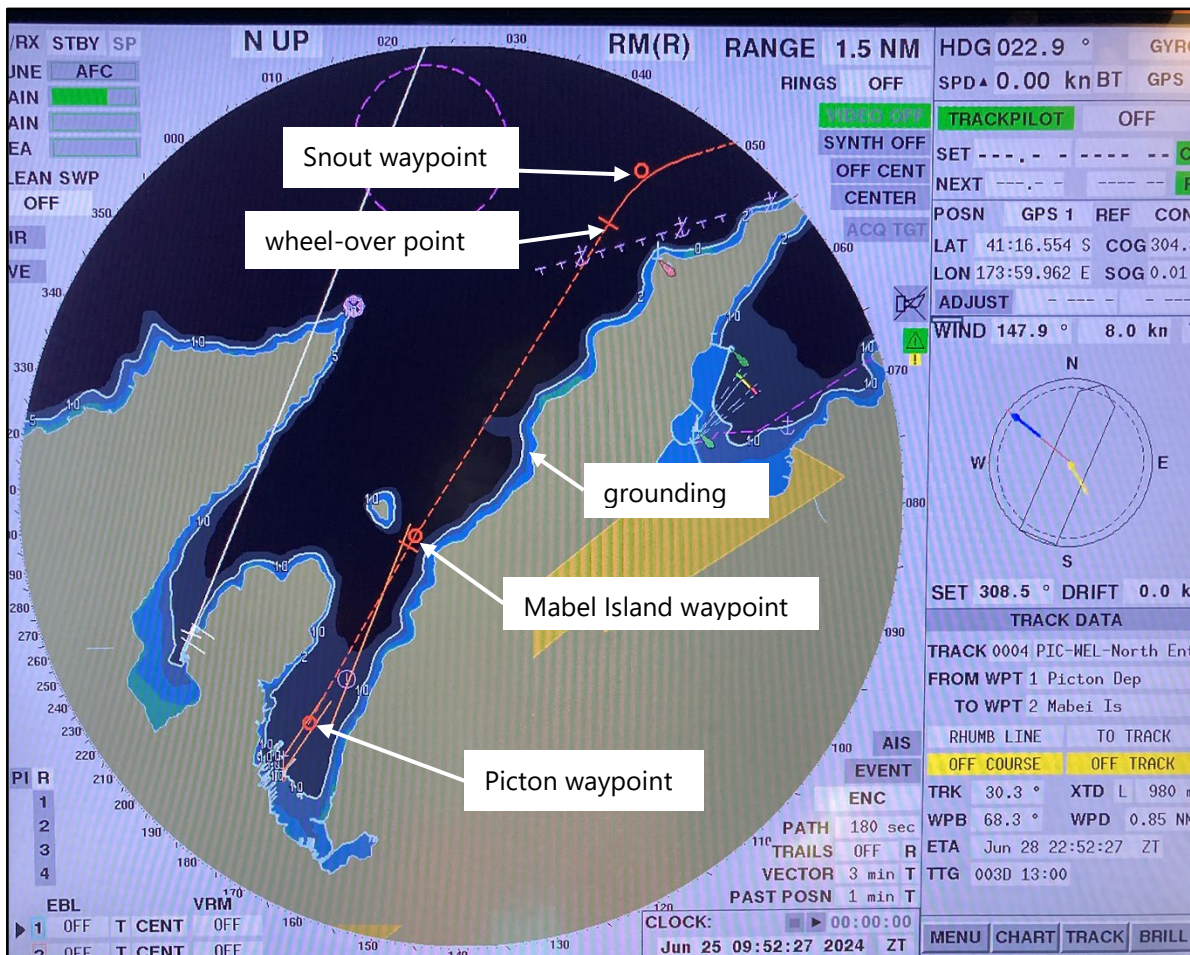
Figure 4: Screenshot from *Aratere's* electronic chart display and information system (ECDIS) showing planned tracks as red dashed lines and waypoints as red circles

- 2.17. The course between the Mabel Island waypoint and the Snout waypoint¹⁷ (the next waypoint) was 033° true. This was a small alteration of 3° to starboard (see Figure 4).

- 2.18. The night master normally waited until the ship was clear of Mabel Island before engaging the autopilot. When *Aratere* was about abeam¹⁸ of Mabel Island, the night master and relieving master discussed whether to use 'heading mode'¹⁹ or 'course mode'²⁰ for the autopilot. The autopilot was engaged on the ship's current heading of 028° in course mode, after which the helmsperson was released from the wheel to stand by on the bridge.
- 2.19. From that point onwards the direction of the ship was controlled by the autopilot through the track pilot module.
- 2.20. The planned track for the passage to Wellington had been programmed into the track pilot as a series of waypoints joined by the track/course lines. The transition from one course to the next at each waypoint was programmed as an arc with a set radius. A wheel-over point²¹ was displayed before each waypoint (see Figure 4).

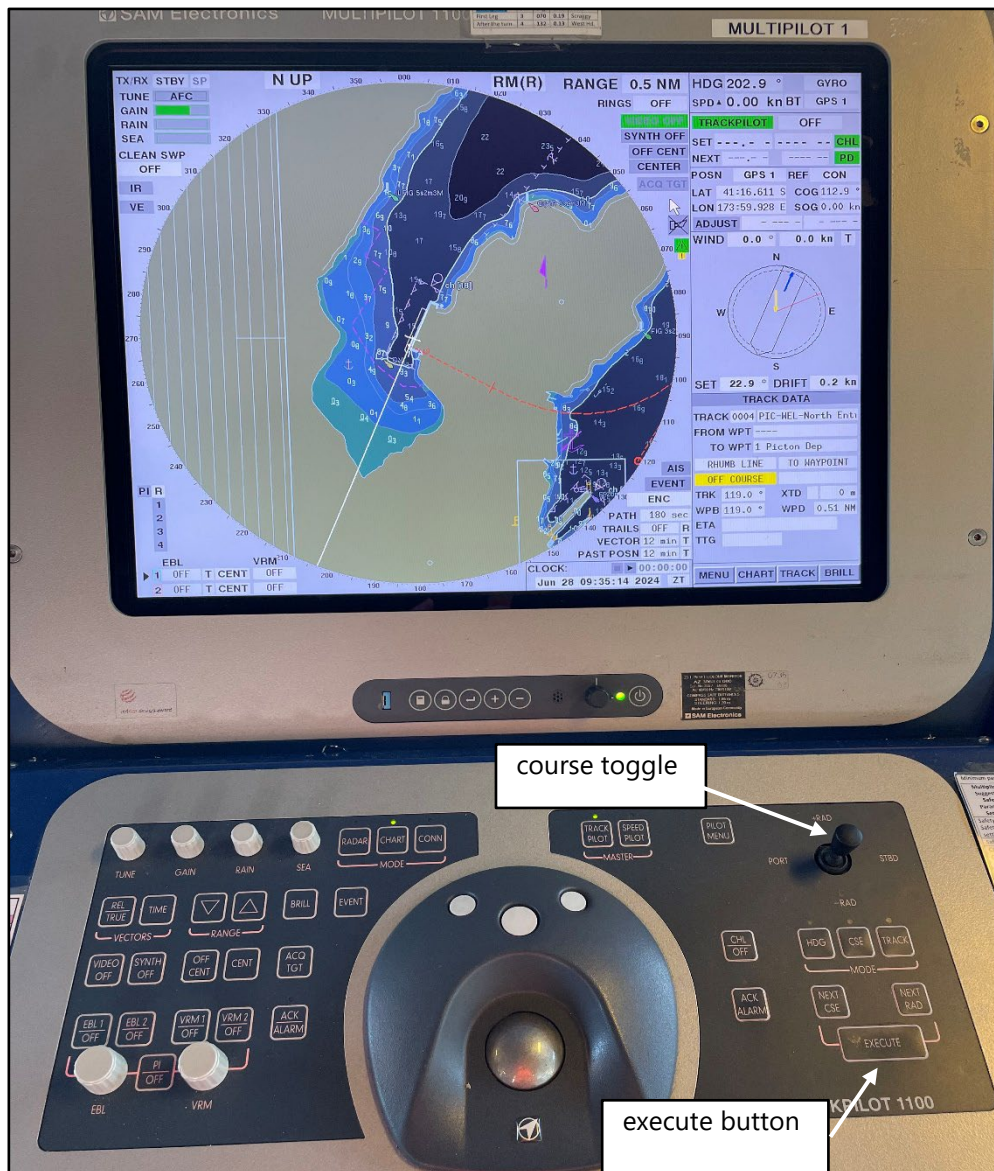
Figure 5: Track pilot incorporating autopilot function

- 2.21. When in course or track mode,²² the track pilot receives additional information from the ECDIS, such as wheel-over point. However, in course mode the track pilot will not automatically begin the turn. The pilot must push the 'execute' button. The track pilot will then apply the required rudder to take the ship around the programmed arc onto the next course. The pilot can make manual adjustments to the course using the course toggle control (see Figure 5).
