Transport Accident
Investigation
Commission

Final report

Aviation inquiry AO-2024-004
Airbus A320, registration VH-VFF
Loss of control – ground (LOC-G)
Christchurch

31 May 2024

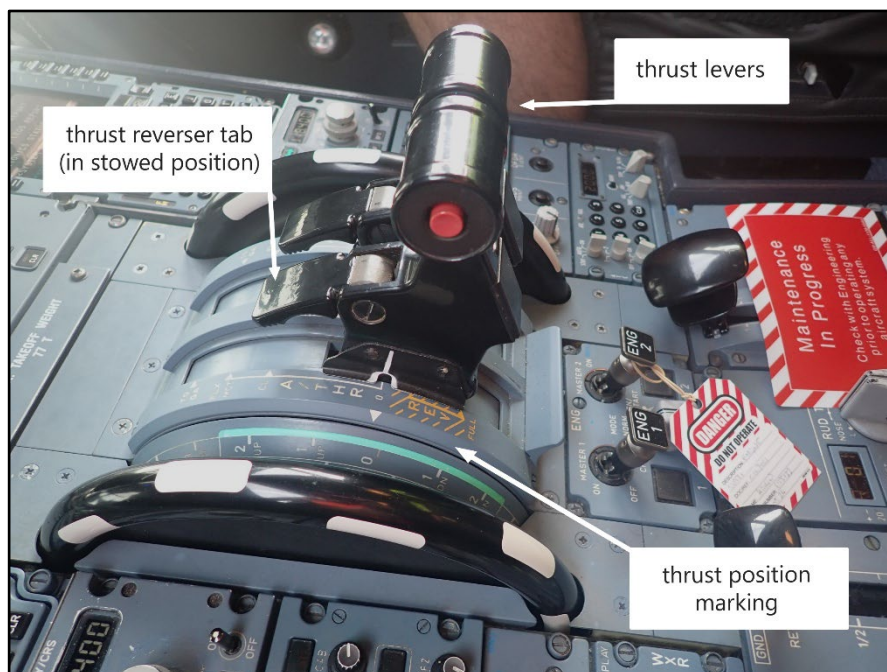
Figure 4: Thrust levers in FWD IDLE

- 2.28. Each of the engines is controlled by a full authority digital engine controller (FADEC), which takes its control inputs from the thrust levers that the pilot operates. The pilot sets the thrust level for the phase of flight, and the FADEC manages the fuel flow to maintain the selected power setting (see Figure 4 and Figure 5 for the different thrust lever positions).

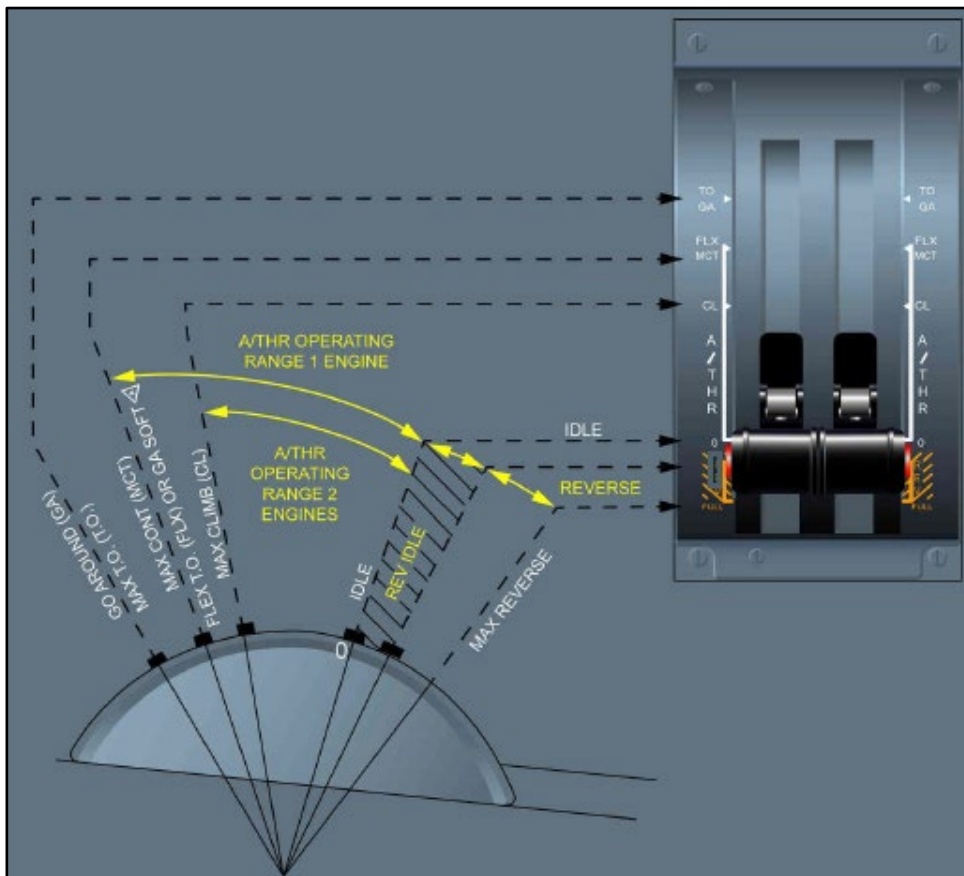
Figure 5: Thrust lever range of movement²⁵

- 2.29. The thrust levers can move forward to the TOGA (take-off/go around) position and back to the FWD IDLE position (depicted as 0 in Figure 5), with a detent that the pilot can feel as the lever passes each marked stage. The lever can only be moved back into reverse thrust positions if the thrust reverser tab²⁴ is lifted.
- 2.30. There are two reverse thrust positions: REV MAX and REV IDLE. When the thrust levers are moved from reverse to the forward thrust positions, the thrust reverser tabs

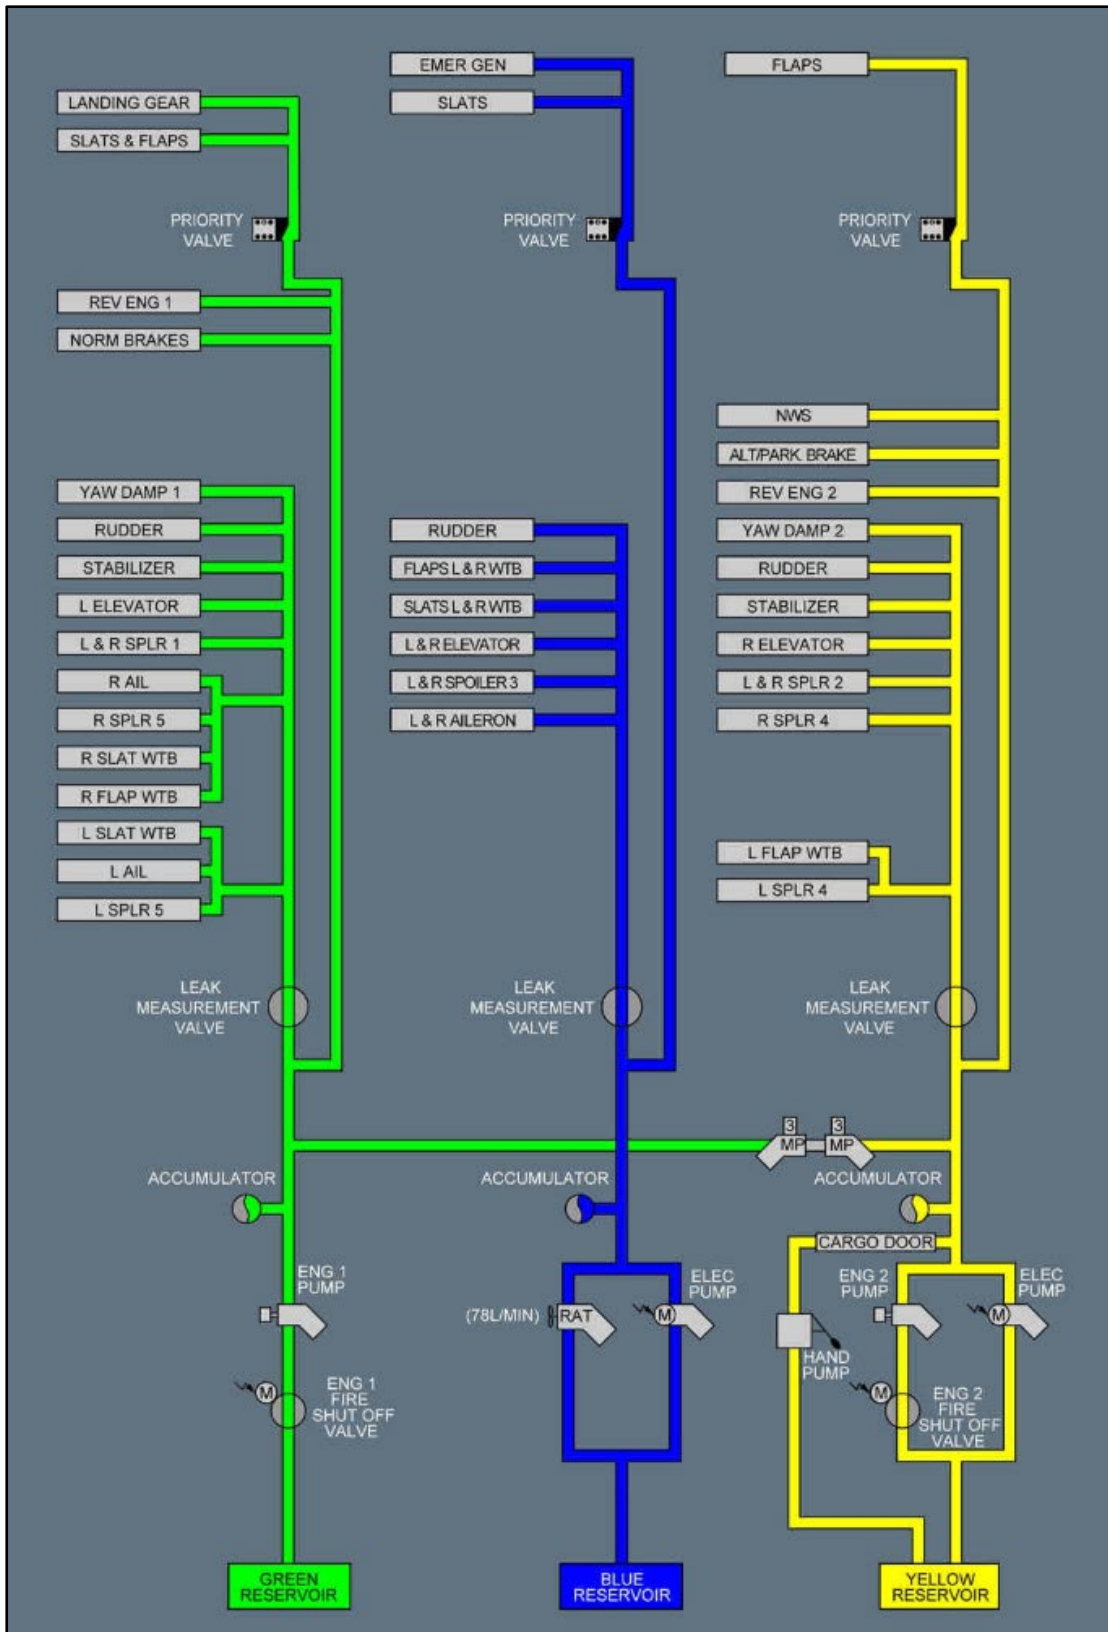
Figure 12: A320 hydraulic architecture

- 2.3. The flight crew then followed the standard operating procedure (SOP) for 'Abnormal' situations as displayed on the ECAM. The ECAM provided guidance to the flight crew for a yellow hydraulics system⁸ failure, helping them identify the problem and the aeroplane's subsequent limitations due to the failure. The caution 'Hydraulic, yellow, reservoir low level' had a checklist of actions that the flight crew started to work through, including switching the yellow hydraulic pumps off. The ECAM also listed all the systems that had become inoperative as a result of the loss of hydraulic fluid (see Appendix 1 for the hydraulics system diagram).
