Transport Accident
Investigation
Commission

Final report

Aviation inquiry AO-2024-005
Airbus Helicopters AS 350 BA, ZK-HJM
Impact with terrain
Paringa River,
40 km northeast of Haast
20 July 2024

June 2026

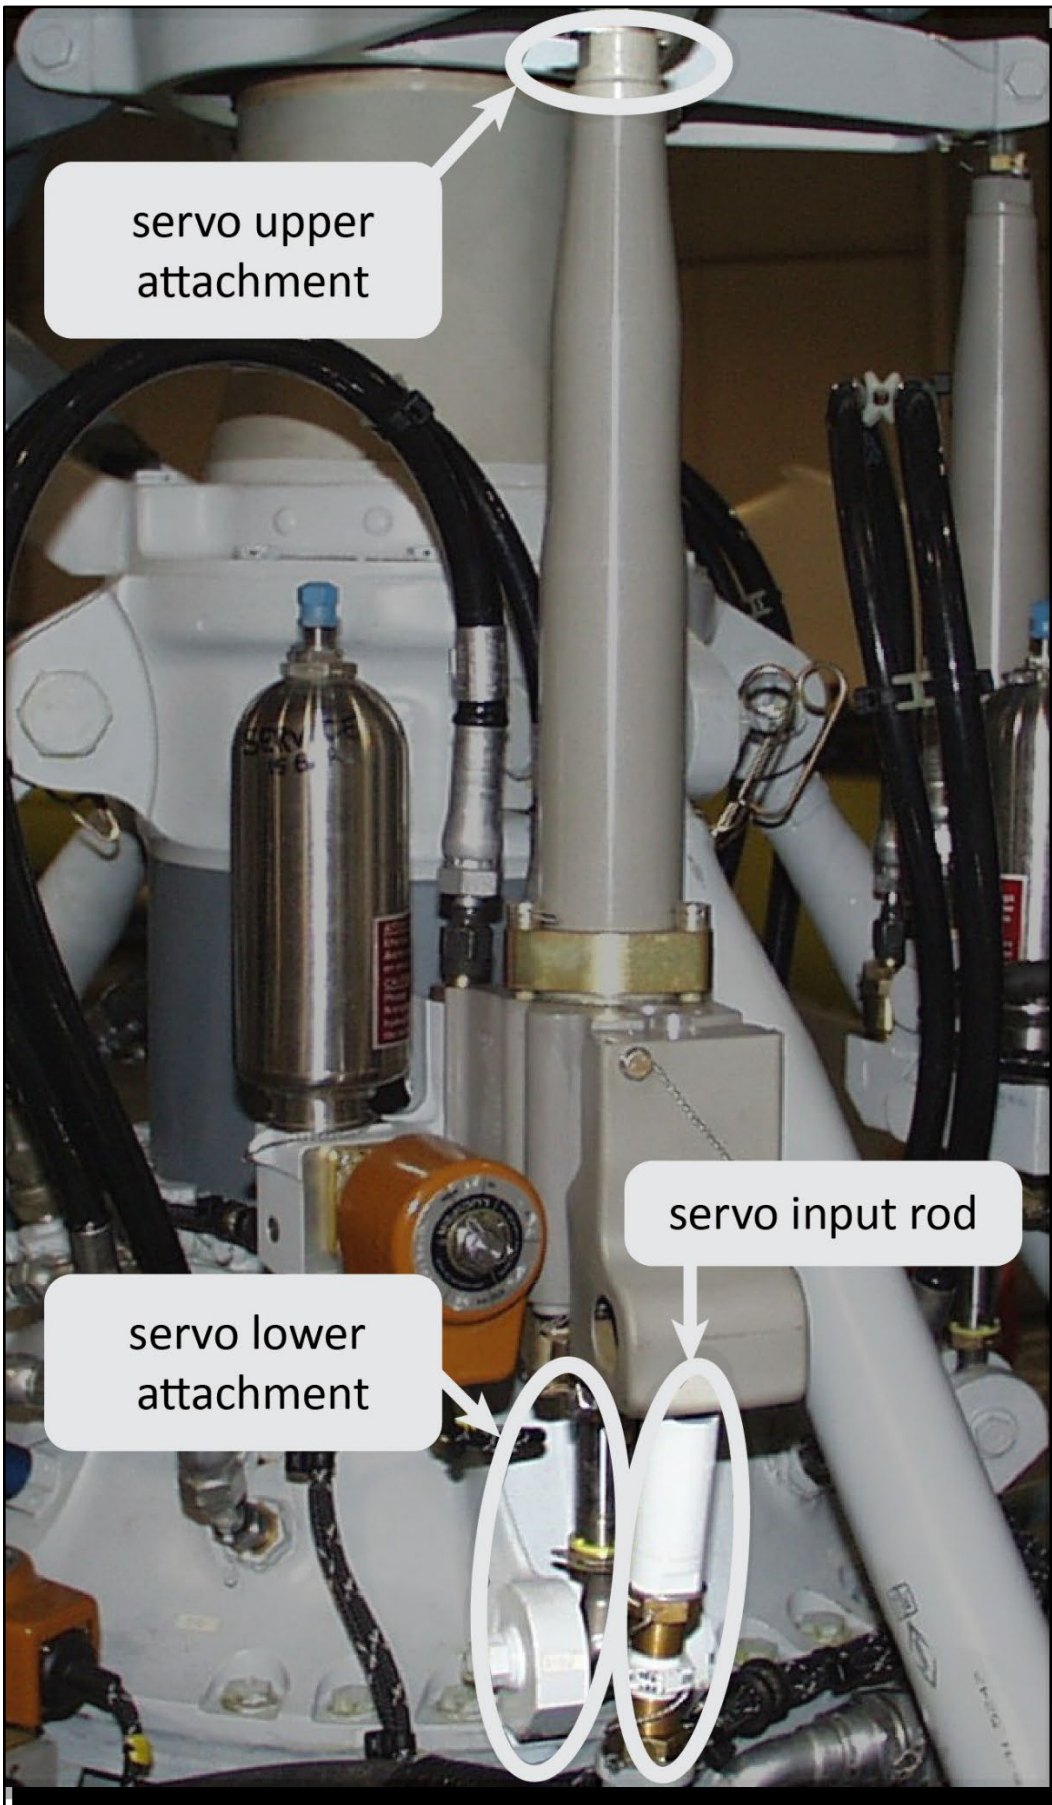
Figure 9: Example of AS350 hydraulic servo attachment points

- 3.49. On Tuesday 16 July 2024, Engineer B undertook work to connect the left and right hydraulic servo input rods. These had deliberately been left undone by Engineer A to facilitate the underfloor connection to the flight controls, and they communicated this to Engineer B during the handover. The position of the left input rod is in close proximity to the lower left servo connection (see Figure 9). However Engineer B noticed nothing untoward while they were connecting the input rod.

- 3.50. Another opportunity arose to notice the incorrectly installed servo on Thursday 18 July 2024. Engineer B tasked the pilot with carrying out the second part of the duplicate safety inspection for the connection of the hydraulic servo input rods they had completed two days earlier. During Commission interviews, the pilot recalled that despite the input rod connection being in close proximity to the lower hydraulic servo connection, they were focused on inspecting the input rods and noticed nothing untoward.
