Transport Accident
Investigation
Commission

Final report

Rail inquiry RO-2024-103
Bridge 57 Main South Line, Pier 8 collapse
Rangitata
12 April 2024

June 2026

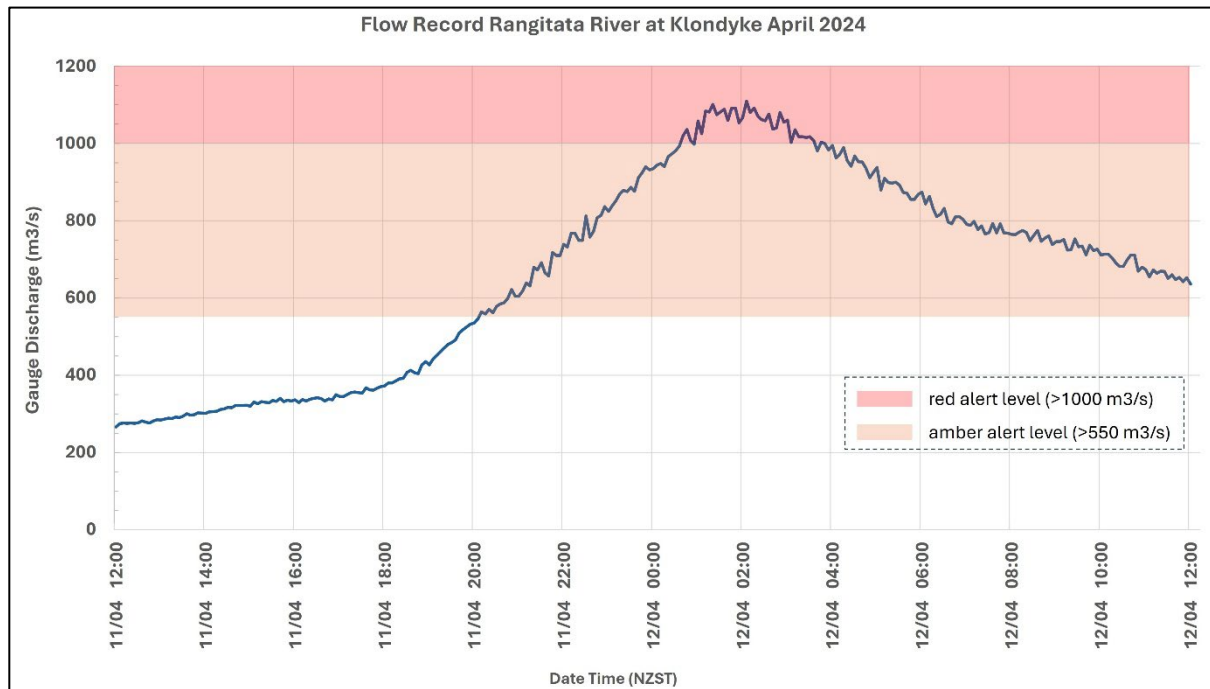
2.11 Because of the heavy rainfall, a flow event with a return period of 0.89 years in the river occurred from 11 April 2024 through to 12 April 2024. The flow peaked between 0200 and 0220 on 12 April 2024 at 1100 cubic metres per second (m³/s)⁷ (see Figure 3).

Figure 3: Flow record for the Rangitata River, extracted from Environment Canterbury’s river-flow data system in the days following the event

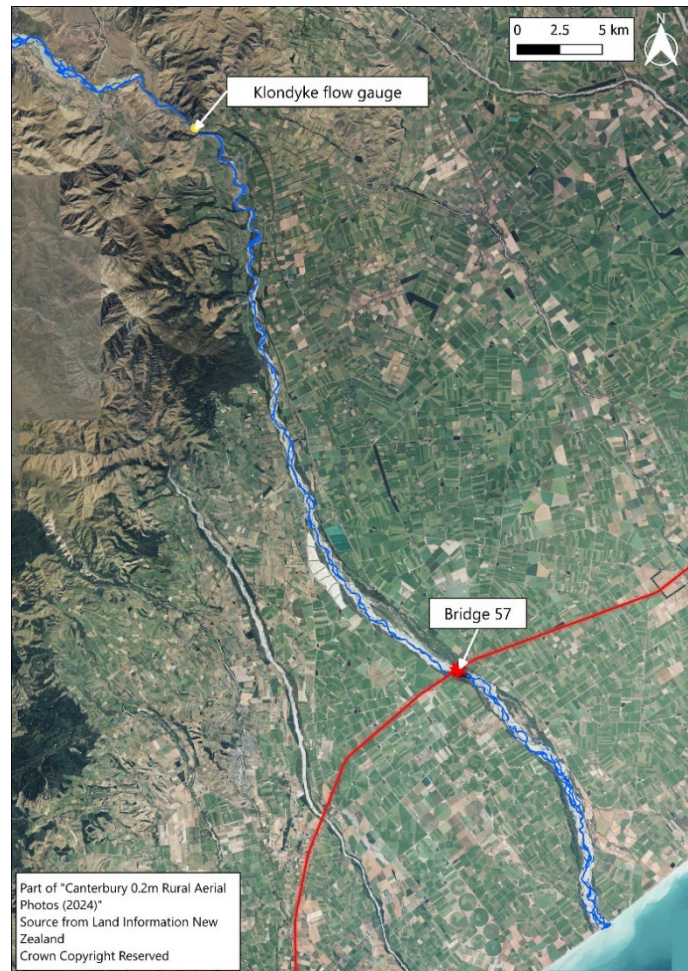
2.12 The flow gauge for the river is located at Klondyke, approximately six hours⁸ upstream from Bridge 57 (see Figure 4). This meant that the peak flow rate that occurred between 0200 and 0220 would be experienced at Bridge 57 at approximately 0800.

Figure 4: Location of Rangitata river-flow gauge

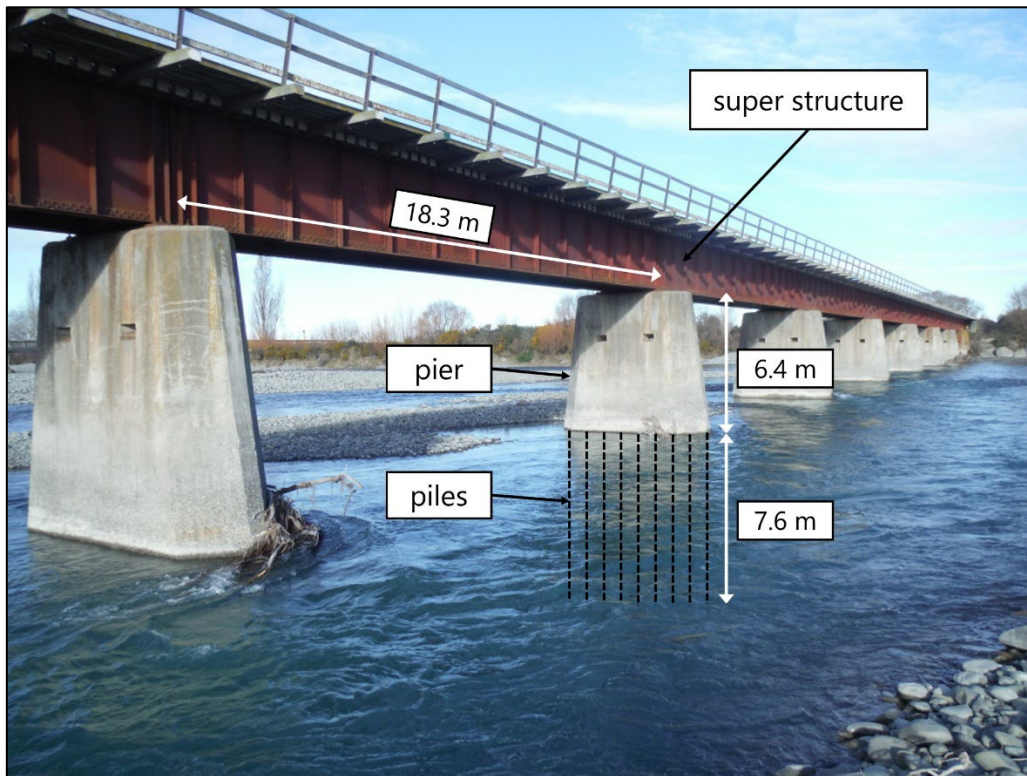
centre and are 6.4 m high. The piles underneath the piers extend 7.6 m below the base of the pier (see Figure 9).

Figure 9: Bridge 57 pier 'as built' measurements
(Credit: KiwiRail – annotated by the Commission)

- 2.55 Bridge 57 was constructed in 1936. KiwiRail was able to provide limited evidence confirming the height of the piers and depth of the piles that form part of Bridge 57. The Commission has therefore determined the pile depth based on the available evidence, which was the design documentation for the bridge.
- 2.56 KiwiRail records from 1983 refer to some 'as built' measurements, which indicate that the assumed depths shown in Figure 9 are a reasonable, conservative assumption for the depth of the piles and height of the pier.

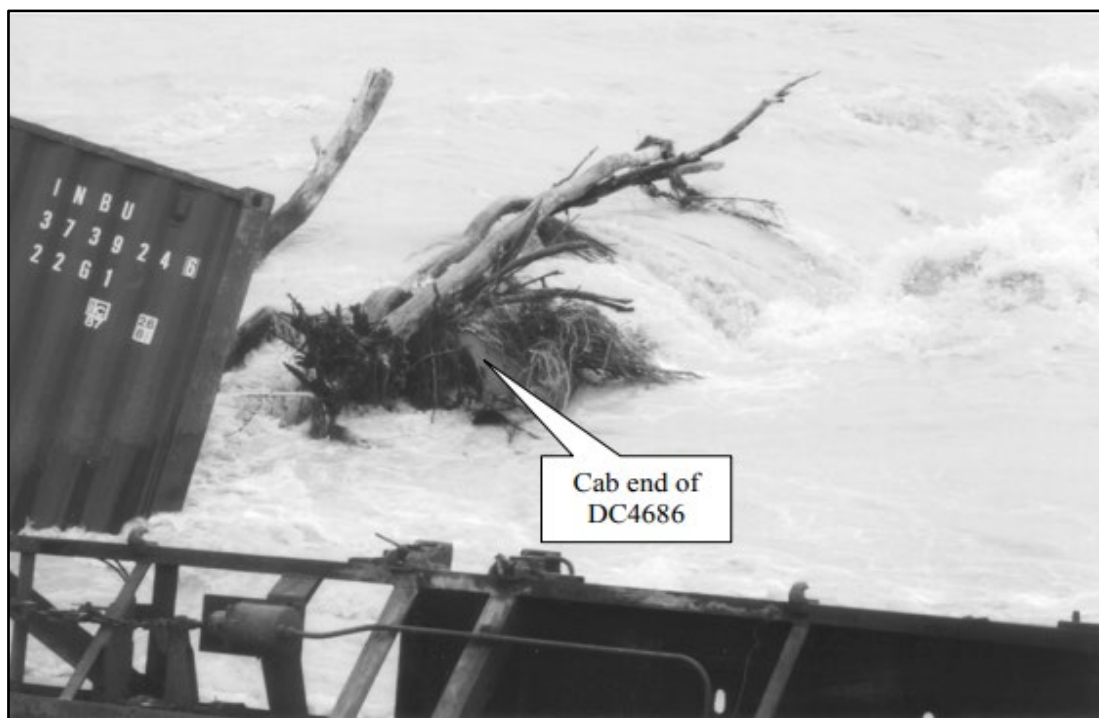
- 2.75 On 4 January 2002, Train 929 ran into a track subsidence beside the Rangitata River on the Main South Line, resulting in two locomotives and five wagons derailing and going into the river (see Figure 10).

Figure 10: Train 929 locomotive DC4686 submerged in the Rangitata River

- 2.76 The Commission found that there was:
- a lack of an early warning for river-flow levels
 - a lack of a defined process for implementing special track inspections during inclement weather
 - no specified time between a special track inspection and arrival of a train.
- 2.77 The Commission made the following recommendations in relation to the incident:
- establish an early warning system that is linked to the existing river-flow gauges
 - conduct inspections immediately ahead of all trains during and immediately following defined river flows.

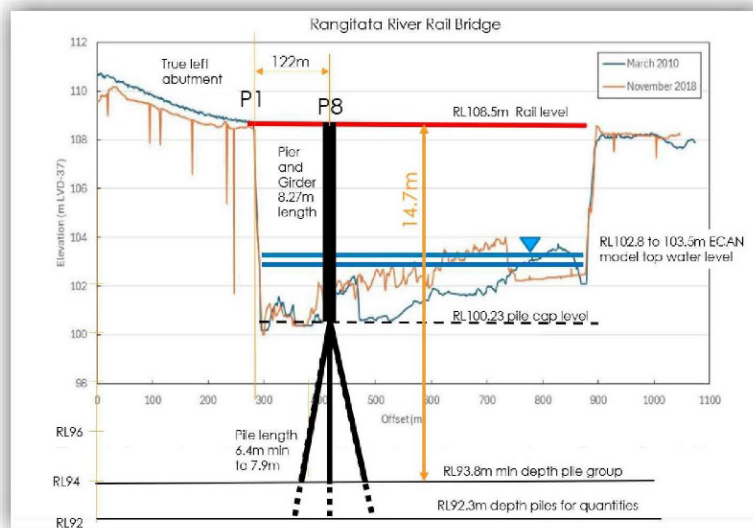
Railway bridge as-built drawings show the dimensions from rail level to pile foundations in imperial units. The rail level is RL160.25 feet and "all piles driven at least to reduced level RL112.00 feet. This is 48.25 feet level difference (converted to 14.6m metric). Refer Figure 1.

From the 1D model cross section at the railway bridge, the rail level is approximately RL108.5m. Therefore, base of pile foundation will be at least RL93.9m. The bridge support structure depth of 14.6m is made up of 1.8m girder beam depth, 6.4m pier depth, leaving at least 6.4m pile length. The pier base level (underside of pile cap) is approximately RL100.23m.

Figure 1: Bridge Support Structure at Pier 8 - main dimensions relevant to scour

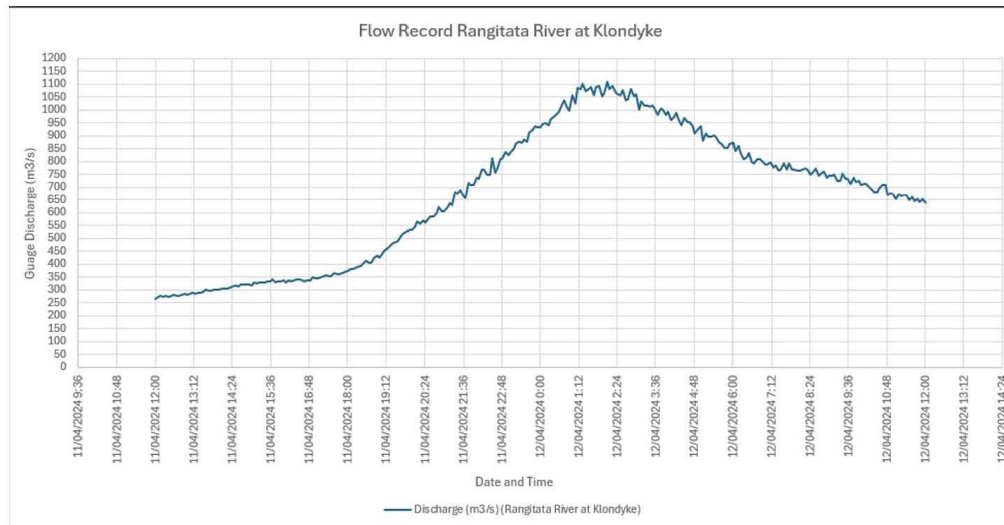
Figure 7: Chart of Rangitata at Klondyke, ECan flow gauge data at time of pier failure. ECan disclaimer: Provisional information has not yet been checked fully using the Council's Quality Assurance audit procedures.
