Transport Accident  
Investigation  
Commission

***Maritime inquiry MO-2025-201***

***F/V Antarctic Discovery***

***Incapacitation of crew***

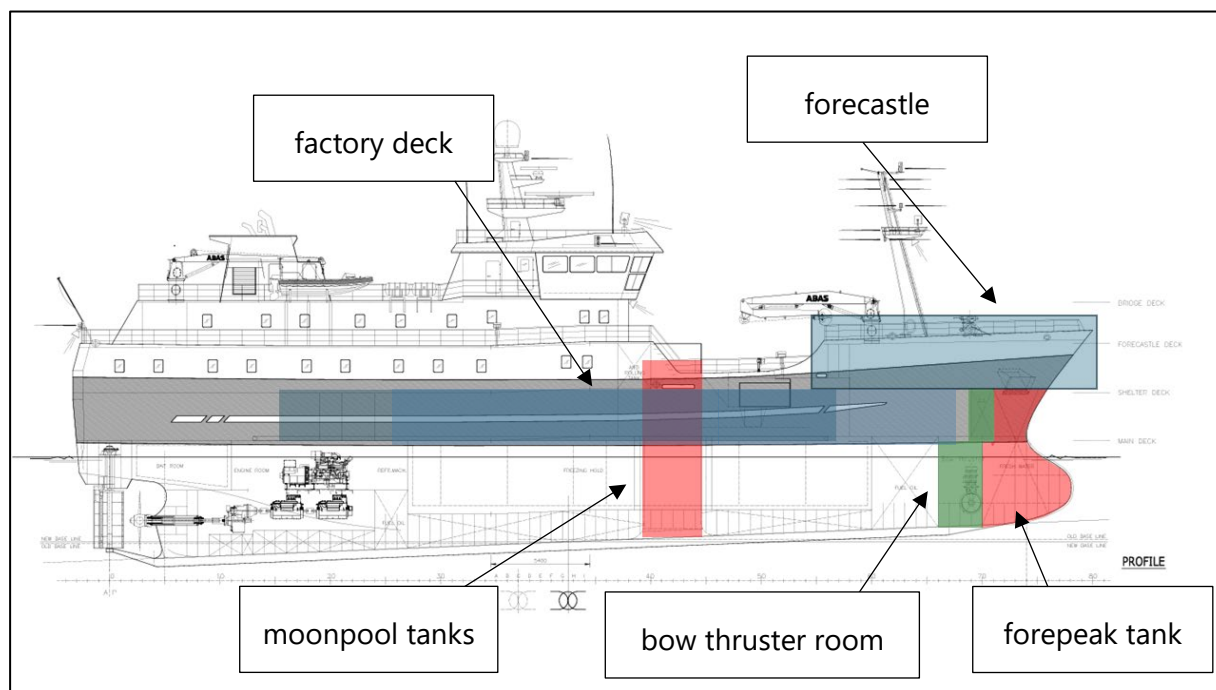
**Figure 4: Side profile showing the general arrangement of the applicable spaces**

- 2.4 The modification included installing an offal chute in the factory deck where the fish were processed. From there, the offal was minced and then pumped forward along the factory deck and up into the forecastle space through a flexible offal line. In the forecastle space, the offal line transitioned to a rigid steel pipe that entered the top of the forepeak tank through the manhole cover.<sup>7</sup>
- 2.5 A void space (the bow thruster room) was located immediately aft of the forepeak tank (see Figure 4). The bow thruster room was accessed through a doorway in the forecastle, then down a vertical ladder (see Figure 5).

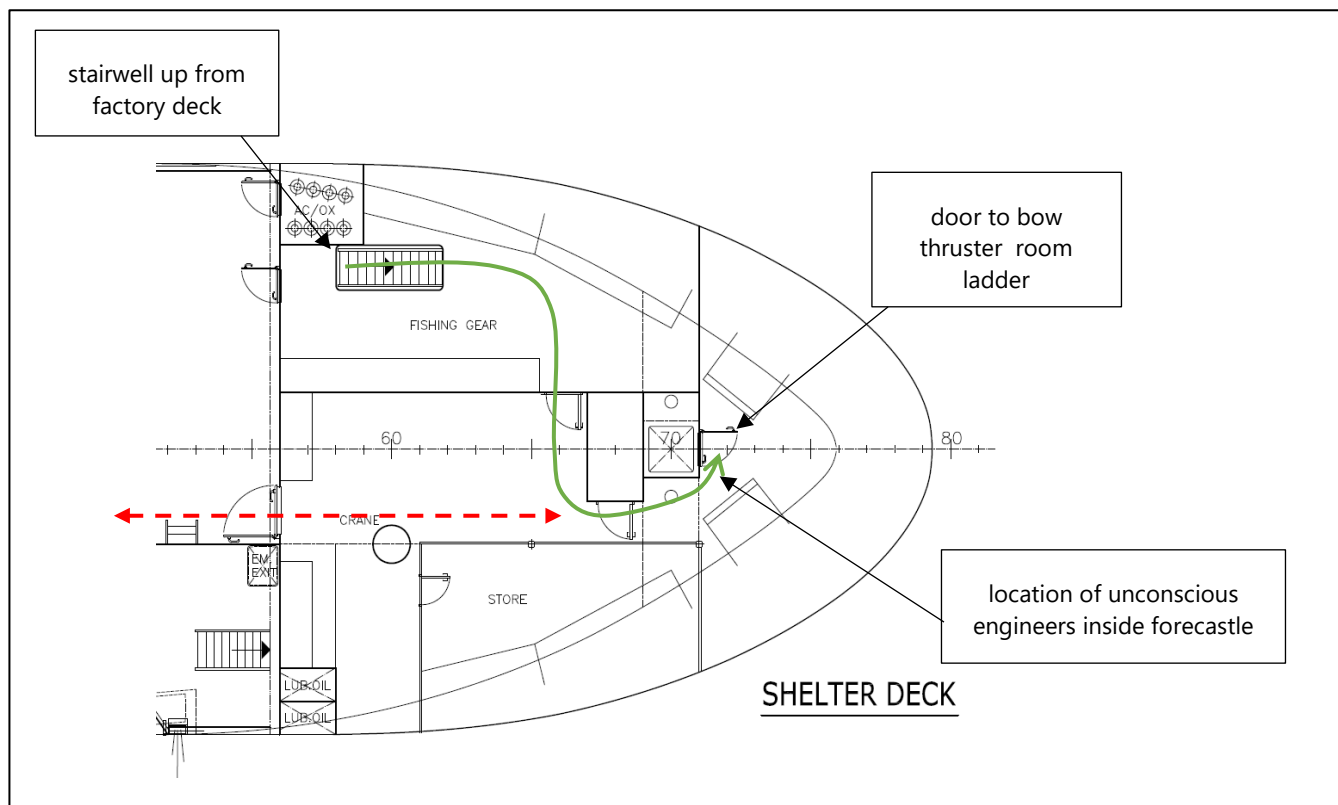
**Figure 10: Plan of forecastle area showing path of engineers (green arrow) and path of superintendent (red dashed arrow)**

- 2.20 There were three entry points into the forecastle: one each on the port and starboard sides from the open deck, and a third via stairs leading directly from the factory deck on the port side (see Figure 10). The superintendent had entered and exited from the starboard side entry point.

- 2.22 At about 0939,<sup>11</sup> the superintendent heard the two engineers entering the forecastle space and approached them to warn them to get out. Before they could do so, both engineers collapsed, the chief engineer furthest inside and the second engineer closer to the door.
