# **Final report**

***Aviation inquiry AO-2023-007***

***DHC-8-311, ZK-NEM***

***Descent below minimum safe altitude, Timaru***

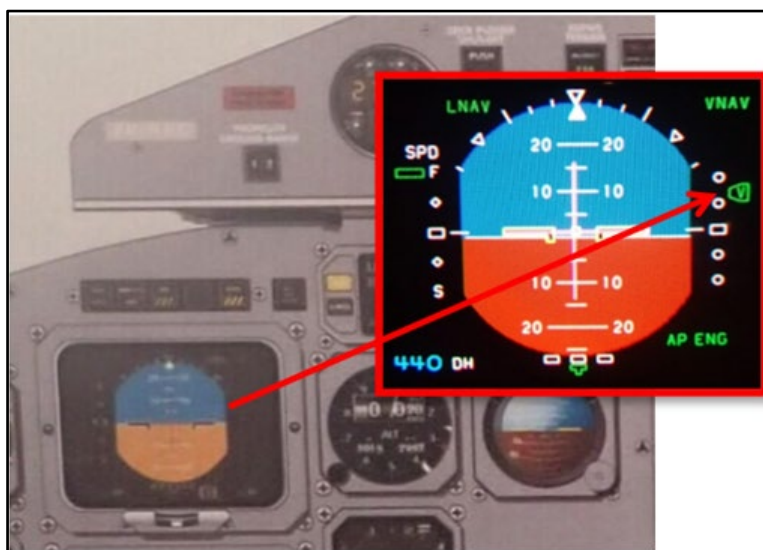
**Figure 7: Flight director indicating FMS is in VNAV mode and below profile ('fly up')**

divergence from the planned VNAV profile increased, the 'V' symbols rose to full deflection (see Figure 7). While this symbol at full deflection may not be particularly obvious,<sup>69</sup> there were other cues available.

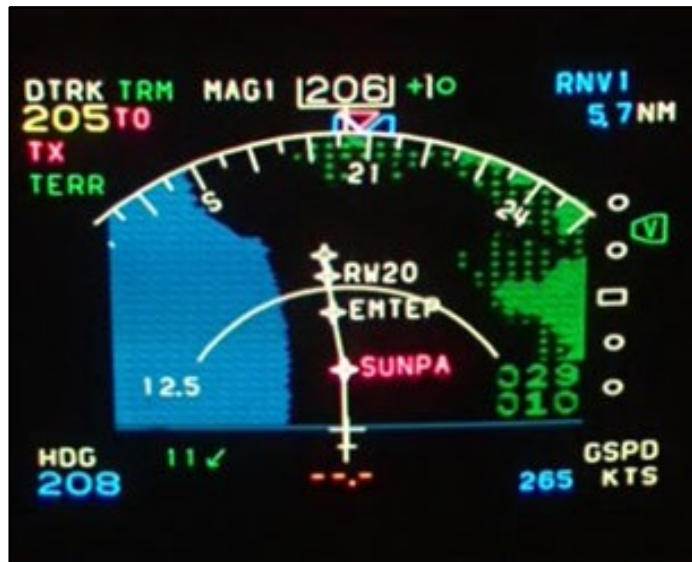
**Figure 9: EHSI displaying the aeroplane has 5.7 NM to run until waypoint SUNPA**

<sup>70</sup> For example, the EHSI display shown in Figure 9 is set to a 25 NM range and clearly shows where the aeroplane is in relation to SUNPA.
