Transport Accident  
Investigation  
Commission

# **Final report**

***Aviation inquiry AO-2024-006***  
***ATR72-600, ZK-MVL***  
***Engine fire and evacuation***  
***Wellington***  
***1 September 2024***

**September 2026**

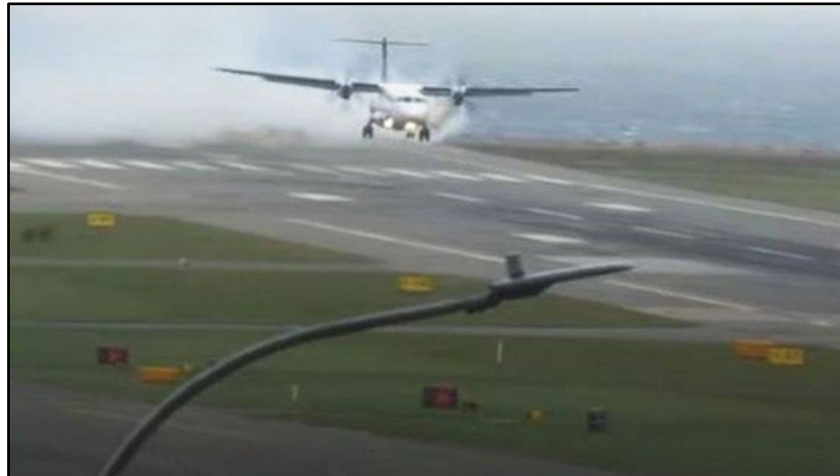
- 2.5. In issuing the line-up clearance, the tower controller was watching the ATR through binoculars as it approached the runway threshold. The tower controller observed smoke coming from one of the ATR's engines and activated the emergency alarm in the tower (see Figure 3). This in turn sounded an alarm in the airport rescue fire service (RFS) building, and the tower controller made an announcement informing RFS staff of the emergency and location. The RFS vehicles were immediately dispatched in the direction of the landing ATR.

**Figure 3: ATR72-600, ZK-MVL, about to land**  
(Credit: Wellington Flights Live)

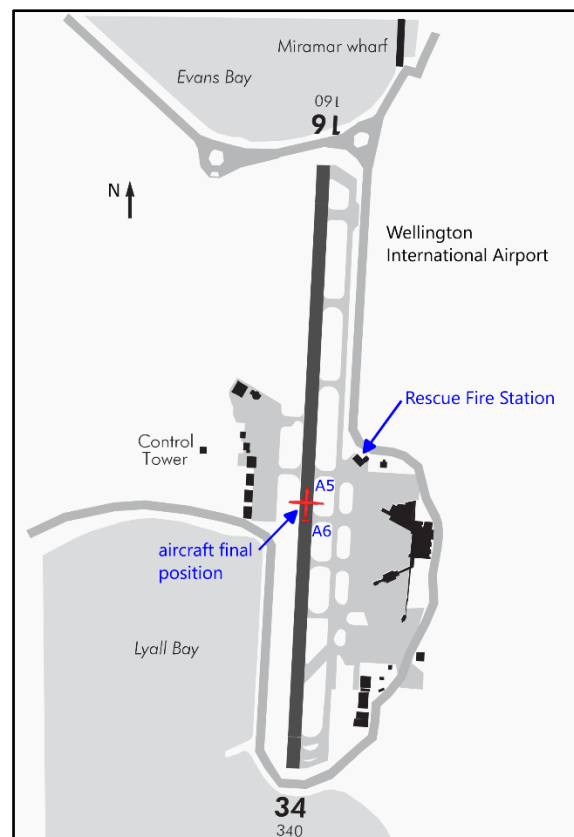
**Figure 4: Wellington Airport**

- 2.6. At 1604:30, the ATR touched down and was brought to a stop about halfway down the runway, near taxiway A6 (see Figure 4). As the ATR was slowing, the first officer made a second Mayday call on the tower frequency. The tower controller acknowledged the Mayday and advised that RFS vehicles were on their way. The tower controller then instructed the next aeroplane on approach to overshoot and remain in the circuit, and for all aircraft on the ground to hold position.

- 2.30. Runway 34 at Wellington Aerodrome was 1921 m long and 45 m wide, with 1815 m available for landing. The ATR stopped between taxiways A5 and A6 (see Figure 4).

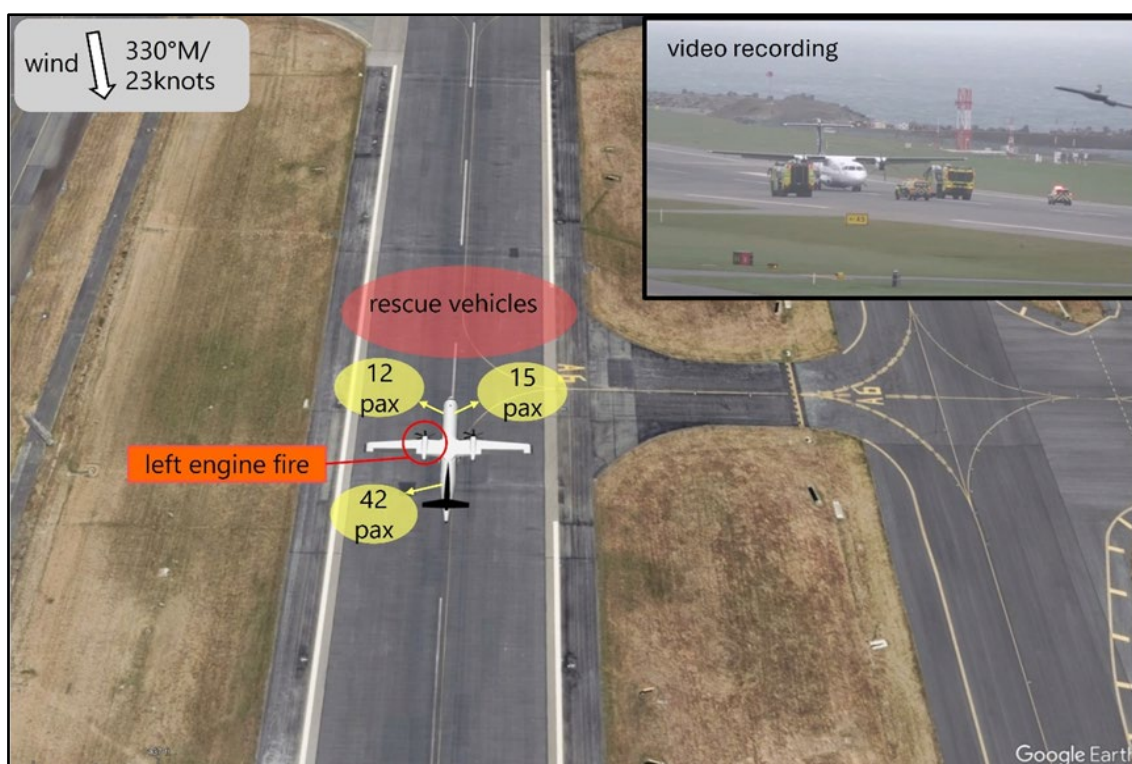
**Figure 7: Evacuation of ATR72-600, ZK-MVL, cabin**

- 3.43. The video recordings show that 12 passengers exited the aeroplane through the forward-left exit and 15 through the forward-right exit. The Commission determined that it was **virtually certain** that the remaining 42 passengers from the cabin exited using the normal entry/exit airstair door at the rear-left of the aeroplane (see Figure 7).

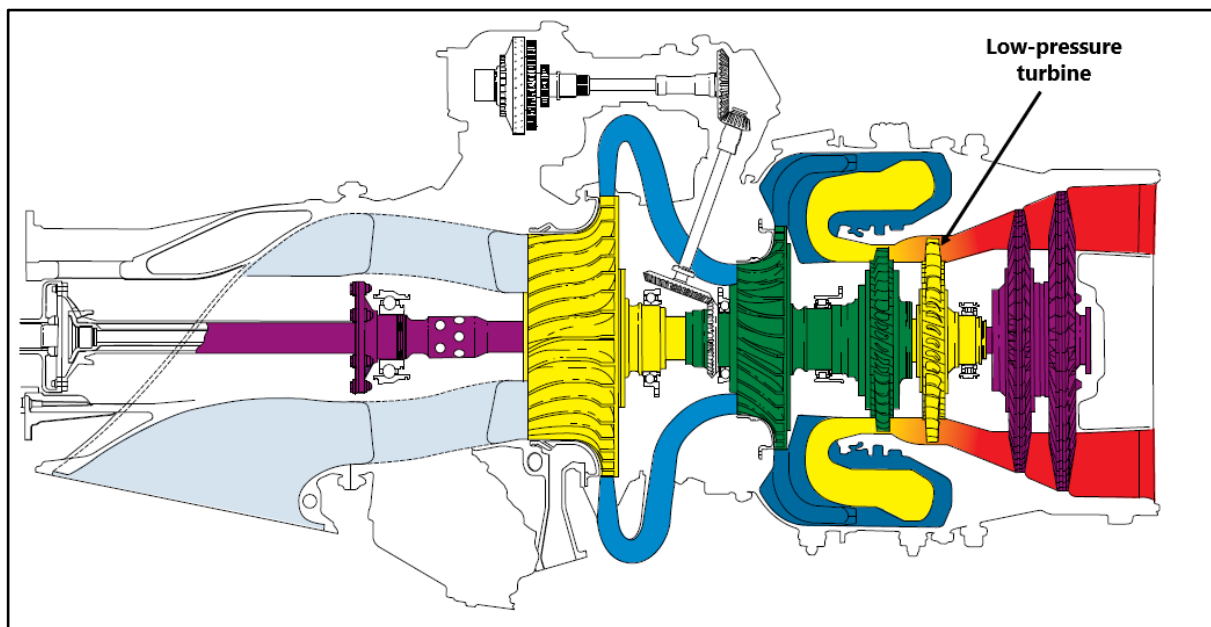
- 2.26. The ATR was powered by two Pratt & Whitney Canada (P&WC) PW127M turbo-prop engines. The original left engine had been removed as part of scheduled maintenance the day before the incident. The replacement engine, serial number ED1493, was installed on the ATR at that time. An engine ground run was satisfactorily completed and the ATR was returned to service.
- 2.27. The replacement engine had been removed from another of the operator's ATR72 aeroplanes earlier in the year and sent to the engine manufacturer's facilities in Singapore for a scheduled overhaul. The overhaul involved a teardown<sup>18</sup> of the engine and the examination or replacement of its individual components. This included replacing the low-pressure turbine (LPT) disc that was becoming time-expired and testing<sup>19</sup> the 47 LPT blades. It was then reassembled (see Figure 8).

**Figure 8: P&WC PW127M engine cutaway**  
(Credit: P&WC Training Manual)
