Transport Accident  
Investigation  
Commission

# **Final report**

***Rail inquiry R0-2025-106***  
***Train DT80***  
***Near miss with track workers***  
***Plimmerton***  
***8 May 2025***

**September 2026**

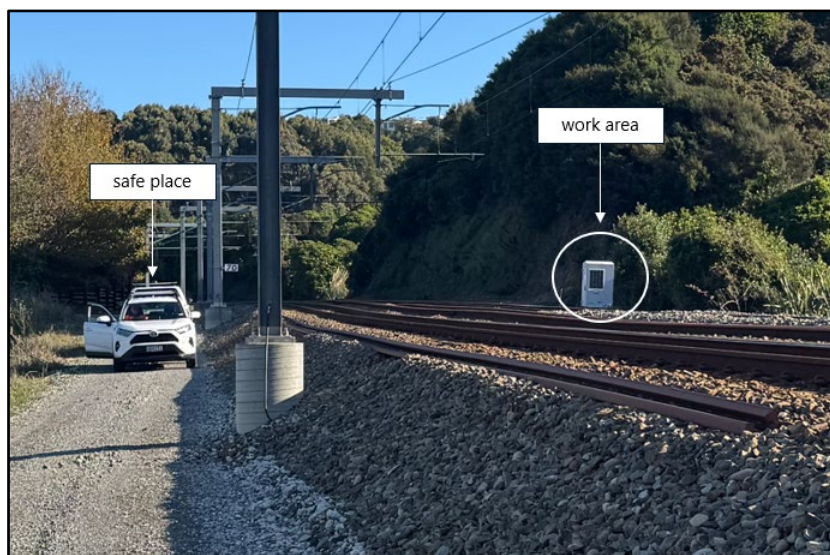
**Figure 5: Worksite location re-enactment**

- 2.14. At about 0830 on 8 May 2025, a KiwiRail RPO arrived at Plimmerton Domain car park. They were to meet SC1 and SC2, who were assigned to repair a trackside grease-dispenser control box located approximately 1 km north of the car park.
- 2.15. By about 0918, both subcontractors had arrived. The RPO opened the access gate so the contractors could follow them, in separate vehicles, to the worksite along an access road next to the rail corridor.
- 2.16. At 0921, they arrived at the worksite and parked their vehicles on the access road (see Figure 5). The RPO then realised they did not have their work-issued iPad or reading glasses. They attempted to use their iPhone to complete the Individual Train Detection (ITD)<sup>11</sup> protection arrangements.

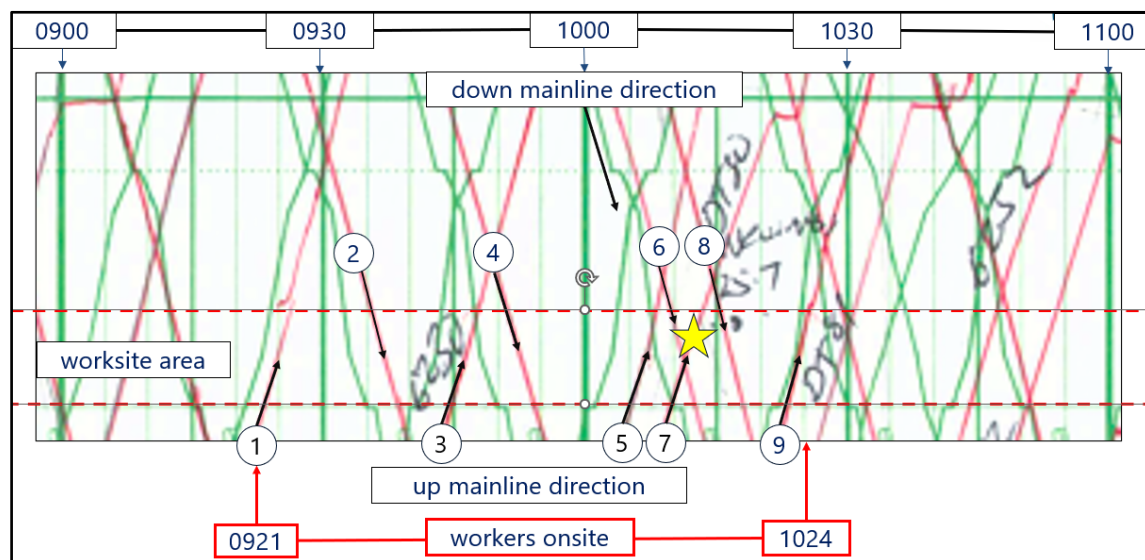
**Figure 7: Recorded train movements past the worksite area**  
(Credit KiwiRail annotated by TAIC)

- 2.21. The RPO stood next to the control box to alert the two subcontractors of any approaching rail traffic.
- 2.22. During the period that they were at the worksite (63 minutes), nine trains passed (see Figure 7). The green lines represent the scheduled train movements as per the timetable, while the red line indicates the actual time each train passed.

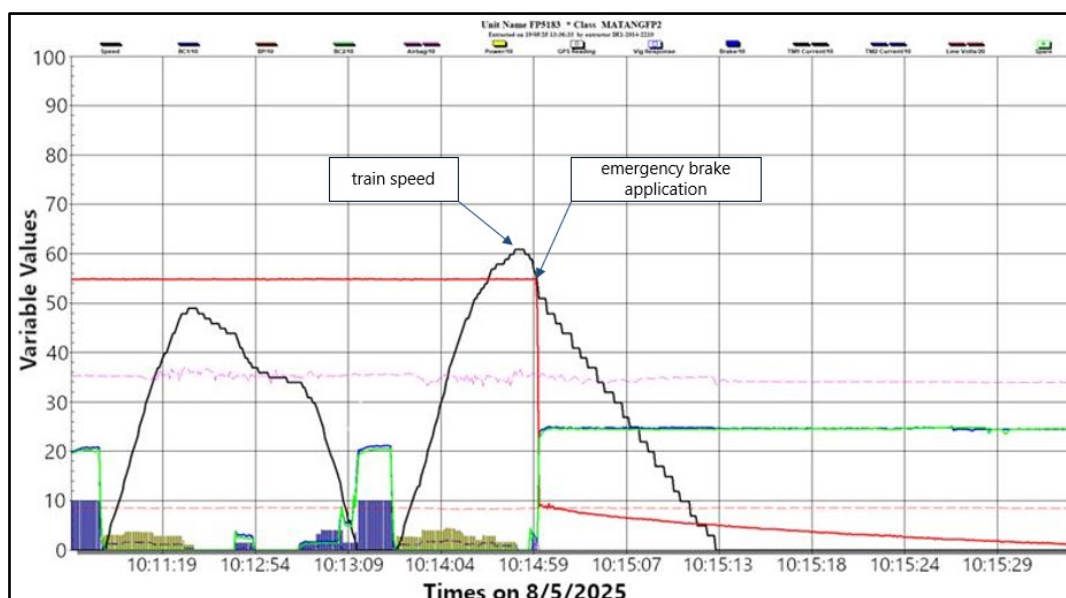
Figure 12: Tranzlog data from train *DT80*

- 2.45. Tranzlog data<sup>18</sup> was extracted and obtained by the Commission and used in this report (see Figure 12).

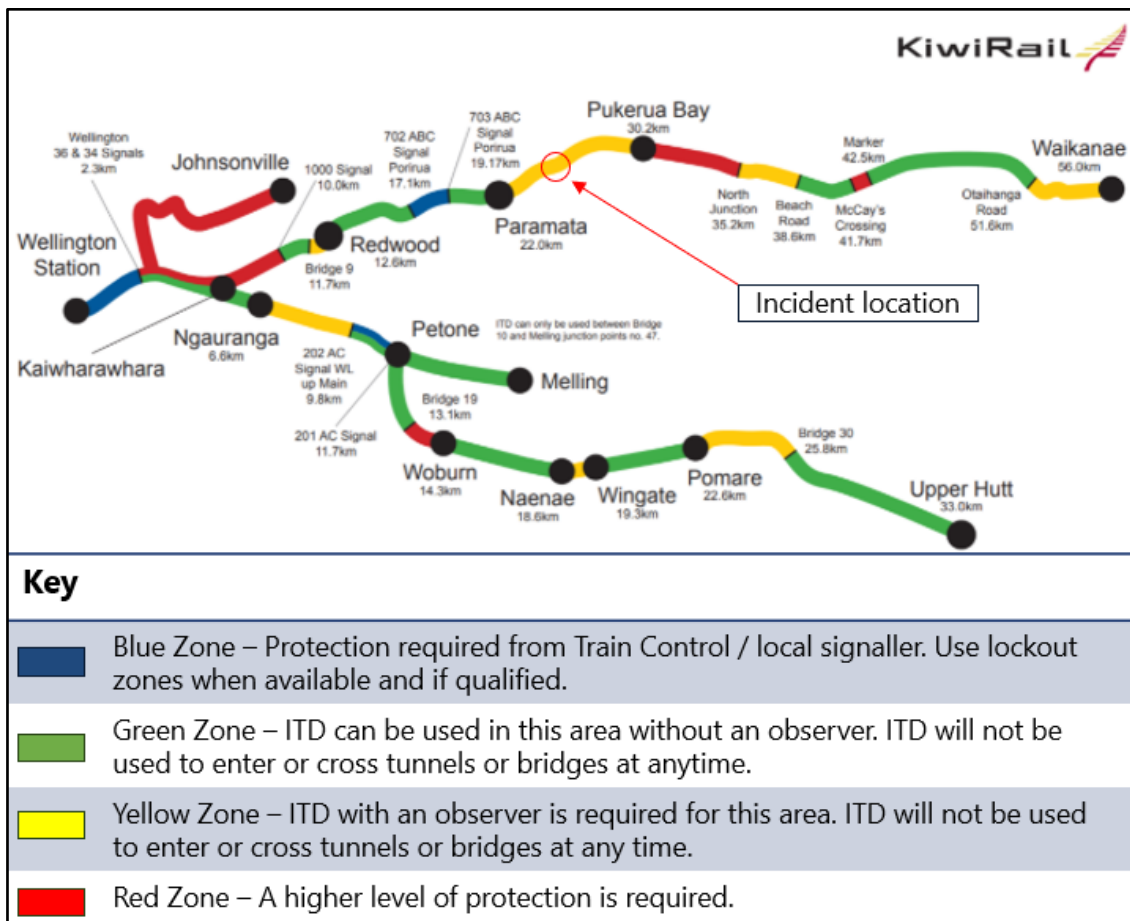
**Figure 15: Wellington ITD guidance map**

- 3.13. Under ITD protection, trains continue to operate through a worksite, and at normal line speed. The RPO was responsible for alerting the subcontractors when trains were approaching.
- 3.14. The use of ITD is only permitted in certain parts of the rail network, and different conditions apply depending on the location, sightline rules and safe place rules (see Figure 15).
