Jet Boat Accidents

Historical Impact Review

CR-2012-505

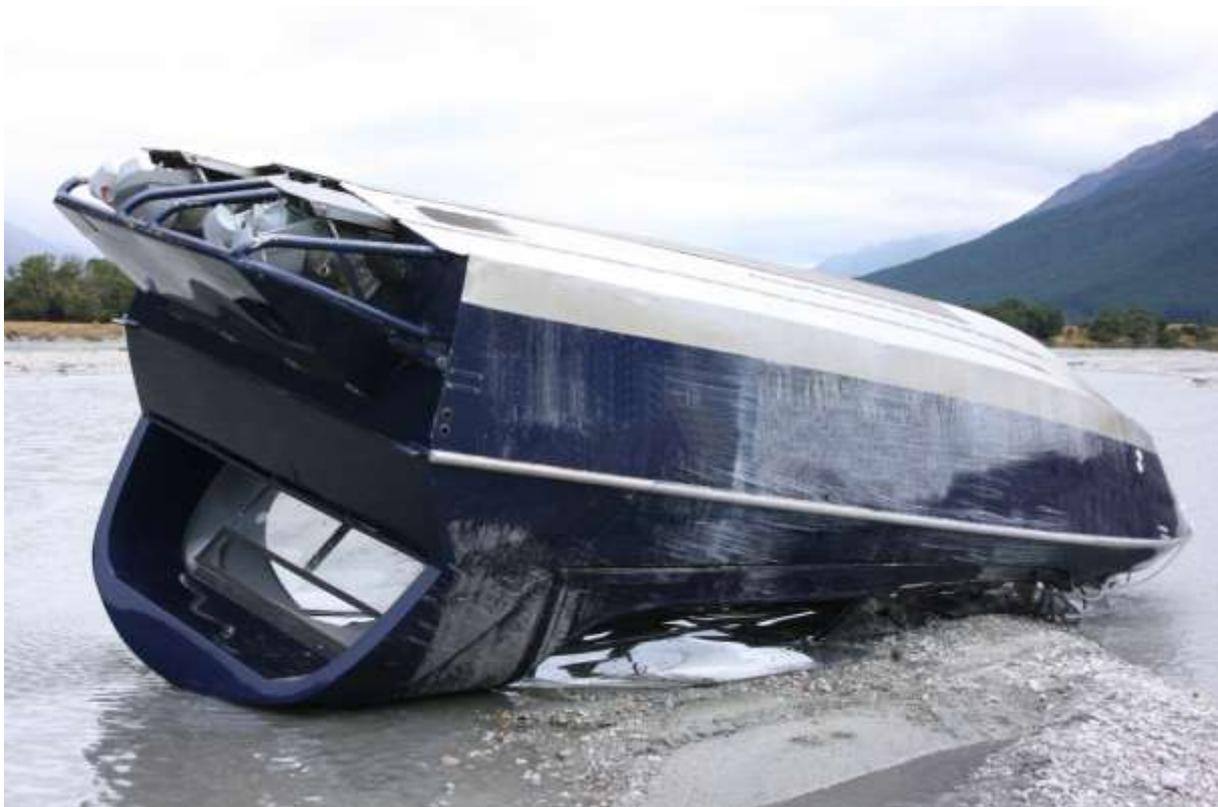
Cover photograph from the Transport Accident Investigation Commission's Report 09-203, jet boat, DRJS-11 grounding and subsequent rollover Dart River, near Glenorchy, 20 February 2009 (Digitally Altered).
